**COMISIÓN DE
INVESTIGACIÓN
DE ACCIDENTES
E INCIDENTES DE
AVIACIÓN CIVIL**

Report IN-029/2016

Incident involving an Airbus A-320 aircraft, registration EC-LRE (operated by Vueling), and an Airbus A-321 aircraft, registration HB-ION (operated by Swiss), in the vicinity of point NITBA in the Barcelona TMA (LECB, Spain) on 25 July 2016.

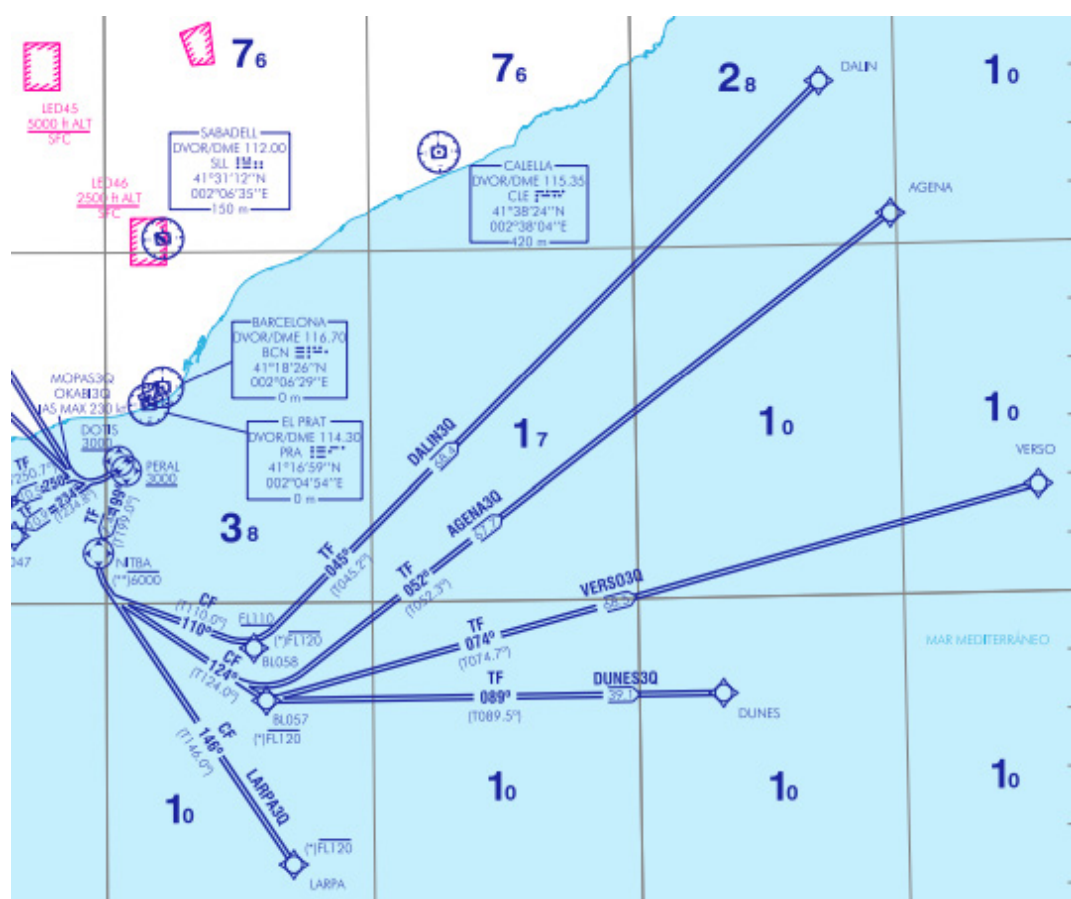
Figure 1: Standard Instrument Departures AIP Spain

Carrying out the instructions received by the controller would cause the flight paths to cross laterally, since point DALIN is further north than VERSO (see Figure 1). The instruction issued was thus incorrect.

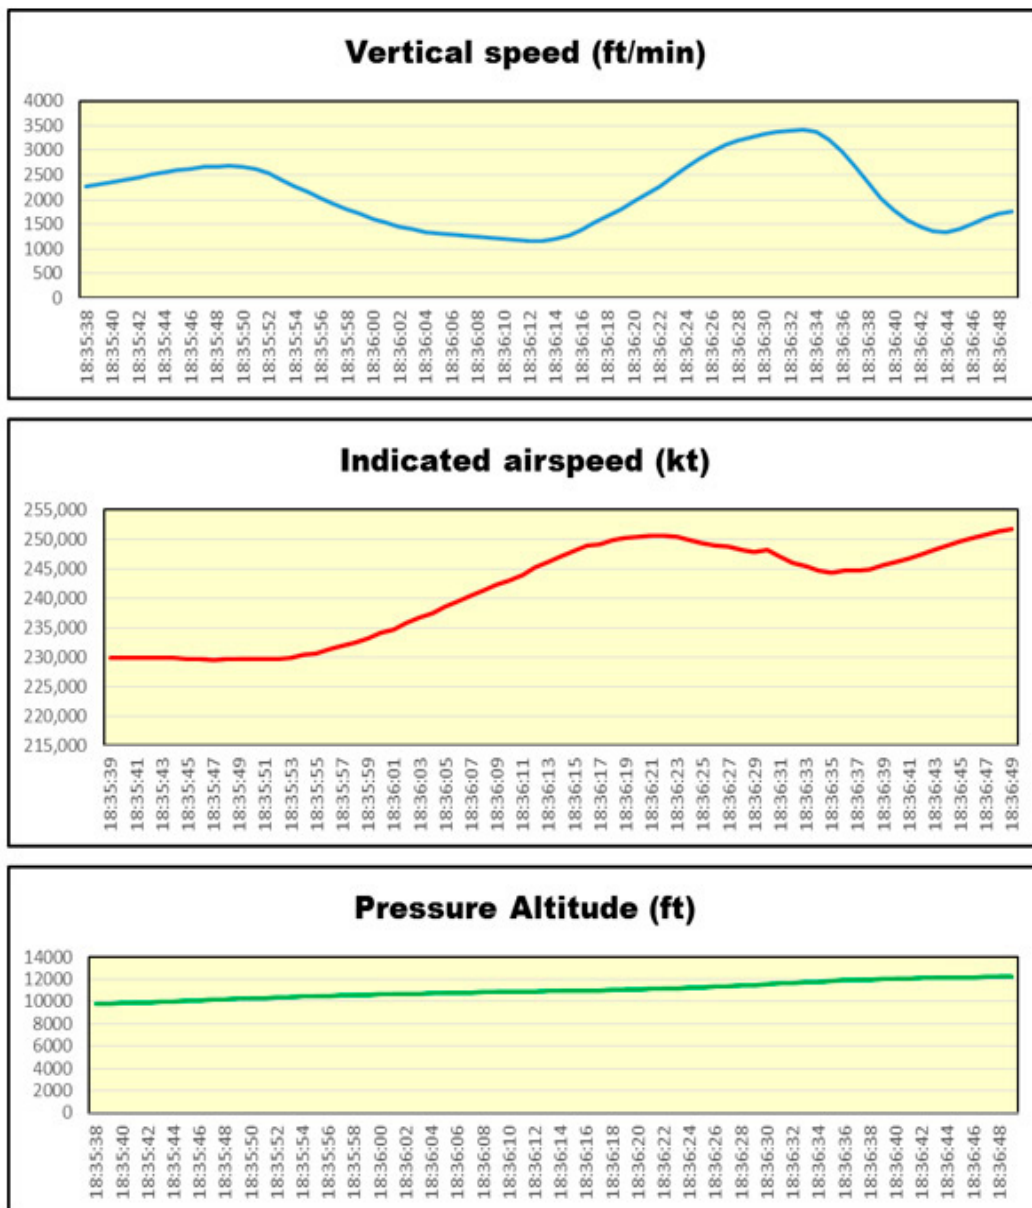
At 18:35:42, the TA was activated. The traffic was climbing through 9900 ft at 230 kt with a climb rate of 2500 feet per minute.

At 18:36:18, the "CLIMB" RA was activated, which required the crew to increase the climb rate. The aircraft was climbing through 11100 ft at 250 kt and 1900 ft/min.

The crew disengaged the autopilot and increased the climb rate to 3400 ft/min, maintaining 250 kt. The RA was activated for 16 seconds.

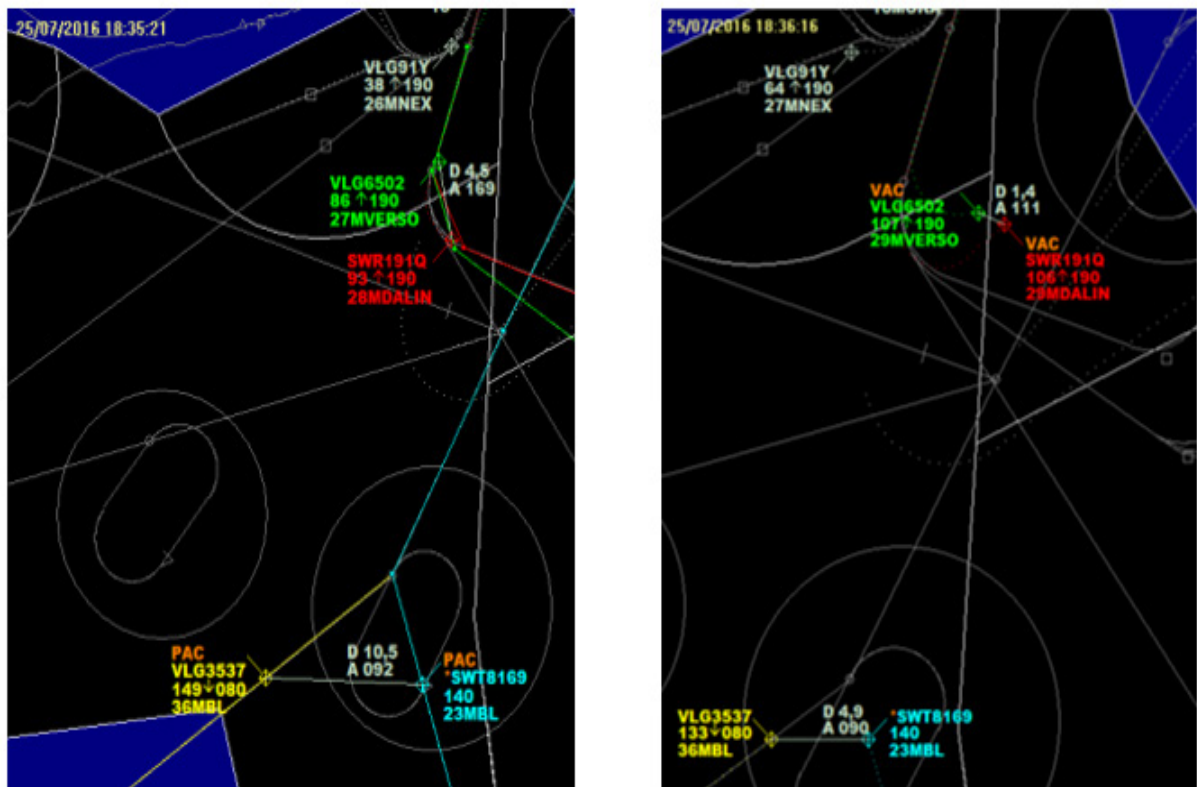
At 18:36:16, a CAV alert was issued due to the two aircraft. The horizontal distance between them had dropped to 1.4 NM and the vertical distance to 100 ft. Both aircraft were above FL105.

So as not give nuisance alerts, this function of the STCA system was inhibited below FL105 at the Barcelona TMA.

The STCA alarm was activated when the separation between the aircraft was lost, resulting in a Conflict Alert Violation (CAV) without a preceding Conflict Alert Prediction (CAP). At the time of the incident, this alarm had been inhibited from FL105 to MSL.
