**COMISIÓN DE
INVESTIGACIÓN
DE ACCIDENTES
E INCIDENTES DE
AVIACIÓN CIVIL**

Report IN-033/2016

Incident involving an Airbus A321-231, registration EC-MHS (operated by Vueling Airlines, S.A.) and an Airbus A320-214, registration G-EZTF (operated by Easyjet Airline Company LTD), in the vicinity of point ASTEK, intermediate approach fix for runway 07L at the Barcelona-El Prat Airport (Spain) on 7 August 2016

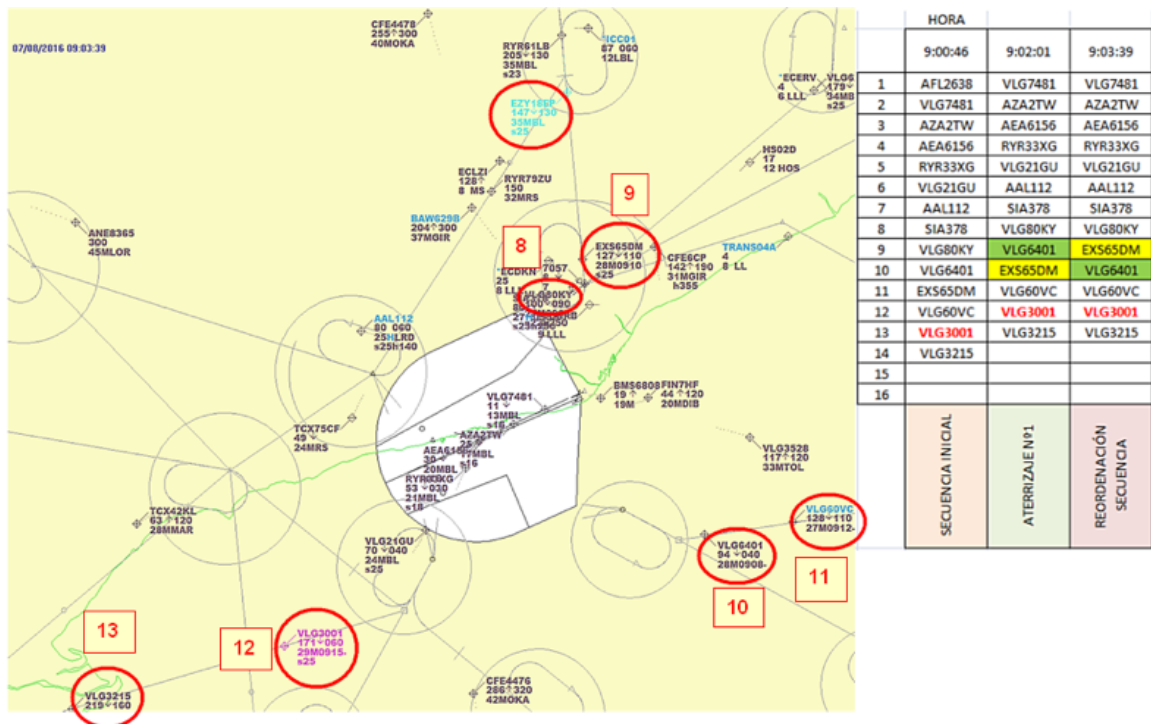
Figure 3. Sequence at 09:03:39

The data from the air traffic control system were used to compile the sequence shown below. Initially, the controller who was handling the arrivals queue (QM) had set up a sequence in which VLG6401 was ahead of EXS65DM. At 09:03:39, the sequence was modified, leaving it as shown below in Figure 3:

Before that time, the AMAN tool had not assigned a sequence number to EZY18EP, RYR61LB or VLG6247, all of them inbound from the north.

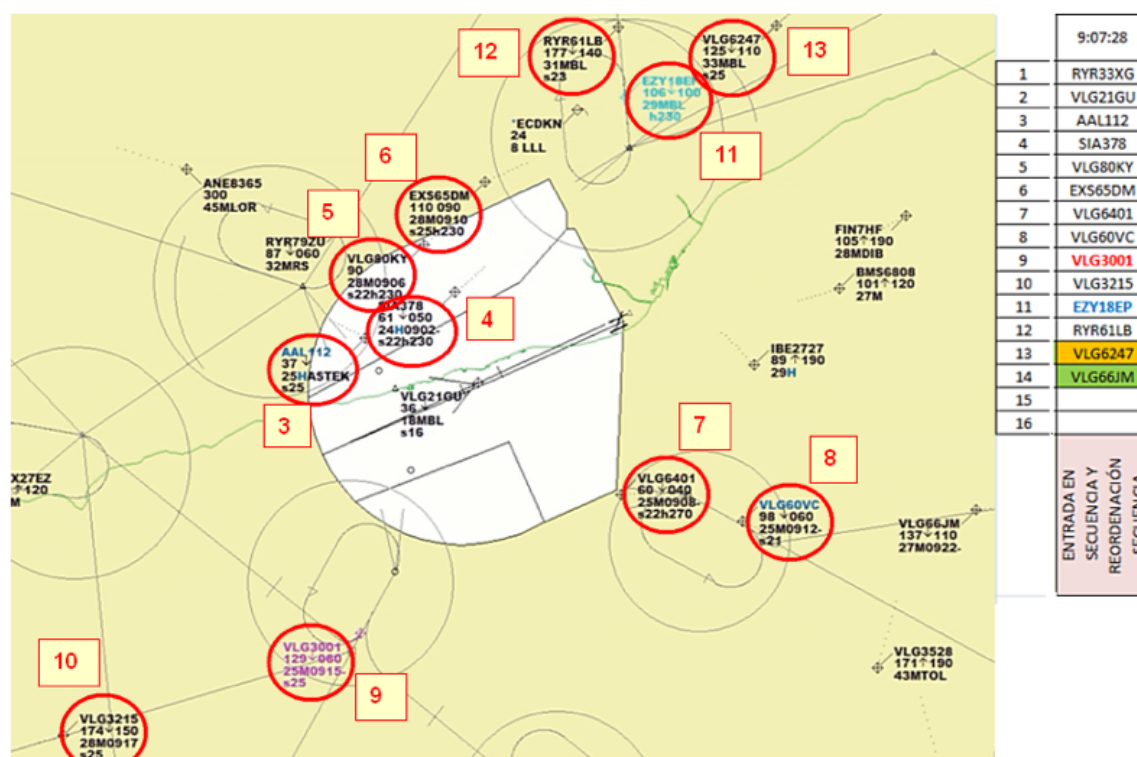
Figure 4. Sequences at 09:07:28

At 09:07:28, an arrival order was assigned to VLG6247, which was sequenced in with two aircraft from the north (numbers 5 and 6), four aircraft from the south (7, 8, 9 and 10) and three more from the north (11, 12 and 13). These last three reached the SLL IAF separated by under 5 NM. Figure 4 shows the position of the aircraft when the sequence was established.

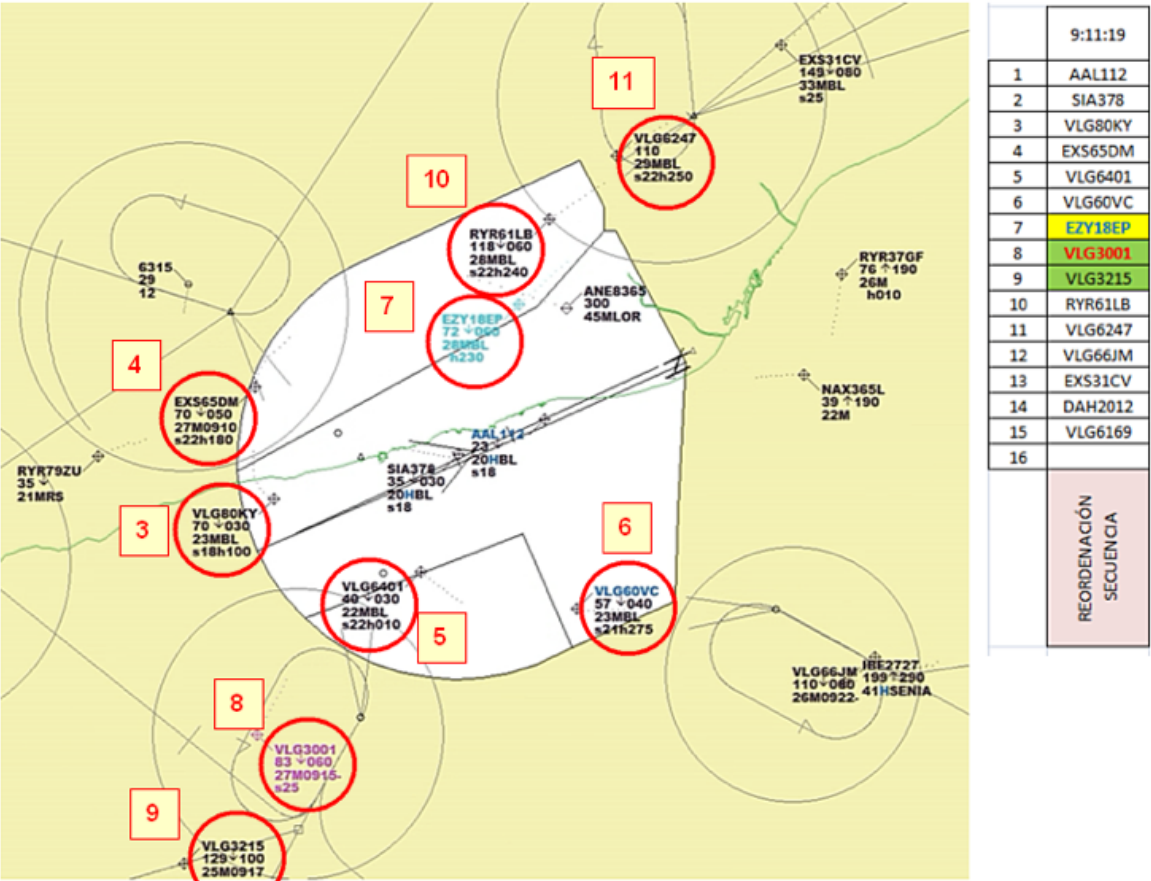
Figure 5. Sequence at 09:11:19

At 09:11:19 (Figure 5), the QM approved a change to the established sequence, moving EZY18EP ahead of VLG3001 and VLG3215.

VLG3001 was still holding at the RUBOT IAF. EZY18EP, RYR61LB and VLG6247, inbound from the north, had left the SLL IAF on headings 230°, 240° and 250°, respectively.

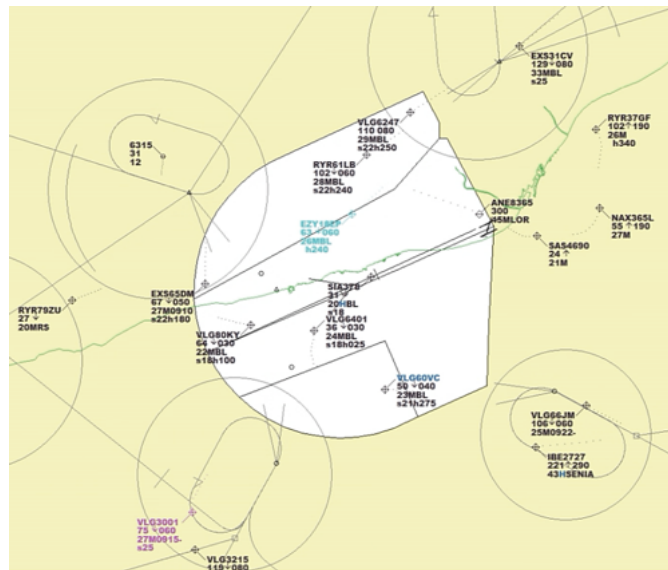
Figure 6. Sequence at 09:11:59

Figure 6, below, shows the traffic situation at 09:11:59, when Sector T3 instructed VLG3001 to proceed to the RUBOT IAF and leave it heading north. It also shows that VLG6401 was being vectored to intercept the Localizer ahead of VLG80KY and EXS65DM, despite being behind them in the established sequence.

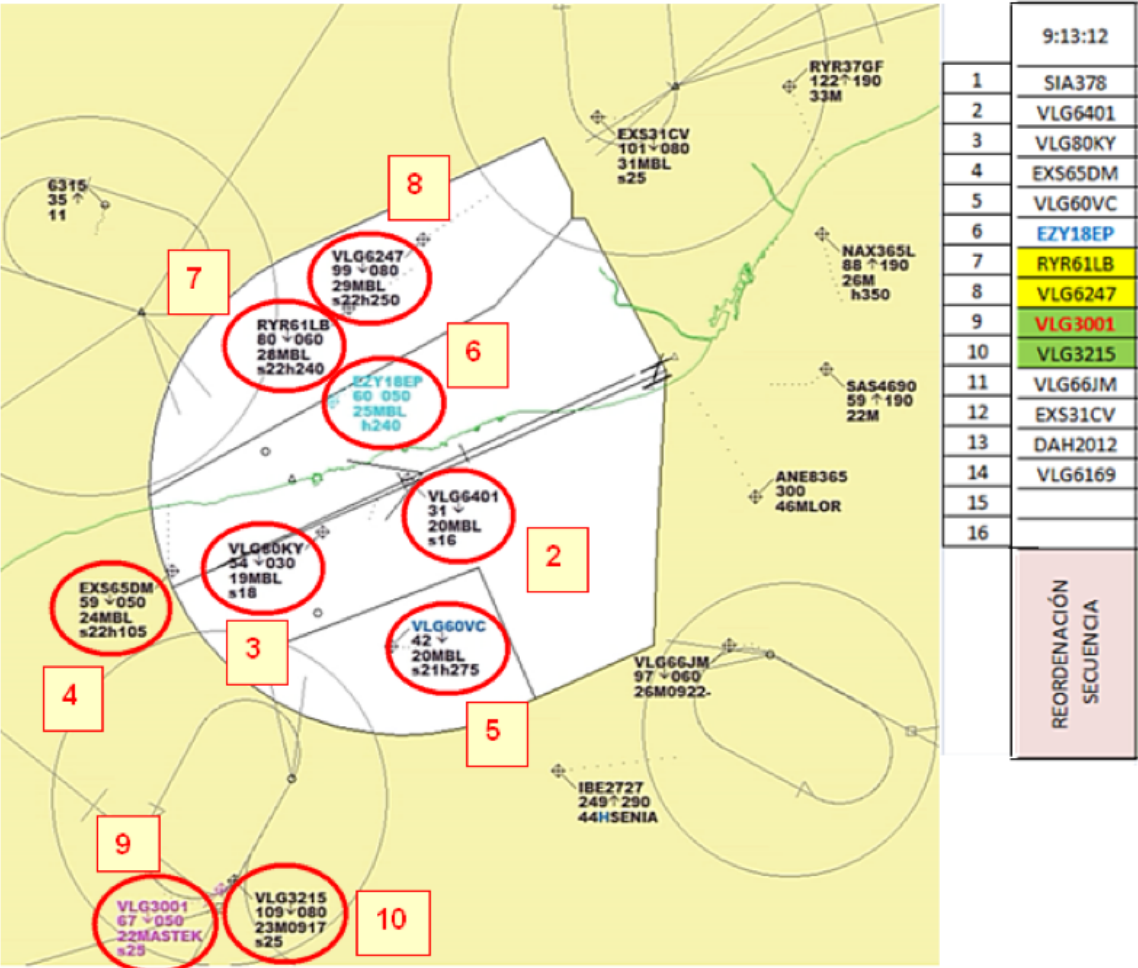
Figure 7. Sequence at 09:13:12

At 09:13:12, Figure 7, the QM made another sequence change, putting RYR61LB and VLG6247, which were inbound from the north, ahead of VLG3001. As a result, the sequence in place meant that after the three aircraft that were at the Localizer (marked with positions 2, 3 and 4 in Figure 7), there was one aircraft (VLG60VC, position 5) inbound from the south, three more (EZY18EP, RYR61LB and VLG6247, in positions 6, 7 and 8, respectively) from the north, followed by VLG3001 (in position 9) from the south.

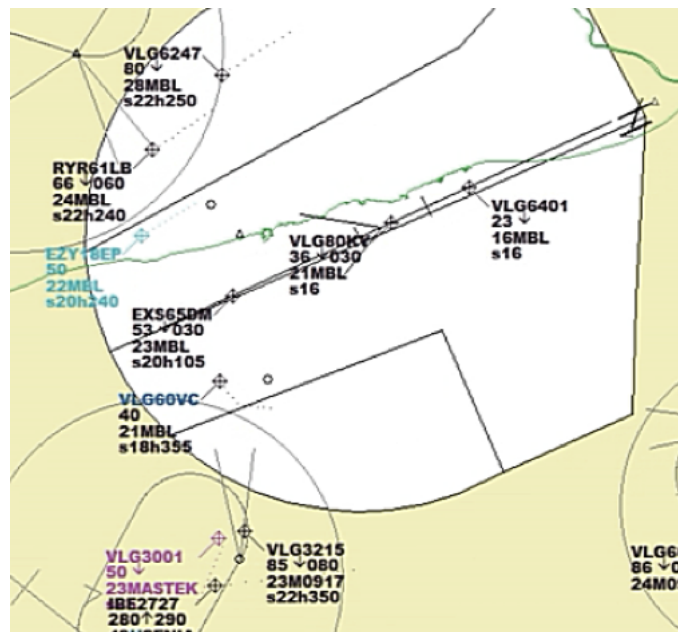
Figure 8. Sequence at 09:14:59

At 09:14:59, Figure 8, when the T3 controller transferred VLG3001 to the Final approach frequency, the aircraft was in the vicinity of IAF RUBOT holding at 5000 ft. There were three aircraft at the Localizer and another four ahead in the sequence that had not intercepted the Localizer yet.

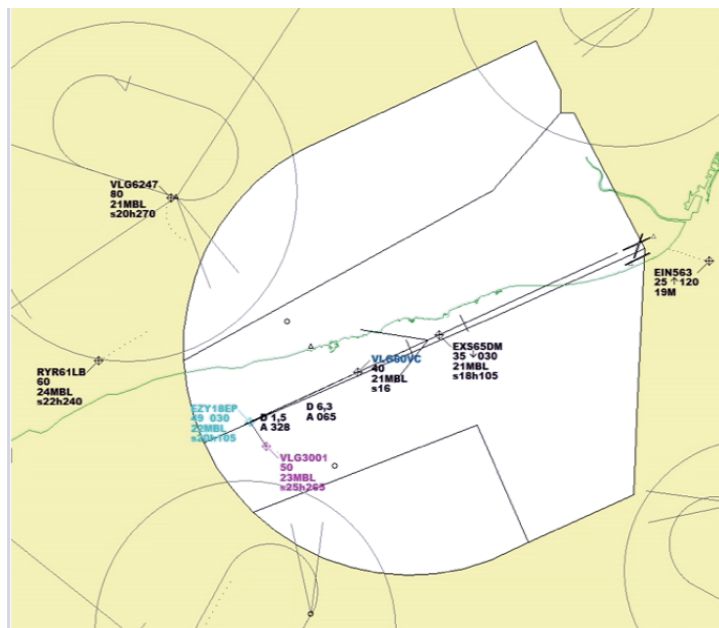
Figure 9. Closest point of approach

By 09:17:09, EZY18EP had started its descent from 5000 ft and was at 4900 ft. VLG3001 was still at 5000 ft and separated horizontally from it by 1.5 NM, Figure 9.

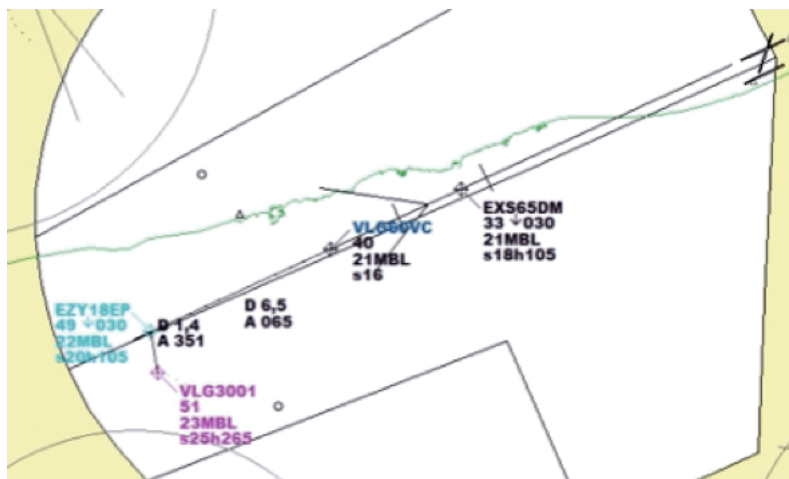
Figure 10. Closest point of approach

Figure 10 shows that the shortest horizontal distance between the aircraft was 1.4 NM. The radar data show that VLG3001 was turning left. The vertical distance between the aircraft at that point was 200 ft, since VLG3001 had climbed to 5100 ft.
