**COMISIÓN DE
INVESTIGACIÓN
DE ACCIDENTES
E INCIDENTES DE
AVIACIÓN CIVIL**

Report A-036/2016

Accident involving a Piper
PA-28-161 Warrior II aircraft,
registration EC-JCI, at the Seville
Airport (Seville, Spain) on 9
September 2016

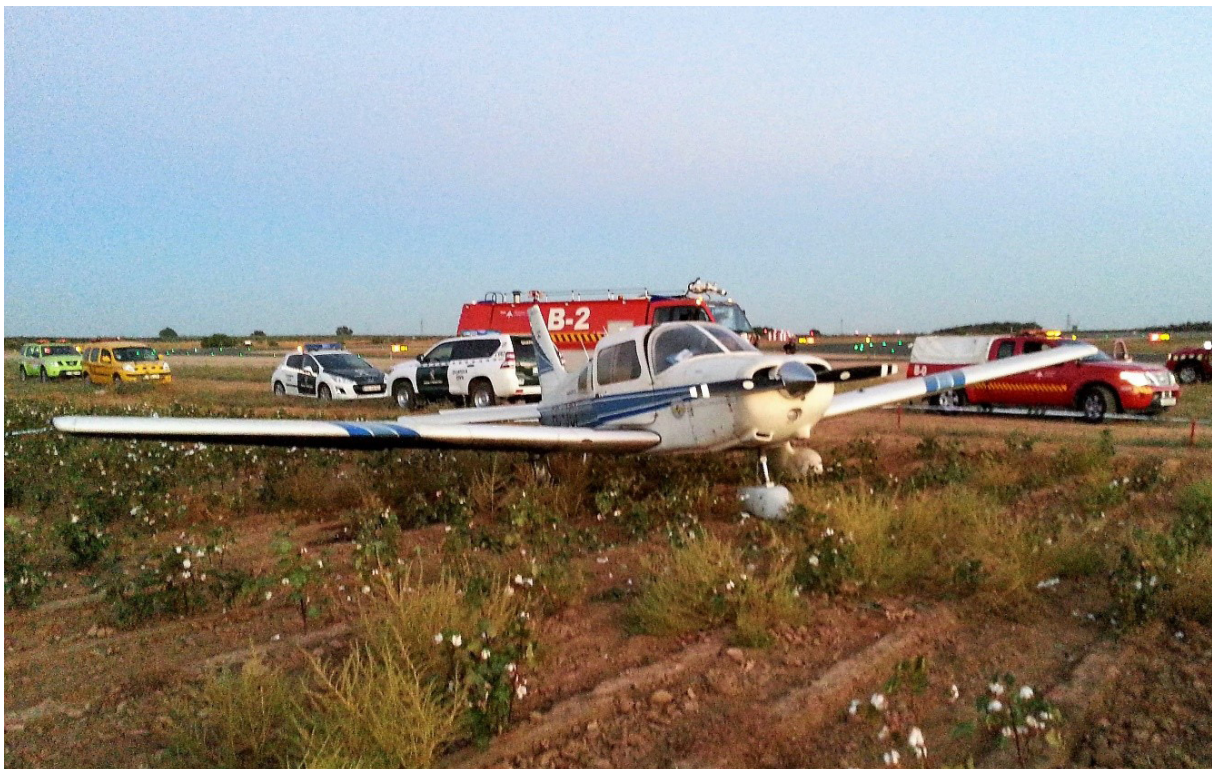
Photograph 1. Accident aircraft after taxiway excursion

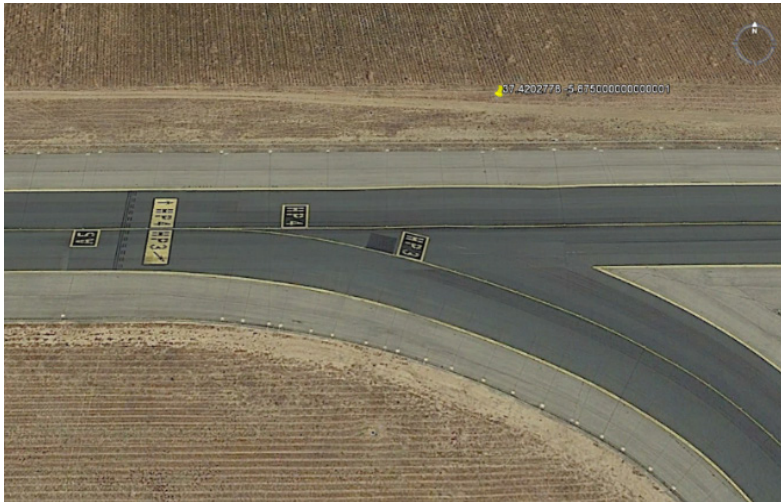
On the paved side strip to the left, where the aircraft veered off the taxiway, a mark

left by hydraulic fluid was found ("point 1" in the diagram in Figure 4). Two curved parallel marks were then identified, which were blackened in the paved area (point 2), probably from the landing gear, marking the path taken by the aircraft to the stopping point.

Photograph 5. Accident site

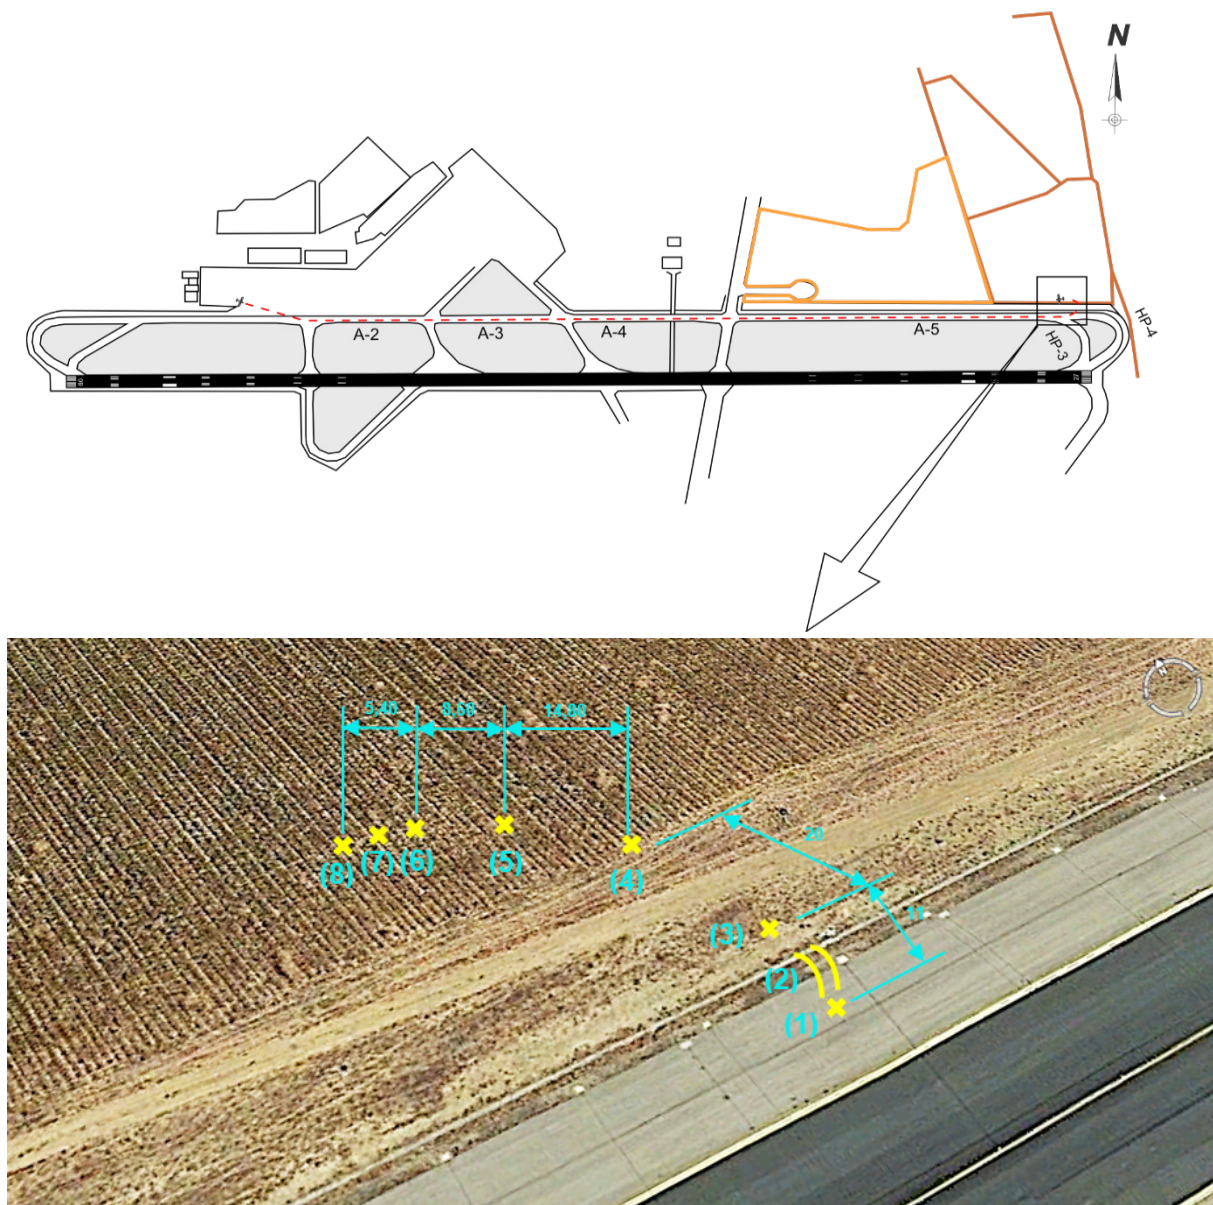
Some 11 m away from the hydraulic fluid mark, and continuing along the path marked on the asphalt, in the middle of some weeds, burned debris from the landing gear fairing were found (point 3). Also identified were further remains of burned fibers and fairings at points 4 (20 m away from point 3) and 5 (14.80 m from point 4).

Bits of melted aluminum were found at point 6 (8.60 m away from point 5). Parts of a burned brake caliper and other melted materials from the brake assembly were found at point 7, and finally, at point 8 (5.40 m away from point 6), where the aircraft came to a stop, the last remains of burned fairing fibers were found.

Figure 4. Locations of debris/marks left by accident

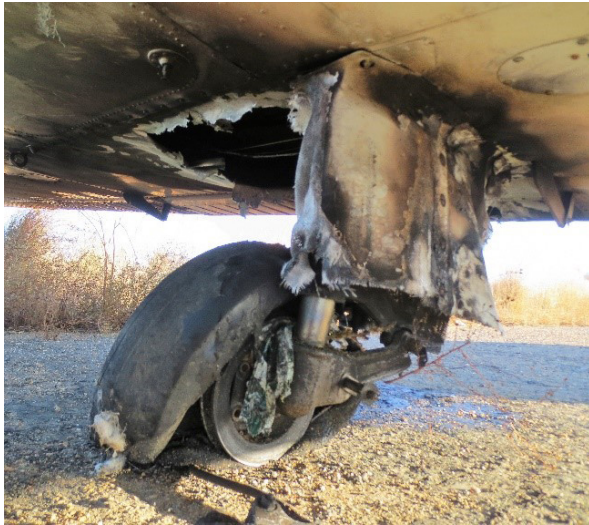
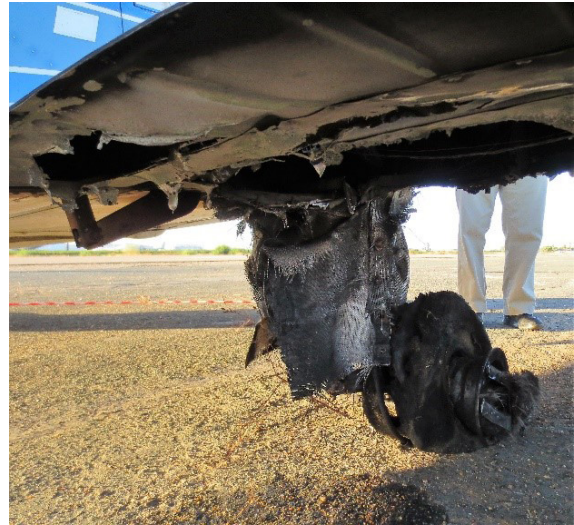
- Right landing gear leg, fairing, wheel, tire and hydraulic fluid lines, burned and rendered completely useless. Photographs 6 and 7.
- Right wing: skin on the wing burned and destroyed, revealing a large hole in the lower surface and a fracture/perforation in the upper surface. Photographs 8 and 9.

The hydraulic fluid line was loose, having been ripped from the brake assembly. The protective sleeve was completely melted, exposing the metallic mesh inside. Of the two straps fastening this line, the top one was broken and the bottom one was melted.

The landing gear cover and fairing were melted, and the top and bottom surfaces of the wing closest to the gear were also burned and the sheet metal was melted.

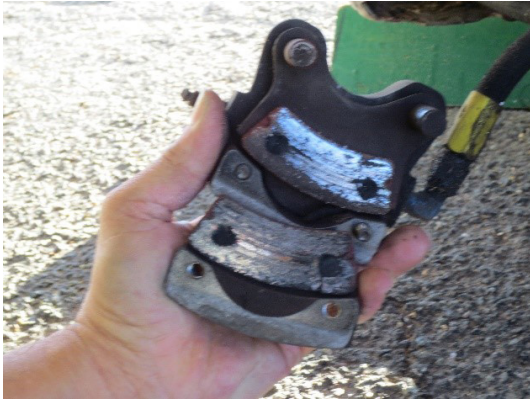
The fairing was removed from the left landing gear leg. The brake system was carefully inspected and the brake assembly was disassembled in order to check the condition of the blocks and disc. Both were in poor condition. The blocks had crystallized and the brake disc was warped and insufficiently flat.

Photograph 10. Shoes, blocks and friction material on left wheel brakes

The wear on both brake blocks was evident, as was their poor condition. The block material was crystallized. This damage leads to poor, inefficient braking. Specifically, the crystallization of the friction lining causes the damage found on the brake discs, though this damage is only caused by the prolonged use of the blocks in bad condition. The overheating identified in the components can also only be produced through prolonged use, and should at least have been detected during the scheduled maintenance inspections, if not during the pre-flight checks while taxiing.

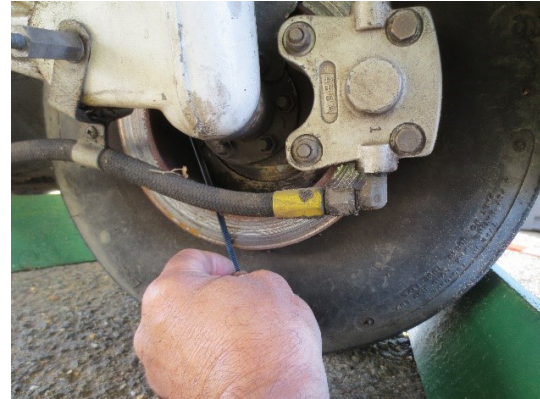
Photograph 11. Brake disc on left wheel

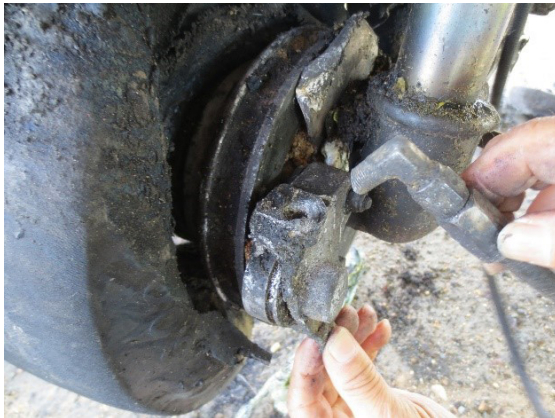
Due to the poor condition of the right landing gear leg, the airplane was lifted on jacks in order to inspect the right wing. All of the components on the right landing gear were disassembled. The brake disc and blocks were in poor condition. The disc was warped and exhibited some concavity. There were also numerous concentric marks and grooves on the braking surface. The blocks were burned and the friction surfaces were thin and crystallized (carburization).

Photograph 12. Brake disc on right wheel

indicative of clearly deficient maintenance. The right-hand system in particular showed significant wear of the brake blocks, and obvious damage to the disc. Even if these components had been replaced during the last scheduled maintenance checks, something for which there is no evidence, these problems should have been identified during the pre-flight inspections on subsequent flights, at least during the taxi checks, since the position of the landing gear fairing makes it difficult for the pilot to easily conduct a specific visual check of the brake blocks without using a tool, such as a lighted mirror or the like. Such a determination would have entailed replacing these components.

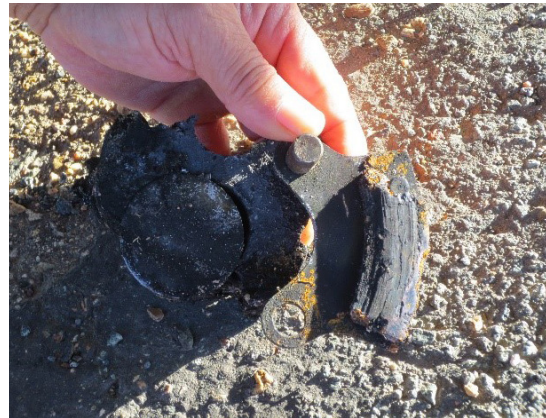
Photograph 13. Shoes, blocks and friction material on right wheel brakes

The considerable wear and evidence of overheating evidenced by the brake blocks is not the result of a few hours of flight time, meaning their poor condition should have been detected prior to this event, at least by the maintenance personnel and at any rate by the pilot while taxiing.

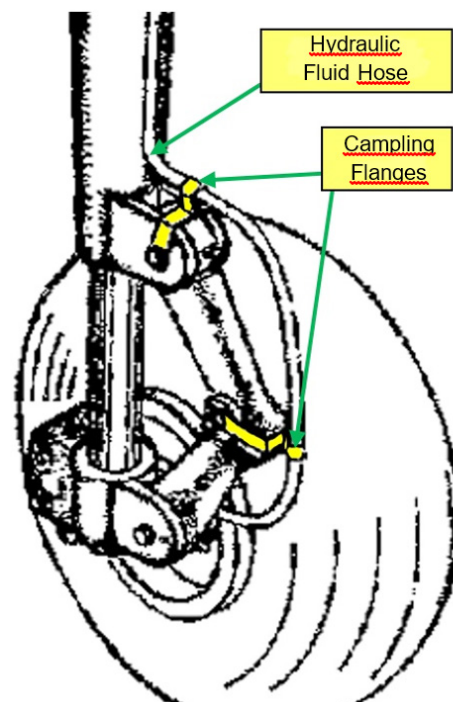
Figure 7. Attachment of hydraulic fluid line.

The hydraulic line that was found detached, and whose coating had melted,

probably came loose when it detached from its connection to the shoes due to overheating, which expanded the material at the attachment point. The remains of the straps used to attach the line to the leg were found. The top one was broken and the bottom one melted. When the bottom strap detached due to the high temperature, the top one could have broken by the force exerted by the loose line while taxiing. This component, however, had been replaced during a recent scheduled maintenance inspection, and its improper attachment during some maintenance activity could also have been the cause behind the detachment.
