## **Report IN-037/2016**

Incident involving a Gulfstream G200 aircraft, registration EC-KBC, at the Barcelona-El Prat Airport (LEBL, Spain) on 26 September 2016.

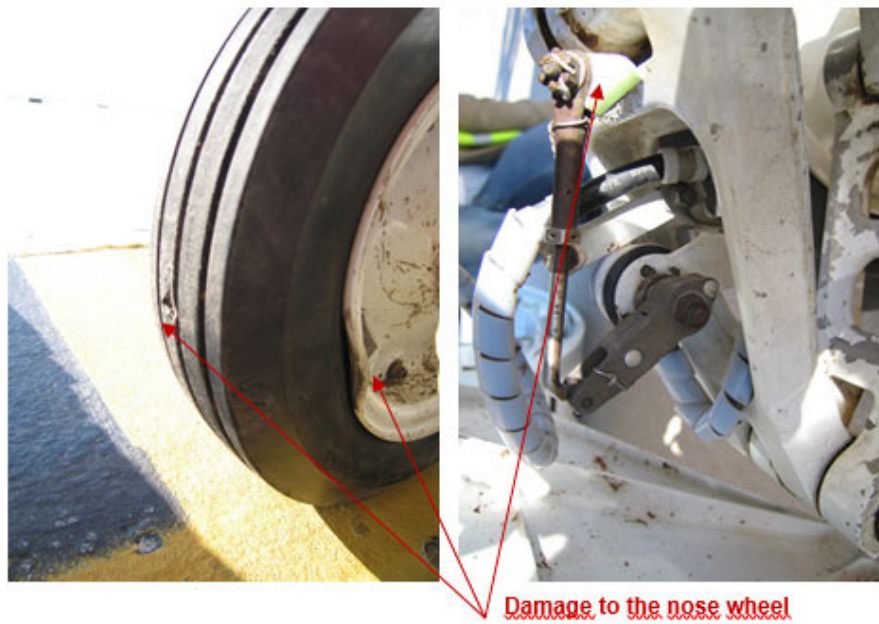
The aircraft had no apparent damage except to the nose gear. This damage consisted of notches on the tire, a dented rim and a broken bracket for one of the weight-on-wheel (WOW) sensors (see Photograph 2).

Photograph 2: Damage to the nose wheel and to the nose wheel bracket.

The manufacturer was subsequently asked about the effect that the broken nose wheel bracket could have had on the aircraft’s steering control if the bracket had broken during the landing run instead of when the aircraft was being towed (as was initially thought). The manufacturer stated that this bracket supplied the third WOW sensor, which affected the reverser system, and that in such a case, the reversers would have retracted automatically. The reversers were in operation throughout, and thus the possibility that this bracket broke during the landing run was ruled out.

The reversers were at full thrust for the entire landing run and runway excursion. This rules out the possibility that the bracket in the nose leg, which was found damaged after the incident, could have broken during the landing run, since it housed the third WOW sensor<sup>47</sup>, which affects only the reverser system, meaning they would have stowed automatically. It was concluded that this bracket must have been damaged while towing the aircraft.

- No FOD was found when the runway was inspected after the incident.
- The bracket that was found broken after the incident did not contribute to the incident and did not affect the directional control of the aircraft.

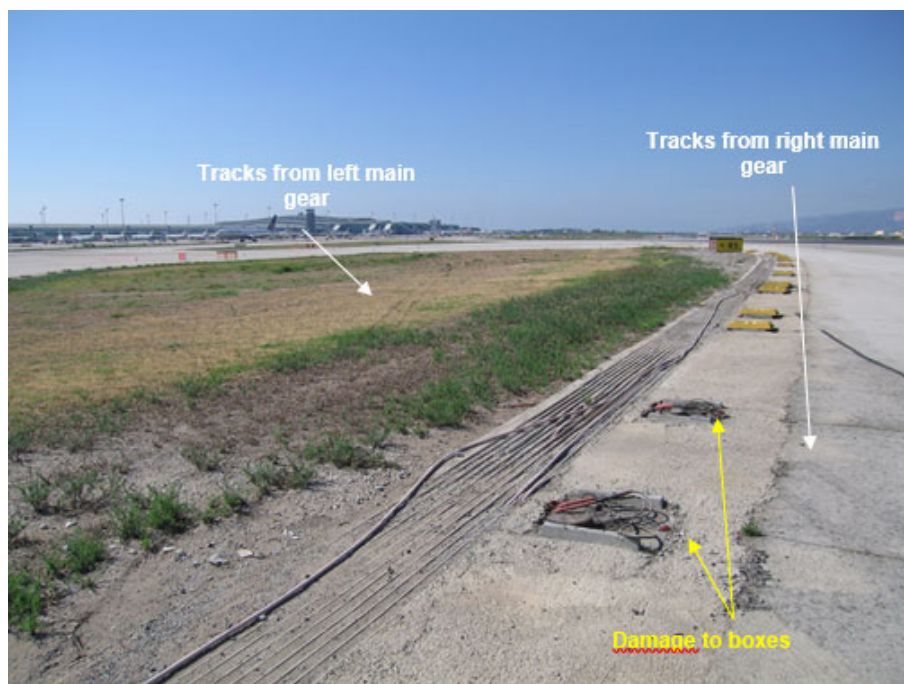
The covers on three electrical wiring boxes, located between the runway in use (25R) and the island between exits R3 and R4, were damaged (see Photograph 3).

Photograph 3: Damage to electrical boxes and tracks of the aircraft seen in the direction of motion of the aircraft.

As corrective measures, the unpaved area was paved after the incident to conform to the values specified for the 07L/25R runway strip, and the damaged box covers were repaired.

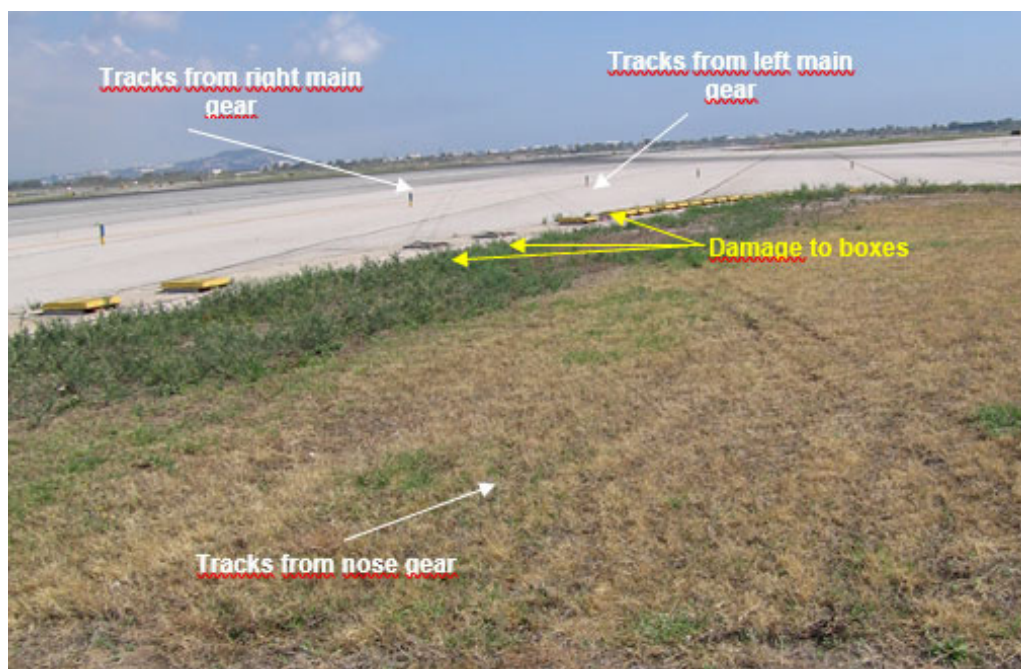
Photograph 4: Damage to electrical boxes and tracks of the aircraft seen head-on.

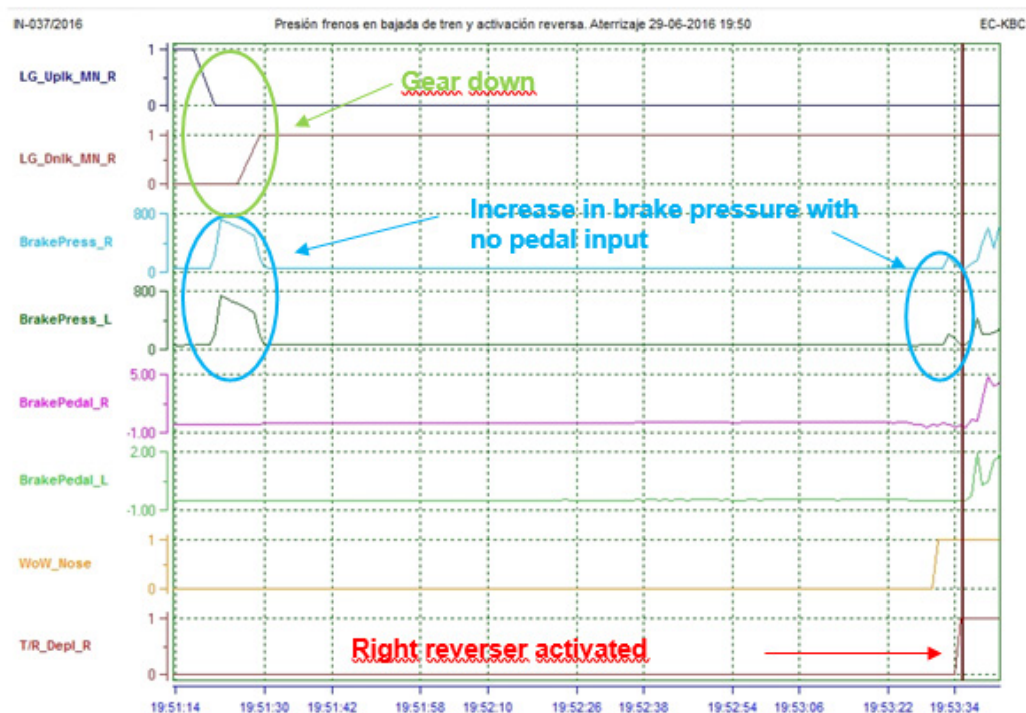
At 19:48:22, the crew selected 20° flaps and at 19:51:22, the landing gear was lowered. At that point, they were descending on the glide slope at an indicated airspeed of 150 kt and an altitude of 1443 ft, 4.4 miles out. During the gear extension process, maximum brake pressure values of 731 and 721 psi were recorded in the left and right systems respectively (see Graph 1).

Graph 1: Increase in brake pressure during gear extension and right reverser deployment

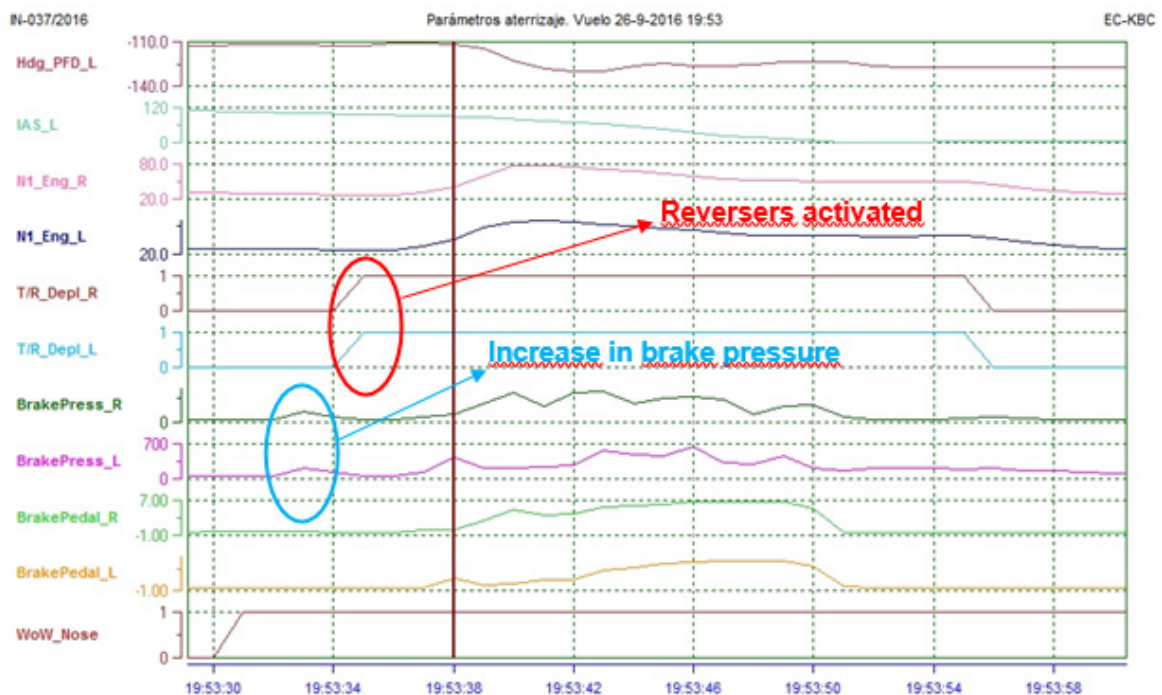
At 19:53:34, there was a symmetric increase in the brake pressure to 218 and 211 psi without there being any brake inputs from the crew, and two seconds later, the reversers deployed simultaneously at full power while at an IAS of 99 kt on a magnetic bearing of 247° (see Graph 2).

Graph 2: Increase in brake pressure and subsequent activation of reversers

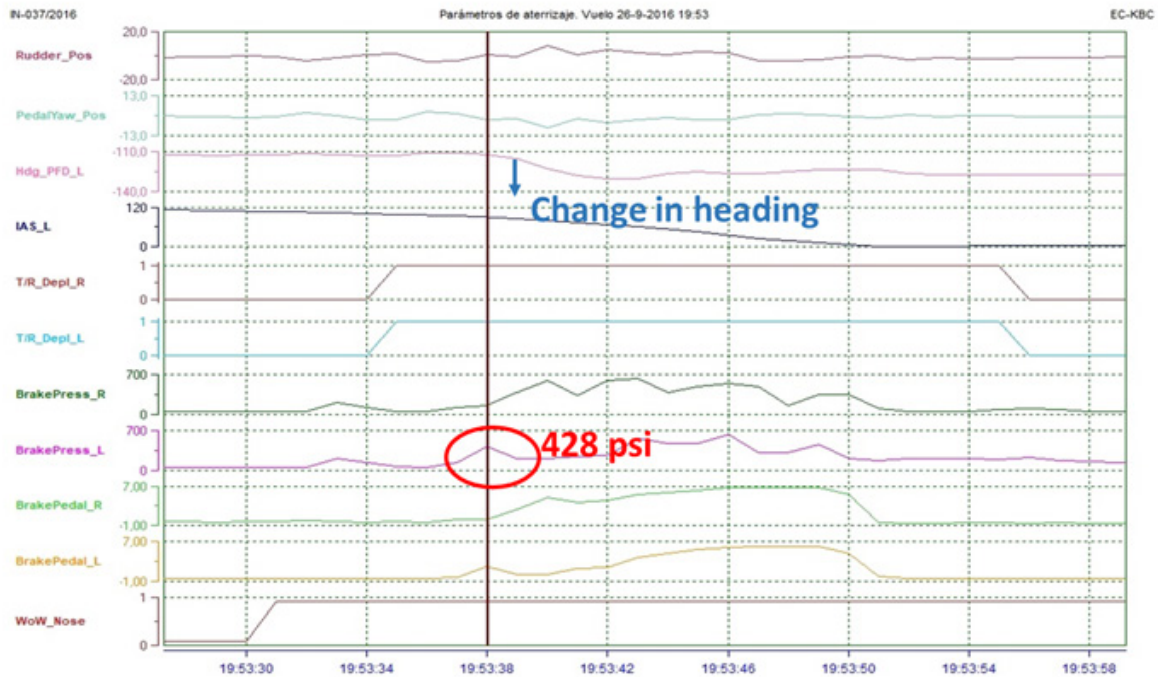
psi in the right. The brake pedal inputs recorded a deflection of  $1.914^\circ$  for the left pedal and  $0.188^\circ$  for the right. The aircraft's IAS was 91 kt. This event coincided with the start of the change in the aircraft's heading from  **$248^\circ$  to  $230^\circ$** .

Graph 3: Left brake pressure at 428 psi and start of heading change

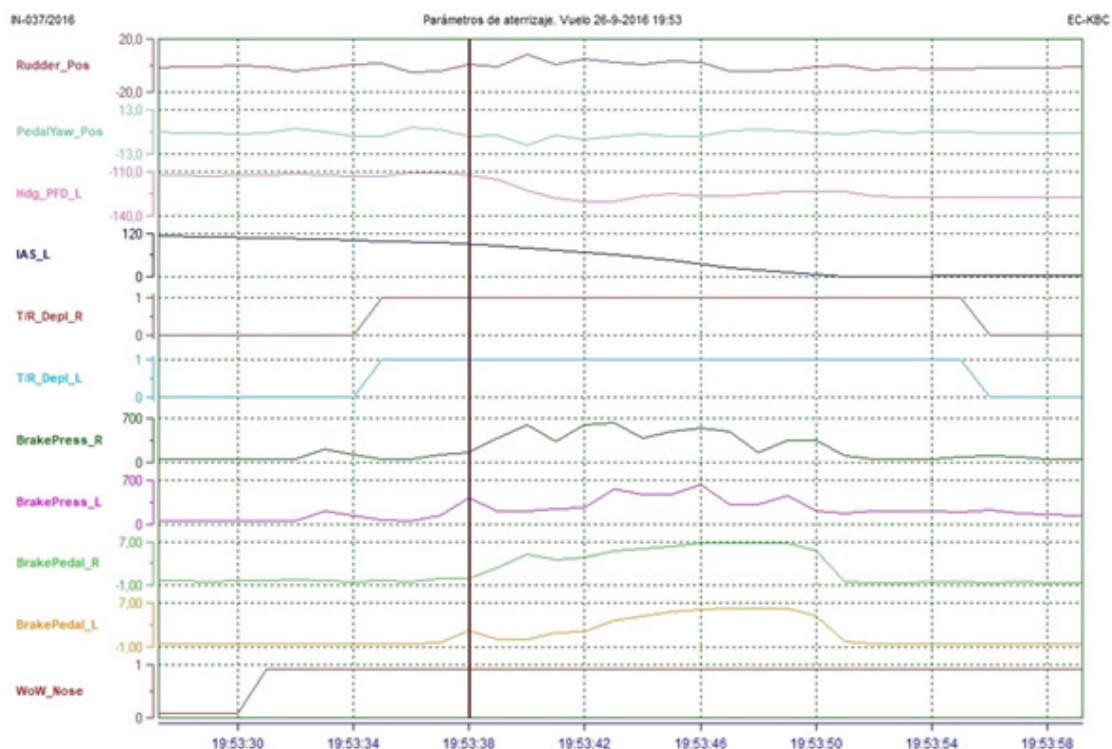
One second later, the right brake pedal was deflected by  $2.263^\circ$ , which translated into a brake pressure of 385 psi for the right brake, versus a brake pedal deflection of  $0.309^\circ$  and 210 psi for the left. The recorded IAS was 87 kt. In the next second, two events were recorded, one an input to the right rudder pedal which translated into the rudder deflecting  $8.616^\circ$  to the right, and the other a higher differential pressure applied to the right brake of 603 psi, versus the 215 psi in the left system, with deflections in the brake pedal of  $4.765^\circ$  and  $0.495^\circ$  respectively. The recorded IAS was 68 kt. The differential braking to the right persisted for an additional two seconds, along with the input to the right rudder pedal. From then on, symmetric braking readings were recorded, though the input to the right rudder pedal was maintained until the aircraft departed the runway.

Graph 4: Brake and rudder inputs

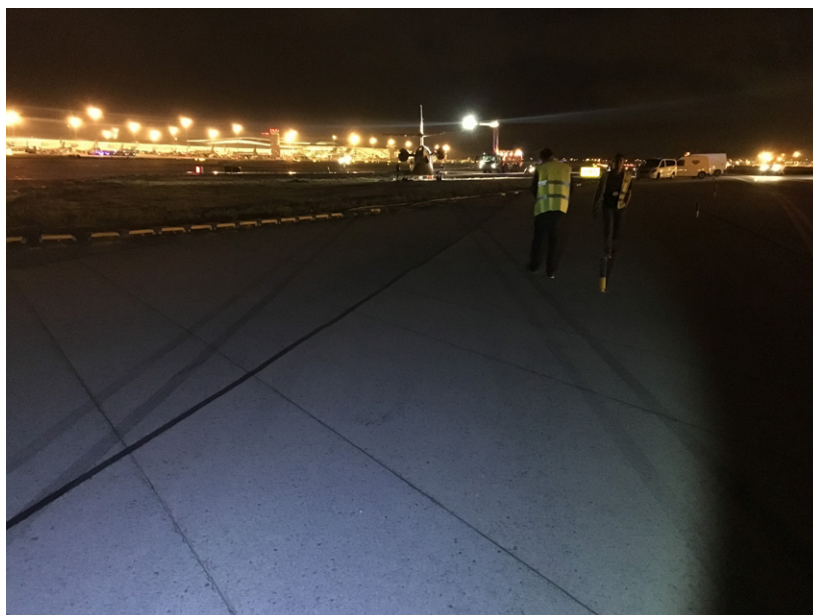
Photograph 9: Aircraft's final position shortly after the incident, with the brake marks on the runway.

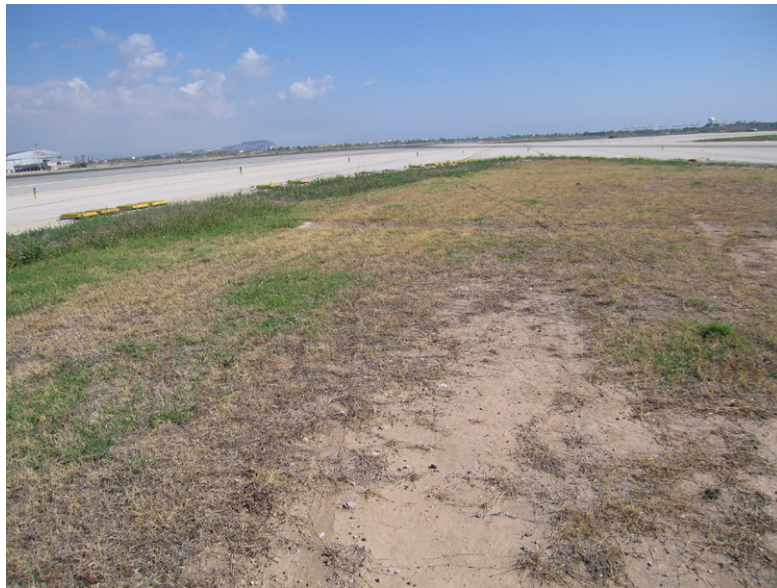
Based on information gathered from measuring the tracks on the runway, the aircraft traveled approximately 233 m from the start of the excursion, and 47 m on the island where it eventually stopped.

Photograph 10: View from the aircraft's final position of the tire marks left on the island.

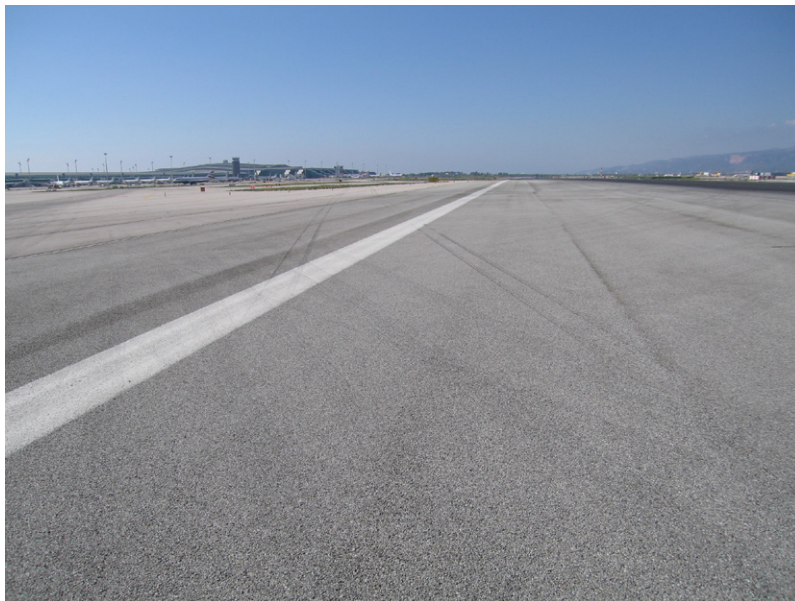
Photograph 11: View of the tire marks left on the runway in the direction of motion of the aircraft.

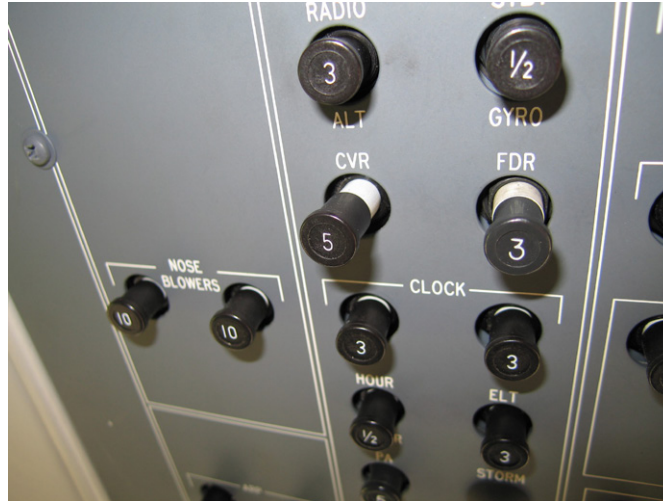
Photograph 12: Condition of the flight recorder breakers.
