**COMISIÓN DE
INVESTIGACIÓN
DE ACCIDENTES
E INCIDENTES DE
AVIACIÓN CIVIL**

Report IN-038/2016

Incident involving a BOEING 737-400, registration SP-ENA, operated by ENTER AIR, and a CESSNA 172, registration EC-JOB, operated by BARCELONA FLIGHT SCHOOL, at the Barcelona TMA (Spain) on 28 September 2016

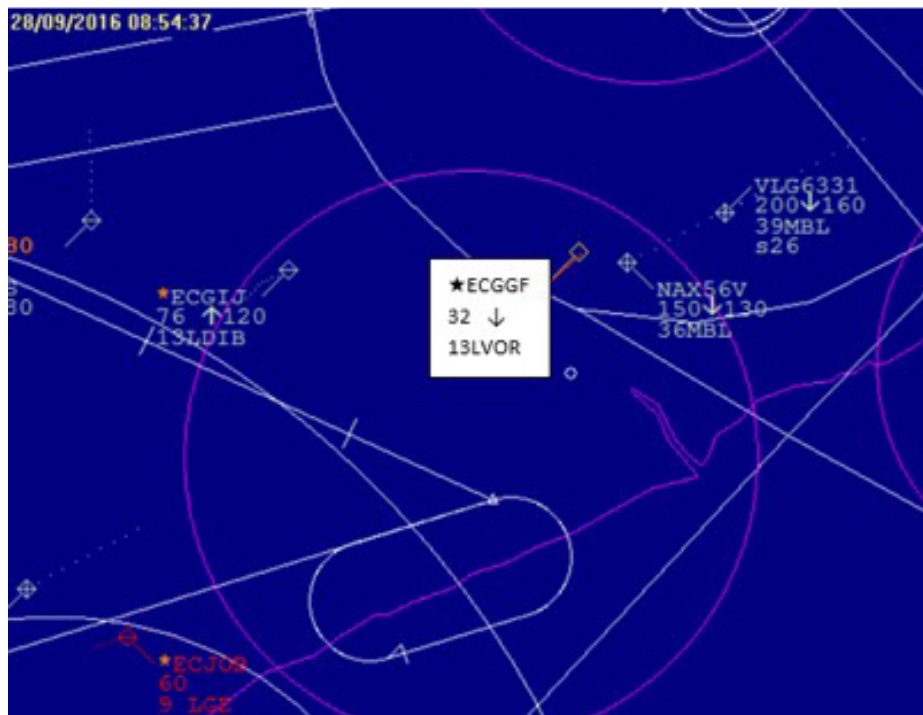
Figure 8. Last radar track for EC-GGF (08:54:37)

08:54:37 At approximately 08:44, the REDAN network goes offline at the Girona Airport. This prevents receiving information from the Girona radar, and results in the signals from aircraft below 3200 ft being lost on the displays at the Barcelona ACC and the Girona TWR. The track for EC-GGF, which is in the Girona CTR and descending through 3200 ft, disappears.

Under these conditions, it is sector TGR that handles approaches to runway 02 at Girona. When this sector was opened, its controllers were not informed about the aircraft flying from Sabadell to Girona (ECGGF, ECJOB and ECGIJ), and thus they were initially unaware of said traffic. Although the Girona tower controller checked with sector TGR about flight ECJOB at 08:55:42, he did not receive a reply since the ATCO at said sector was unaware of the existence of ECJOB. This traffic was visible on the display, but the sector's ATCO was focused on finding out the position of ECGGF, which had been transferred to the Girona TWR at 08:50:45 by sector T1E and was completing its approach without being visible on the radar due to the loss of the network. The last radar blip for this traffic had been at 08:54:37, when it descended below 3200 ft, as shown in Figure 8.

Although the communications between the ATCO make reference to the fact that EC-GGF could not be seen on the display at 08:55:42 due to problems with the Begas radar, this was actually caused by the loss of the REDAN data network.

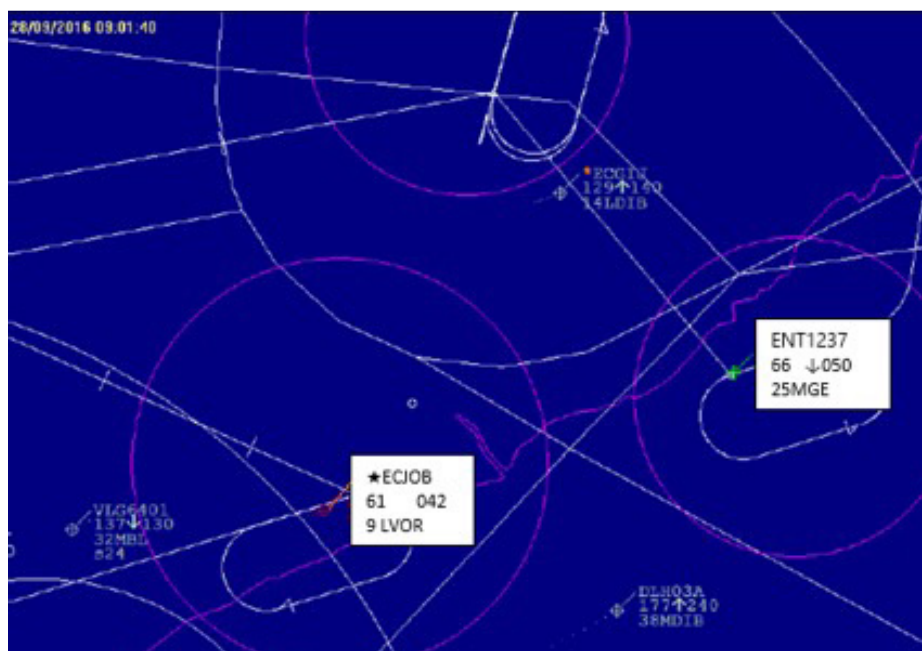
Figure 11. ENT1237 transferred to LEGE TWR (09:01:40)

09:01:40 Sector TGR transfers ENT1237 to the Girona TWR. This aircraft is over point OKETA, as shown in Figure 11.

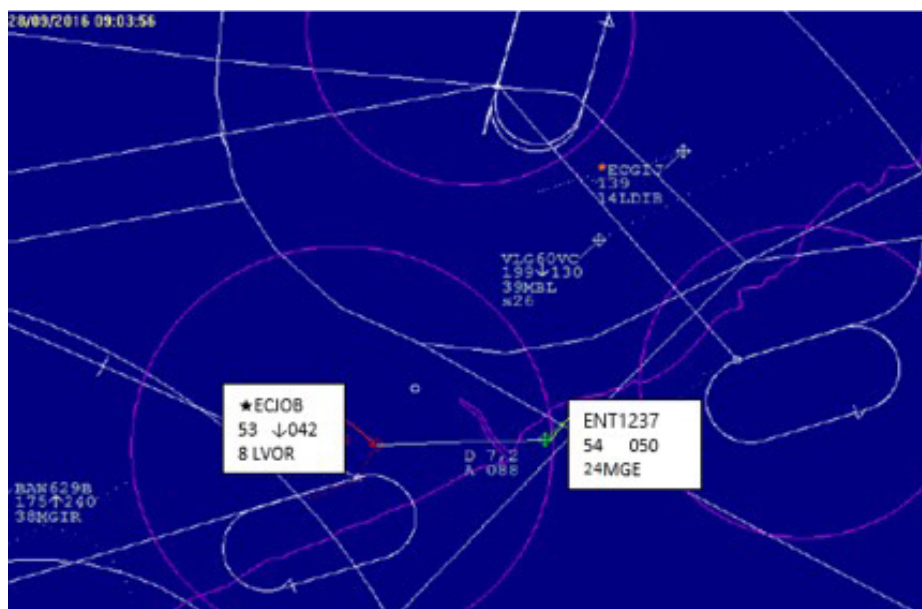
Figura 12. EC-JOB en aproximación a LEGE (09:03:56)

09:03:56 The D1E sector ATCO transfers EC-JOB to Girona. The traffic is 3 NM away from TISGO.

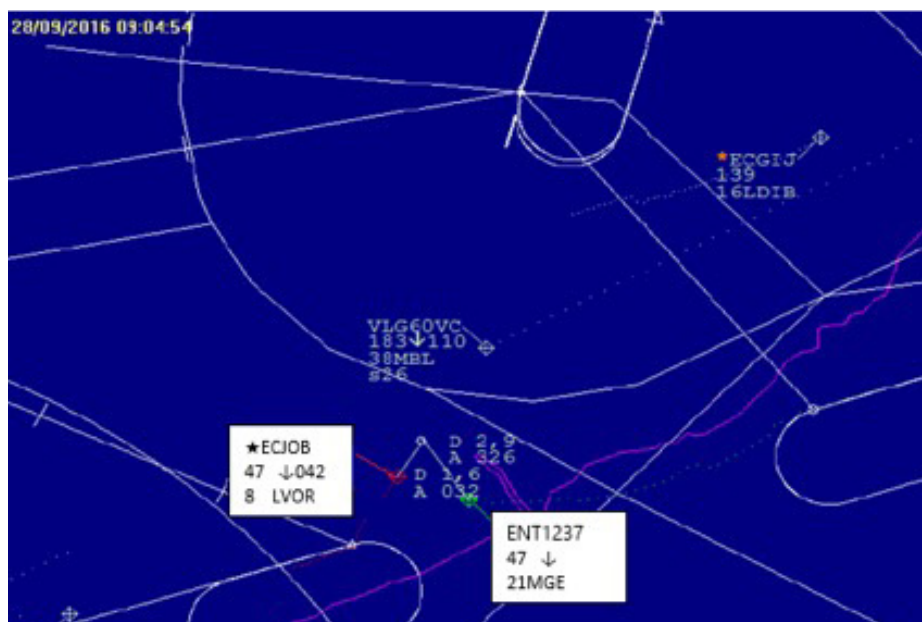
Figura 13. Pérdida de separación entre ECJOB y ENT1237 (09:04:54)

09:04:54 Separation lost between the two aircraft proceeding to TISGO.

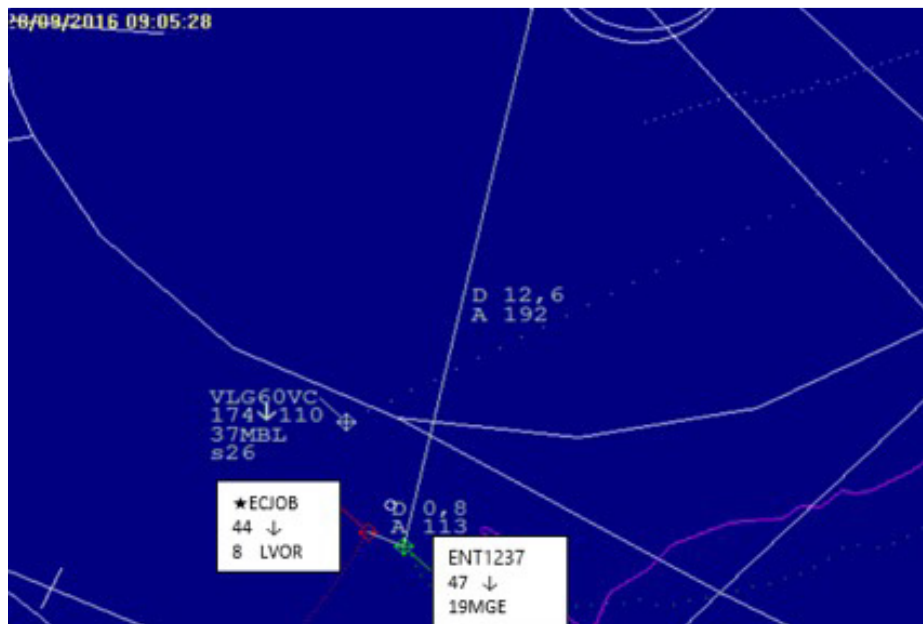
Figure 14. Approach between the two aircraft (09:05:28)

09:05:28 The ATC at the Girona TWR asks ENT1237 to confirm its position. Once reported, he instructs the aircraft to continue on approach as number one.

ENT: ... a traffic at TCAS and visual contact with aircraft who is near, too near to us.

ENT: Near behind us, we are 4200 ft at 13.2 DME.
