Report A-045/2016

Accident involving a VELOCITY
173RG aircraft, registration
PH-FUT, in Santa Cruz de Tenerife
(Spain) on 27 December 2016

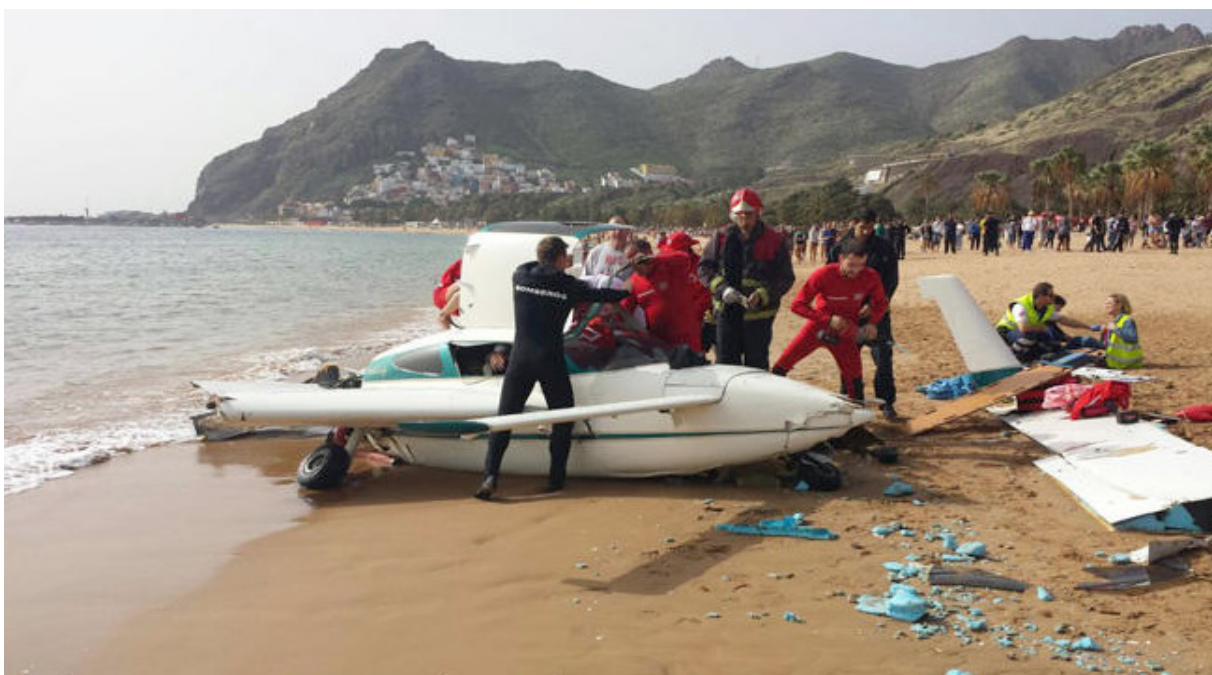
According to the pilot's statement, he was forced to land in the water due to the presence of people on the beach. He landed in such a way that the left wing entered the water first, which made the aircraft turn counterclockwise as it continued moving before coming to a stop on the shoreline.

Figure 4. Aircraft after the accident

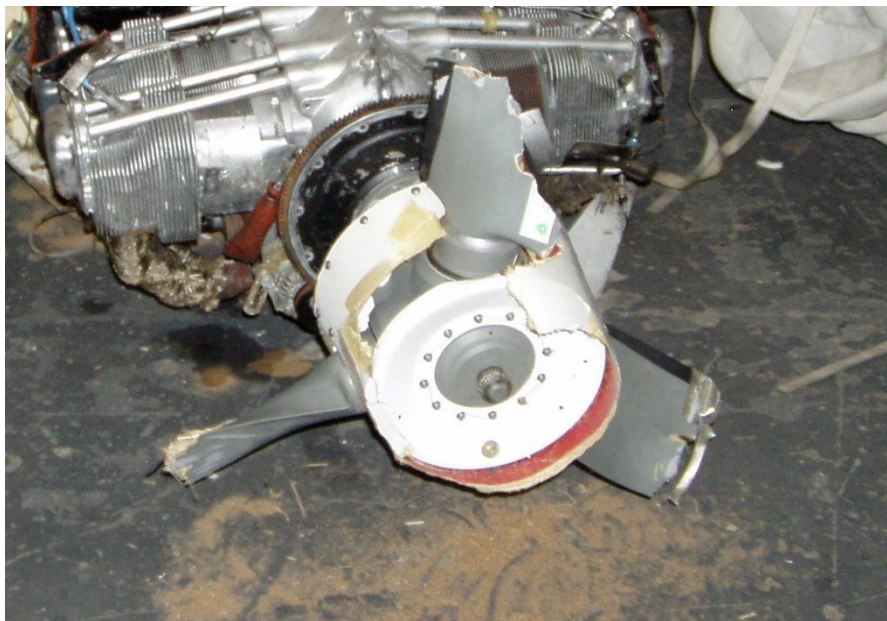
All three propeller blades were fractured, as shown in Figure 5.

Figure 5. Propeller blades

Two of the fractured blades had damage and abrasions along their leading edge, indicating that they broke when they impacted the terrain upon landing.

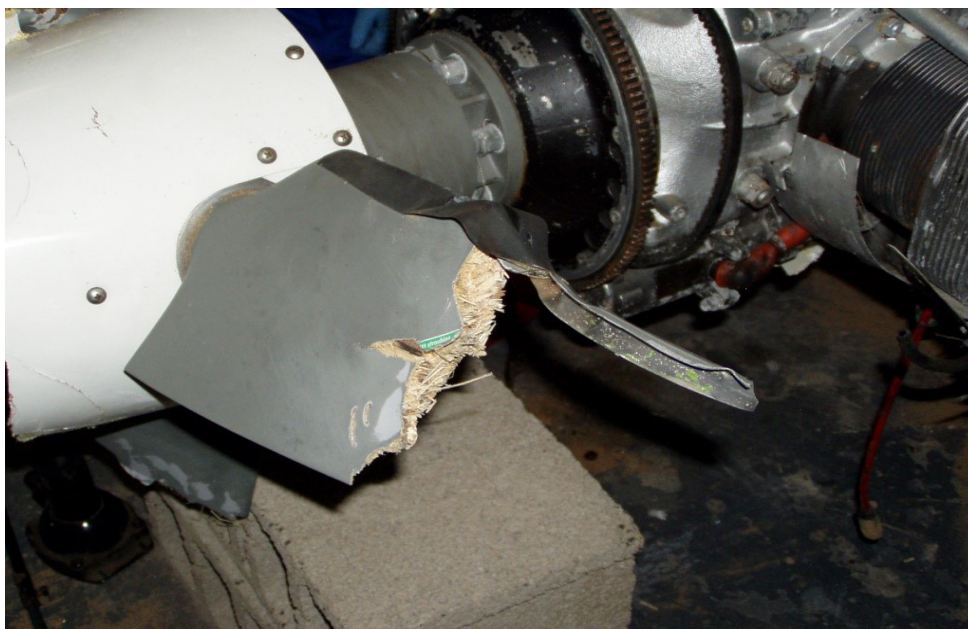
The other blade exhibited a fracture perpendicular to its length and preserved part of the protective metal strip along the leading edge, as shown in Figure 6.

Figure 6. Blade broken under bending load

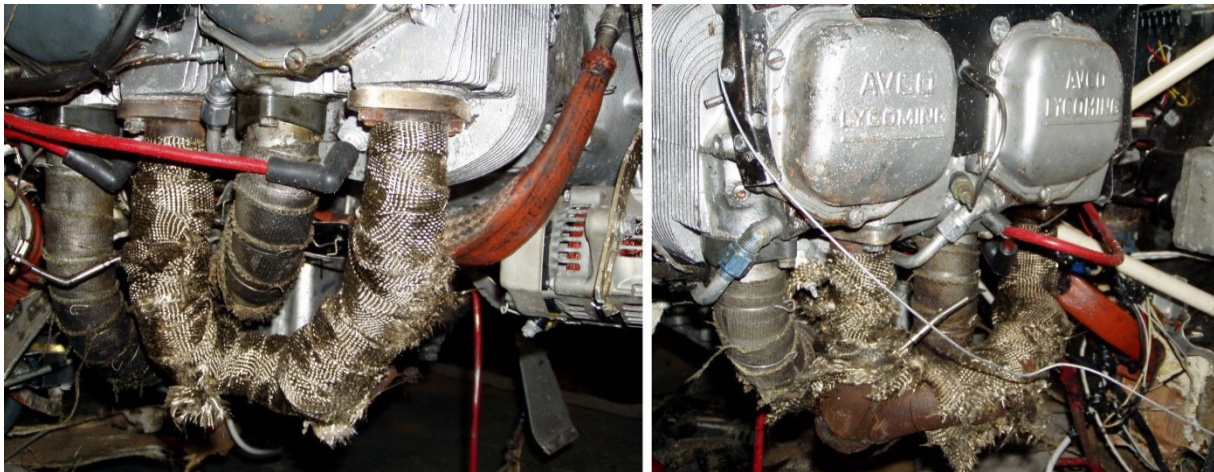
The intake and exhaust lines for the cylinders were wrapped in thermal tape held in place with wires, as shown in Figure 7. This modification had been made to prevent the high temperatures in these lines from burning the inside of the engine cowl.

Figure 7. Cylinder intake and exhaust manifolds

As for the fracture of the right exhaust manifold, the fact that it was wrapped in thermal tape would have contributed to raising its temperature. The tape would also trap in moisture, thus promoting the corrosion of any parts in contact with the moisture. The tape around the tubes would also have concealed any potential cracks or fractures during visual inspections.

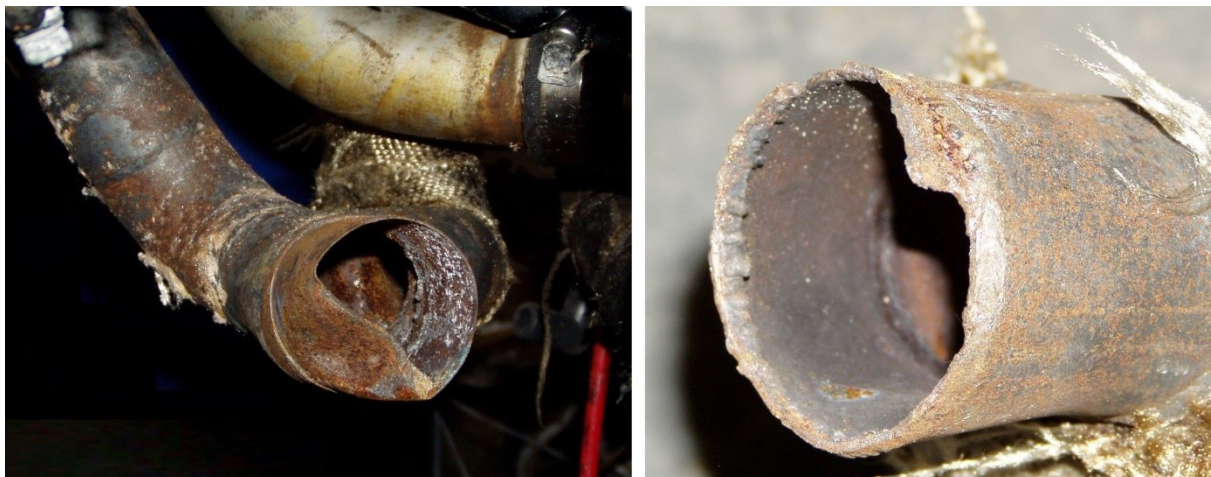
According to the information provided, the owner had modified the original exhaust system, removing the silencer and attaching metal tubes to each of the exhaust manifolds to route the exhaust gases. These tubes were clamped in place. Both extension tubes that had been installed were lost in the accident and could not be located. The left manifold was whole. Its intake was fractured, probably by the impact sustained on landing. There was a segment missing from the right manifold, which had broken off at a welded joint, as shown in Figure 8.

Figure 8. Left and right exhaust manifolds

An inspection of the right manifold revealed different colors in the fracture area, indicative of a gradual fracture due to material wear, and not a sudden fracture at the moment of impact during the accident.

It is probable that the small vibrations felt initially were caused because when the right exhaust manifold fractured, the final portion of said manifold, along with the tube that was clamped to it, were only being held in place by the thermal tape covering them. Once the tape broke, the assembly detached, striking and breaking one of the propeller blades. This is when the much stronger vibrations

When the fracture area was inspected, it was noted that it had different colors, indicative of gradual wear of the material, wear that was aided by the thermal tape.
