## **Report ULM A-003/2017**

Accident involving a Tecnam P2002  
Sierra aircraft, registration EC-FP6, at the  
Villaverde aerodrome (Toledo, Spain)  
on 8 February 2017

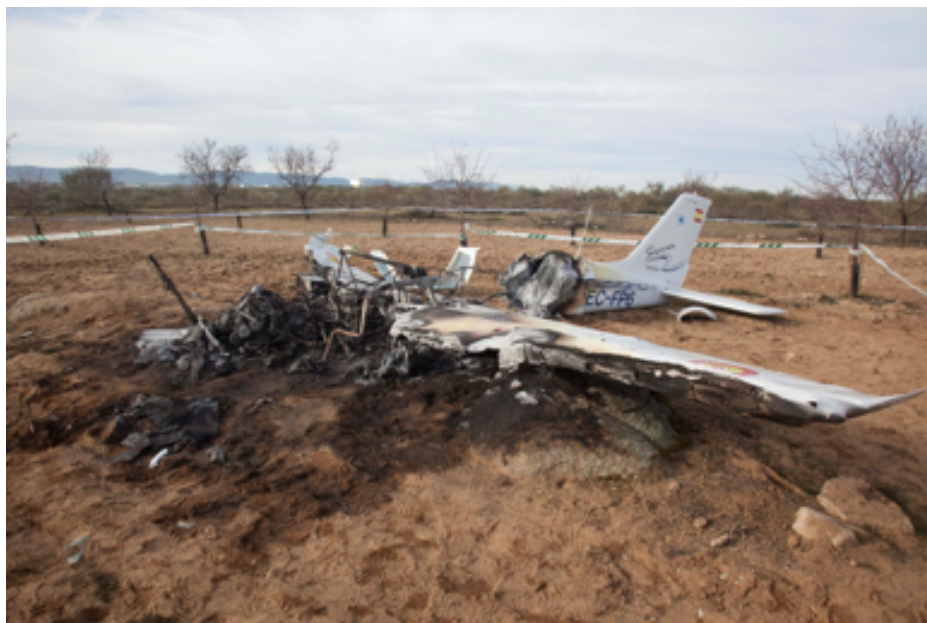
After crashing into the ground, a fire broke out that caused the ballistic parachute triggering device to explode. Both aircraft occupants were killed in the accident and the aircraft was destroyed (Figure 1). The position of the aircraft relative to the runway is shown in Figure 2.

**Figure 1.** Aircraft EC-FP6 after the impact and fire

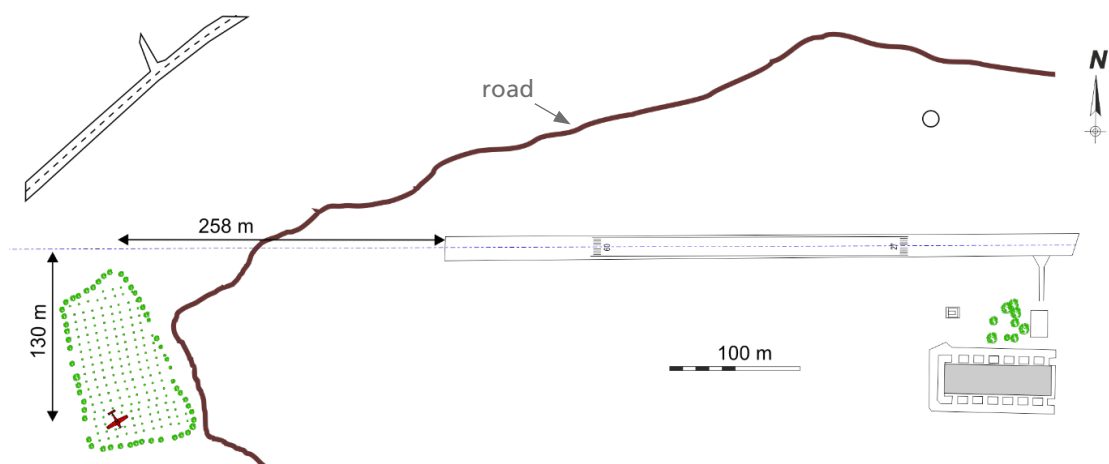
**Figure 2.** Position of the aircraft relative to the runway

Given the 130-m distance between the runway centerline extension and the point where the aircraft crashed, and the eyewitness statements, a left turn after takeoff can be ruled out. Therefore, the aircraft's position relative to the runway was caused by the motion of the aircraft during the initial climb, during the descent or a combination of both.

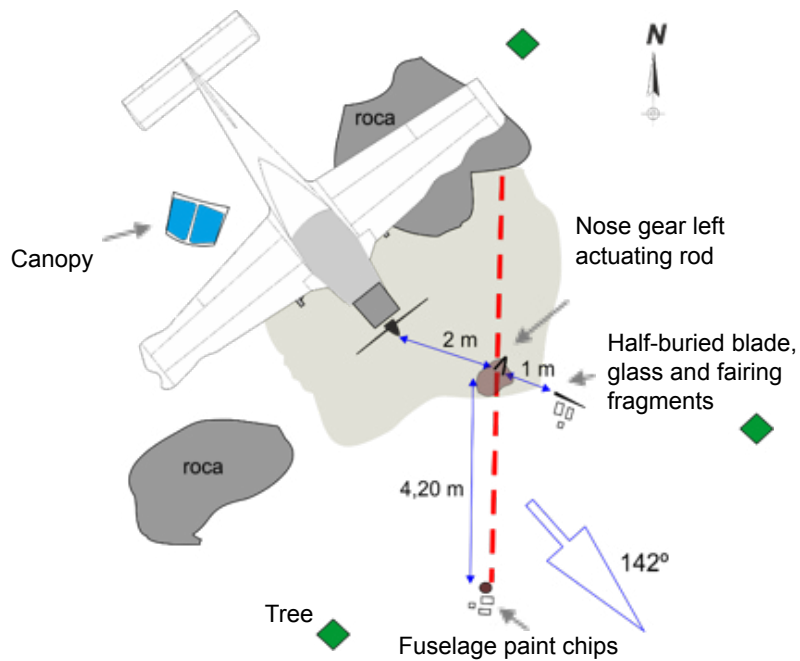
The aircraft was found in a field with rows of fruit trees planted in a north-south orientation. During its descent, the aircraft did not damage any of the trees, nor were drag marks found on the ground, which indicated that the impact had been vertical. The wreckage was not scattered. The aircraft was in a normal flight position, resting on its lower fuselage, and exhibited impact and fire damage (see Section 1.14). All of the aircraft's structural components were present. Figure 4 shows a diagram with the general layout of the wreckage.

**Figure 4.** Location of debris

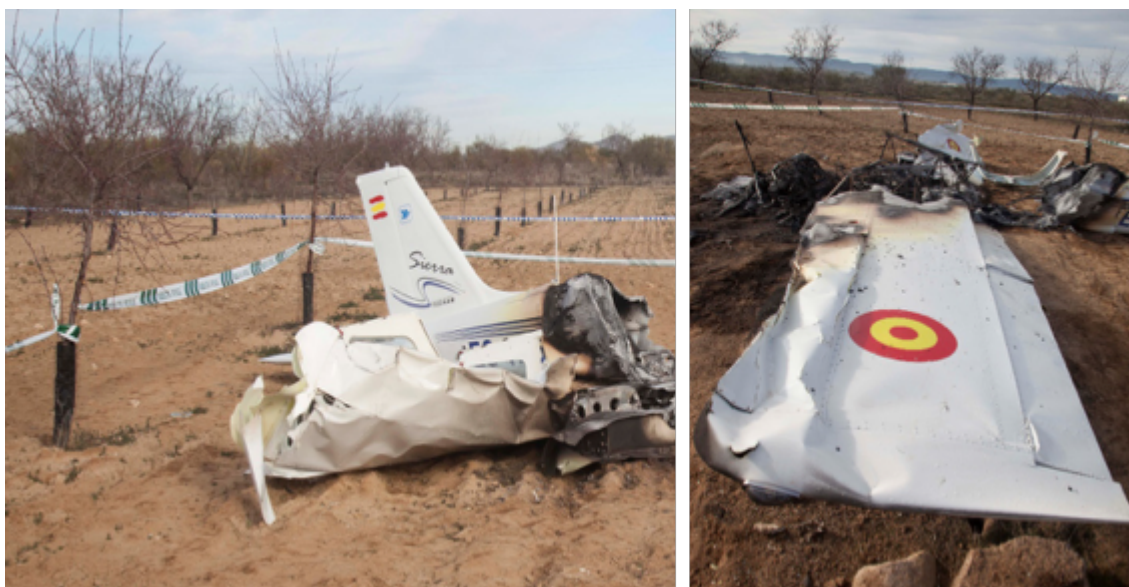
All throughout the right wing there were compression marks, from the end of the wing to the root. The first third of the wing was noticeably twisted. The wingtip was broken, and part of the material had detached. The left wing was less damaged than the right wing, and exhibited compression marks located primarily along the leading edge. The wingtip was minimally damaged, and the light was still intact. The left wing was resting on a rock on the ground. Neither wing seemed to have shifted from its installed position. The flaps were confirmed to be retracted.

**Figure 5.** Left and right wings after the accident

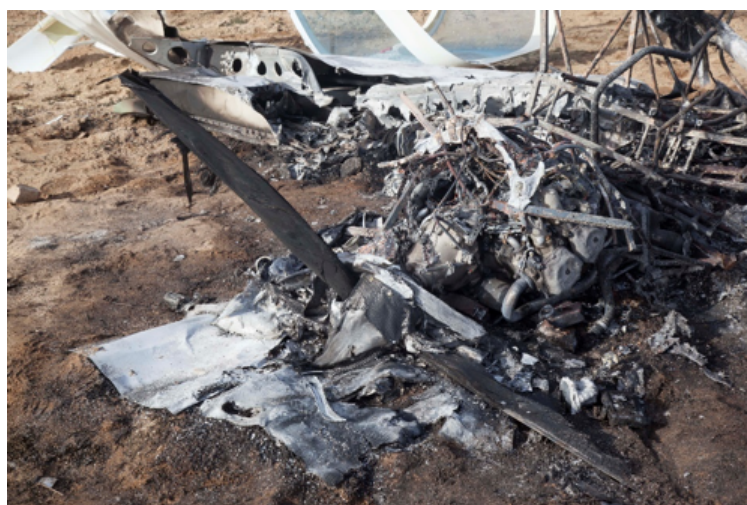
The propeller was attached to the engine. Two of the three blades were attached to the hub and, though burnt, were practically intact over 90% of their surface. The third blade was found half buried three meters forward of the aircraft, along with some glass and a fairing fragment. This blade was not burned. Two meters

**Figure 6.** Propeller and engine after the accident

- Although a disassembly of the engine indicated that it was either stopped or outputting little power, the absence of damage to the three propeller blades indicates that the more likely possibility is that the engine was stopped at the time of impact.
- No operating problem was found to explain, or that could have influenced, the lack of engine power just before the impact.

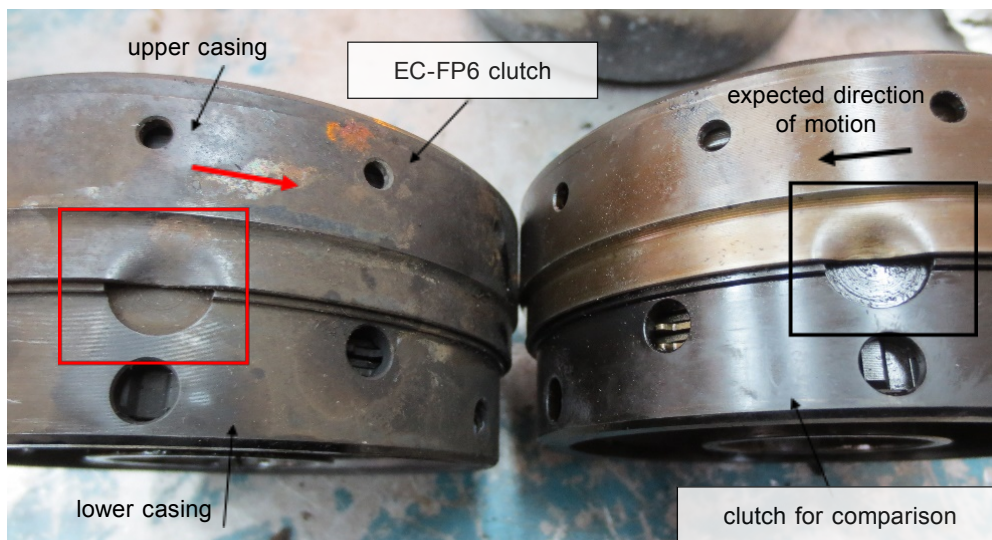
in another clutch following a sudden stoppage of the propeller during an impact with the ground and the engine at power. The alignment dimple shifted to the edge of the groove in the lower casing.

**Figure 8.** Shift in the opposite direction of the alignment dimple on the clutch

Based on information provided by the Rotax representative in Spain, when the alignment dimple on a friction clutch is found to have shifted after an accident, the clutch is replaced with another one, it is never repaired. In the case of the clutch installed on aircraft EC-FP6, the clutch had been worked on and the alignment dimple (which acts as an indicator) had been forced beyond its normal position, leading to a condition that cannot occur.

- the clutch was not inspected, despite documentation to the contrary, or
- the clutch was inspected and the condition of the friction clutch was not identified, or
- the fault in the clutch was identified and left uncorrected, or
- the fault in the clutch was identified and instead of installing a new one, an effort was made to repair it, causing the shifted alignment marks found after the accident.

At least one of the above situations, or a combination thereof, was involved in the inspection of the aircraft conducted by Álamo Aviación. Since it is impossible to confirm the origin of the work done on the clutch, a generic safety recommendation is issued intended to enhance the training given to the mechanics on the maintenance techniques and practices to be used on the ROTAX engines that are maintained by the Álamo Aviación maintenance center.
