Report A-016/2017

Accident involving a Piper PA-18-150
aircraft, registration EC-JBP, at the
Sabadell Airport (Barcelona, Spain)
on 5 August 2017

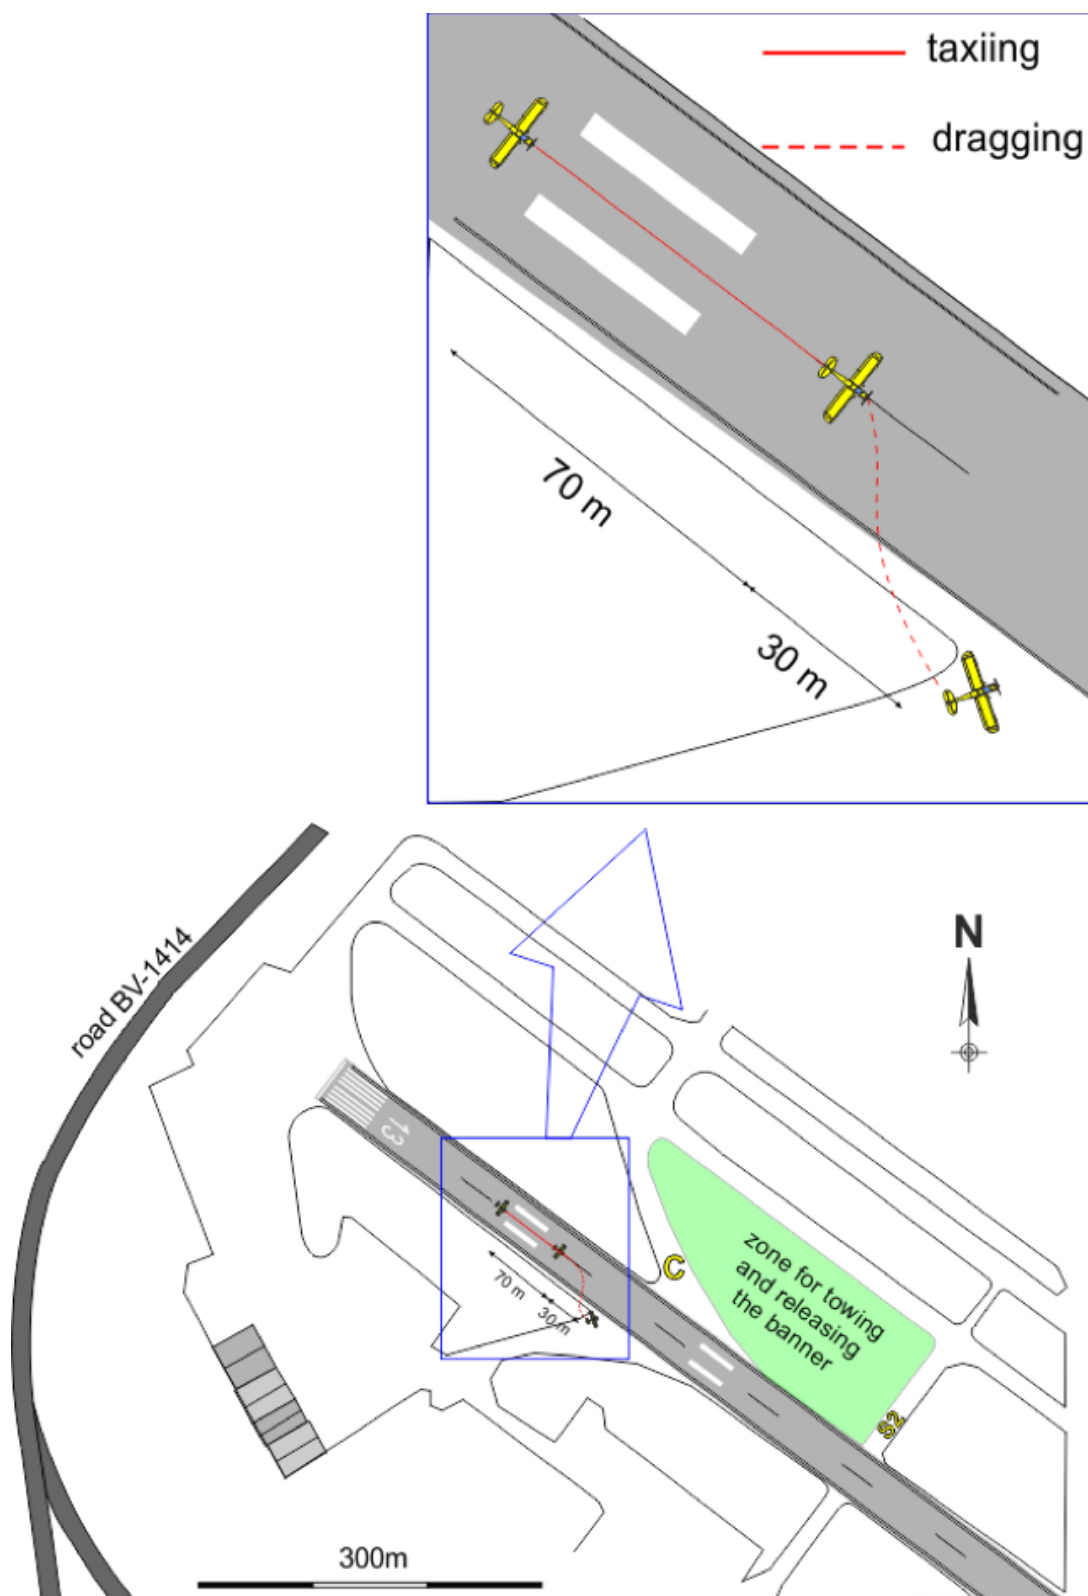
After traveling some 70 m, the left main landing gear leg collapsed, causing the left wingtip to strike the ground and the aircraft to drag along the runway for approximately 30 m. During this time, the aircraft veered gradually to the right until it exited into the parterre, at which time the aircraft turned sharply left before coming to a stop in the paved area of runway exit B.

Figure 1. Diagram of the location of the wreckage and the path taken by the aircraft on the ground

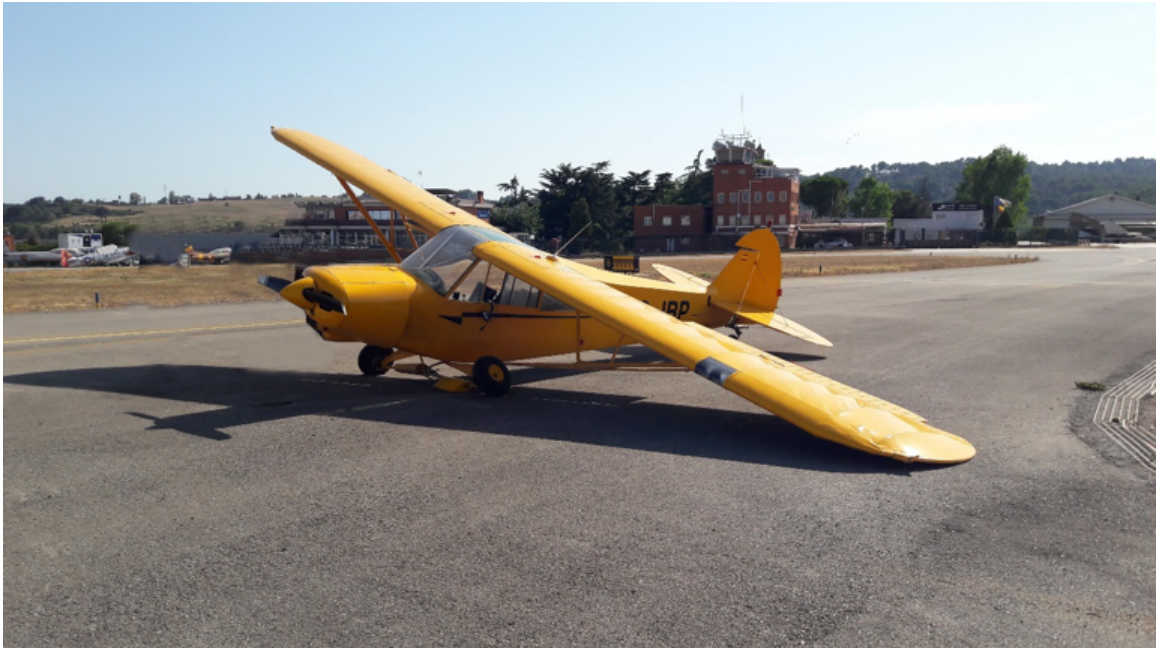
The occupant was not injured, but the aircraft sustained significant damage to the propeller, left wingtip and left main gear leg.

Figure 2. Final condition of the aircraft

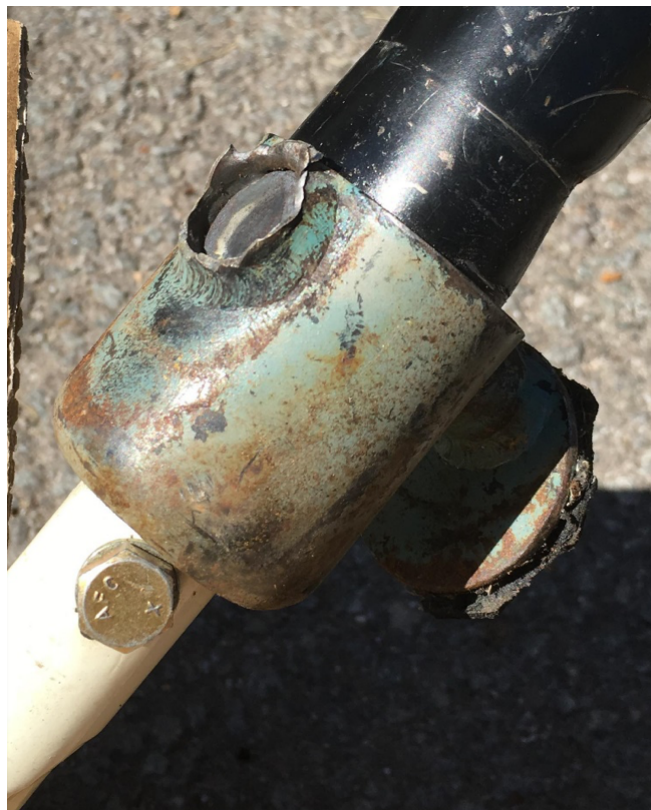
One of the lugs on the long segment of the strut on the left landing gear leg had broken off.

Figure 4. Close-up of fractured lug on left main landing gear leg

The lug of the long segment of the strut on the left landing gear leg was verified to be broken, which rendered one of the shock cords unusable and made it impossible for the sole remaining shock cord to keep the landing gear structure in the retracted position.

What is clear is that the aircraft's main landing gear hit the runway hard, and most likely in a position that was not entirely stabilized, and that the impact was supported primarily and initially by the left main landing gear leg. This would be consistent with the fracture of one of the lugs on the left strut.

The accident occurred due to the hard impact of the landing gear during the landing, which caused the fracture of one of the lugs that holds the shock cords for the struts that comprise the landing gear.

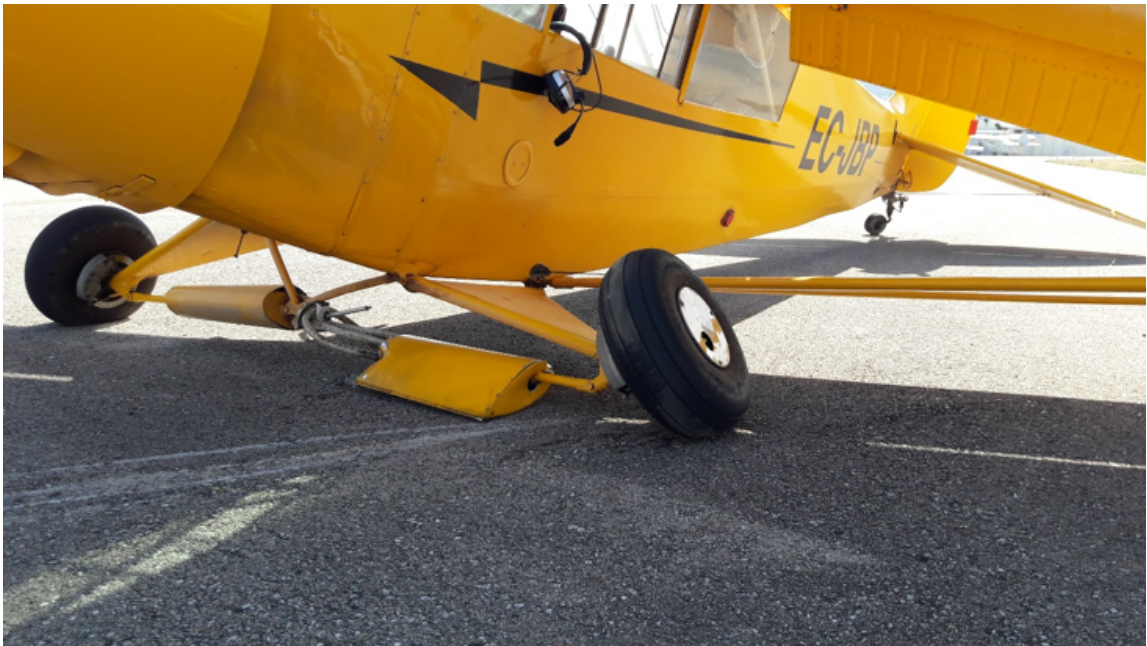
As a result of this, the aircraft sustained damage to the left main landing gear leg, the left wingtip and the propeller.

Figure 5. Condition of the main landing gear

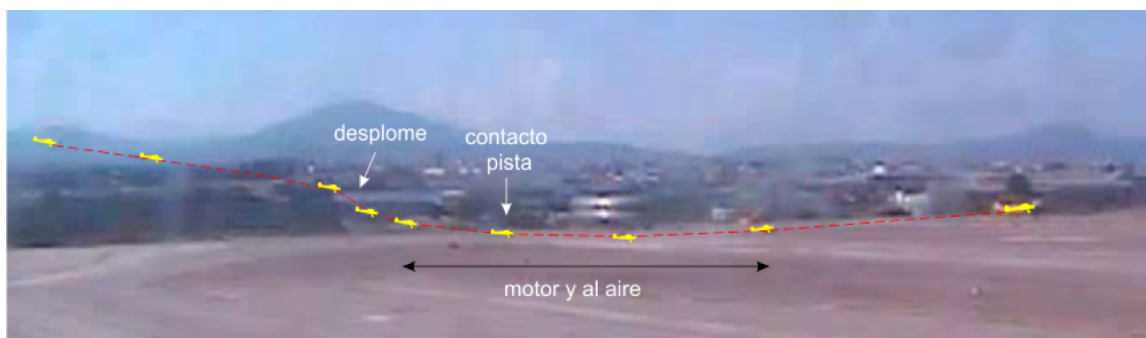
As concerns the final approach of the first landing, the videos show a shallow approach at low altitude, during the final segment of which the airplane's altitude drops suddenly while descending, with the airplane making contact with the runway before the threshold marking.

Figure 6. Approach path during first landing

According to the pilot's statement, and as observed in the videos from the airport's cameras, in the final segment of the first final approach, the aircraft experienced a sudden drop in altitude while on the glide slope that caused it to contact the ground before the threshold marking at an excessive speed. It could not be determined if this occurred due to windshear or to a deliberate action by the pilot. Although no other aircraft reported being affected by windshear conditions, the prevailing weather conditions at the time of the accident, with variable wind from the south and a temperature of around 36° C, are perfectly consistent with the presence of windshear phenomena.
