## Report IN-005/2017

Incident involving a BOEING 737, registration EC-JBK, operated by AIR EUROPA, and a CESSNA Citation C510, registration EC-LCX, operated by CALADERO AVIATION, 13 NM north of the Palma de Mallorca Airport (Illes Balears, Spain) on 20 April 2017

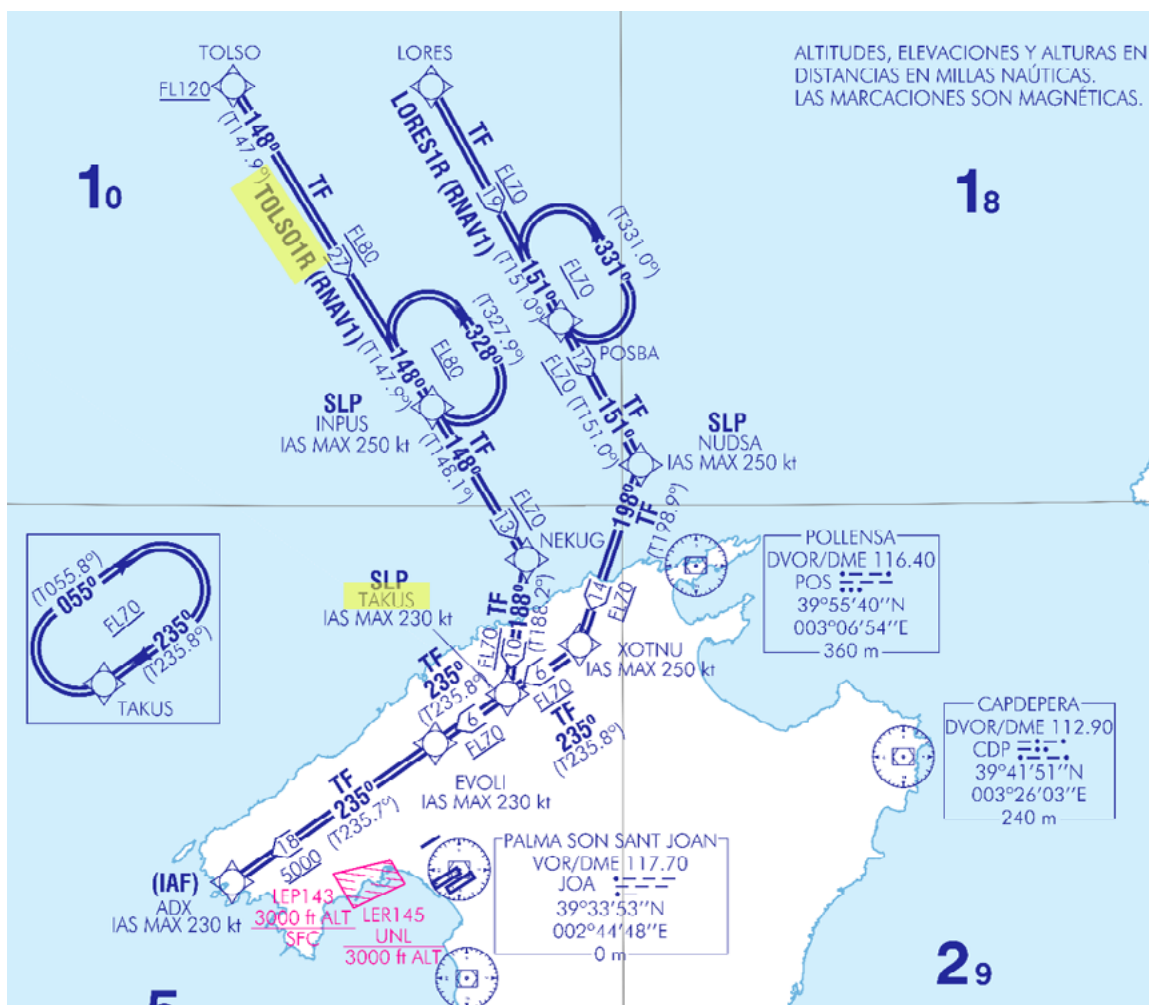
Fig. 1. Section of chart AD 2 – LEP/LESJ STAR 2.1 (STAR TOLSO1R)

As figures 1 and 2 show, the flight paths of the two aircraft cross in the vicinity of point TAKUS. Sector F1X of the Palma ACC was charged with ensuring separation between arriving and departing aircraft in that area for the operational configuration in use on that day.

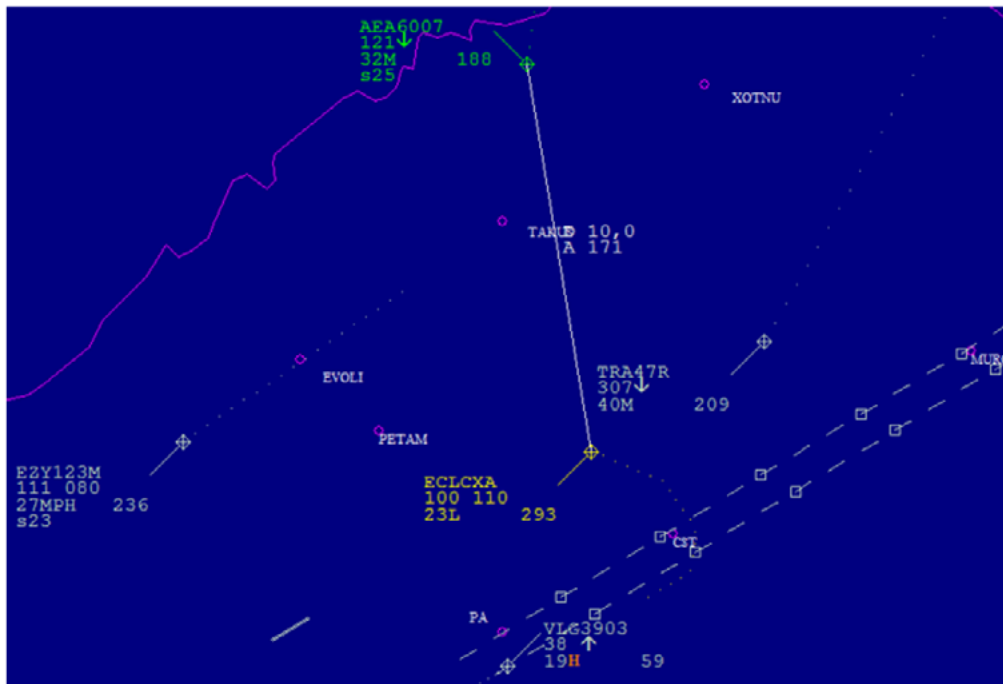
Fig. 3. Palestra image for 06:56:28

Figure 3 shows that the controller set FL110 in the CFL (cleared flight level) field of the label (in yellow) for aircraft EC-LCX. The green label corresponds to EC-JBK, with callsign AEA6007.

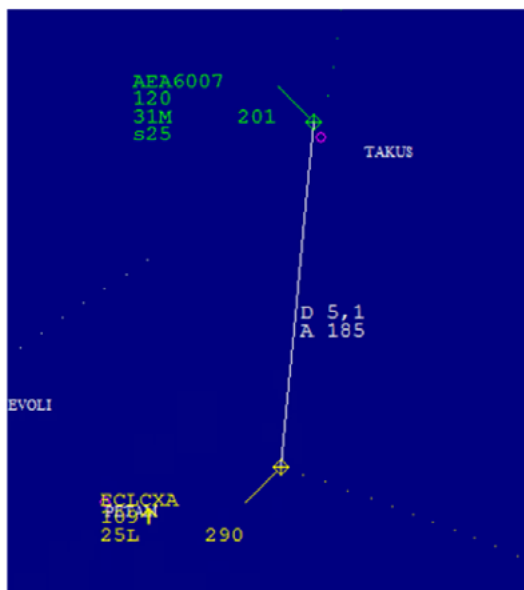
Fig. 4. Palestra image for 06:57:13

Although the figures (generated after the fact by Palestra) show the conflict alert through the PAC (conflict caution alert) and VAC (conflict violation alert) warnings, this is not what was displayed to the controller on his screen. In fact, these warnings were not shown to the controller since the system that generates them (STCA system) was not implemented<sup>11</sup> in this airspace volume on the date of the incident. If it had been, a PAC warning would have been generated at 06:57:22, according to the data from the Palestra system.

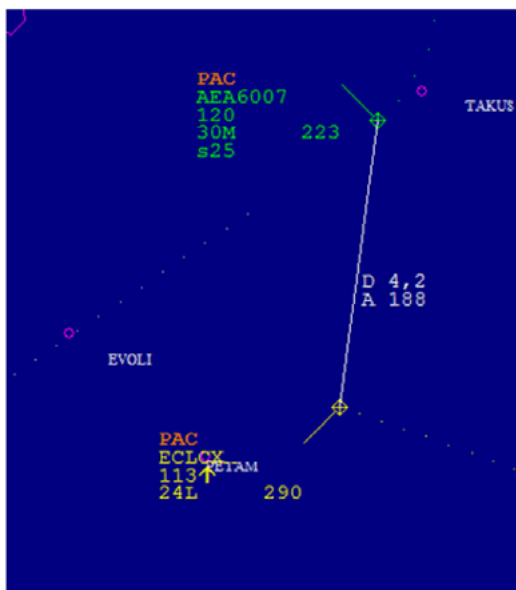
Fig. 5. Palestra image for 06:57:22

By 06:57:22, the aircraft had climbed to 11300 ft, and it was 4.2 NM away horizontally from AEA6007.

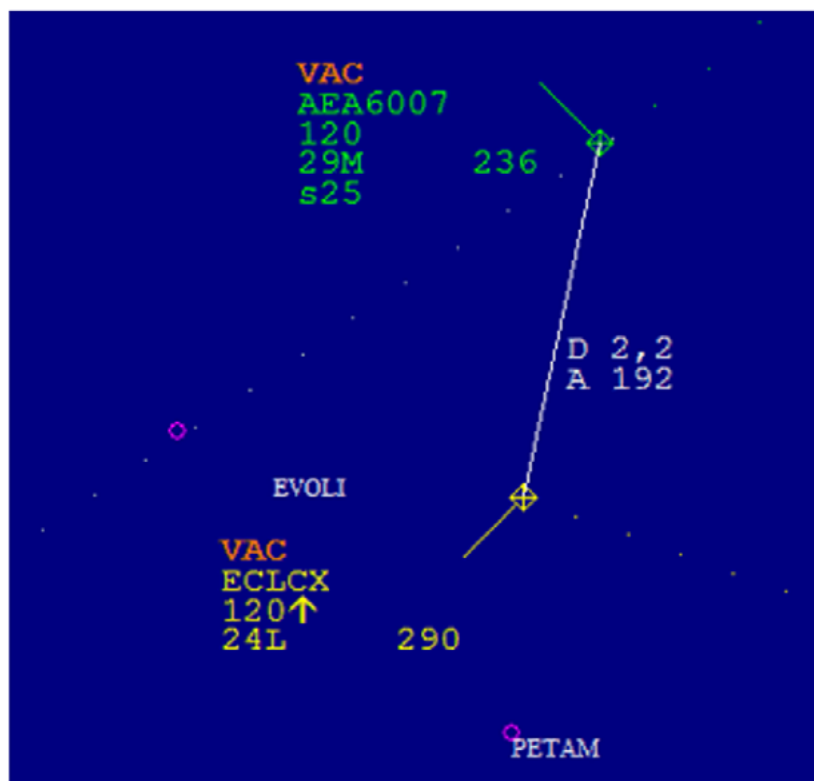
Fig. 6. Palestra image for 06:57:51

At 06:57:52, the controller instructed EC-LCX to turn left immediately heading S, and then instructed AEA6007 to turn right (he did not give a reason to either crew). The crew of the latter reported it had received a TCAS RA. At that point, the horizontal distance between them was 2.2 NM. Both were level at FL120.

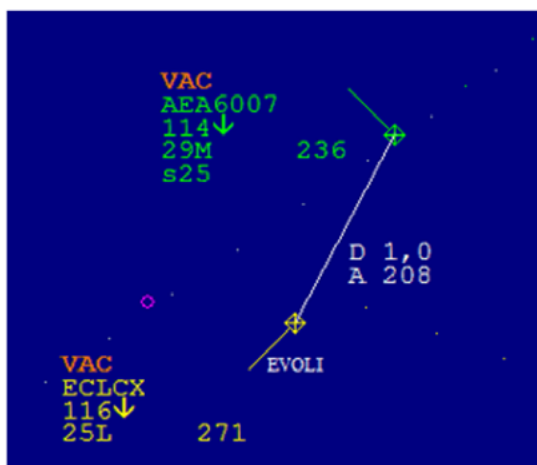
Fig. 7. Palestra image for 06:58:10

AEA6007 was the first to descend from FL120. A few seconds later, EC-LCX also started to descend. From 06:58:10, EC-LCX had a descent rate that was higher than that of AEA6007, and their flight paths began to diverge since EC-LCX had started a left turn a few seconds earlier.
