## **Report IN-013/2011**

Incident occurred on 20 April 2011, involving an Airbus A-320-211 aircraft, registration number EC-GRH, operated by Vueling, at Seville Airport (Seville-Spain)

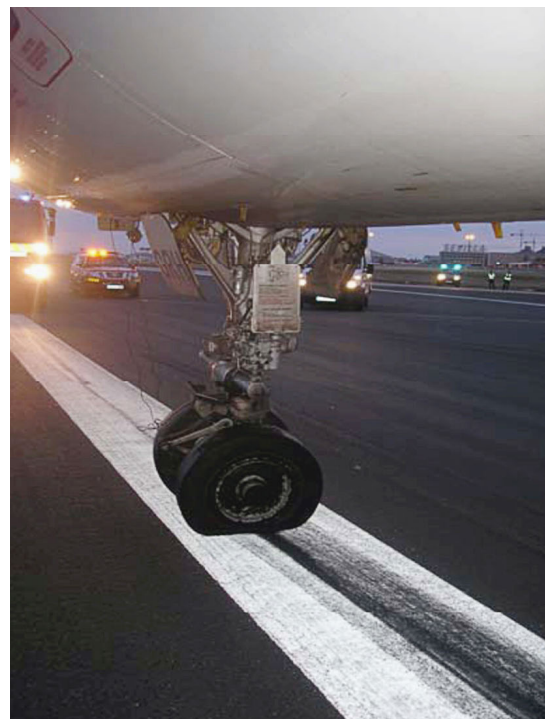
Figure 2. Aircraft stopped on the ground

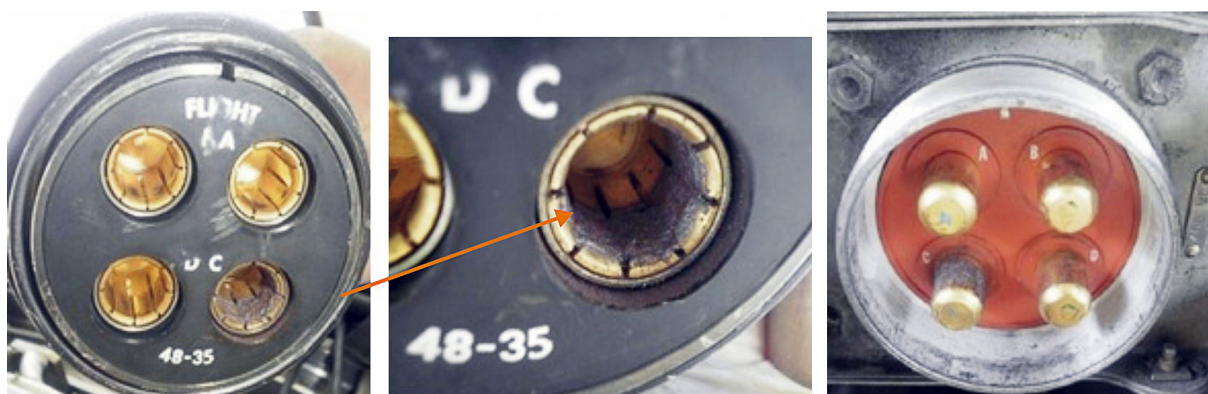
Figure 9. Detail of contact elements

- Tangential abrasion on the surface of the pins corresponding to phases A and C, with damage to the gold plating, allowing the copper base material to be visible at certain points. This abrasion was considered to be the result of cleaning of the terminals with abrasive tools or products, a practice that is not recommended for this type of items, which must be replaced in the event of any type of damage being discovered.

These evidences underline the existence of problems during earlier maintenance and lead to the conclusion that the incorrect positioning of the connecting plate, that led to insufficient insertion of terminal C in its housing, was probably the primary cause of a deficient contact condition that gave rise to the fluctuations in the electrical current experienced, these being the origin of the incident.

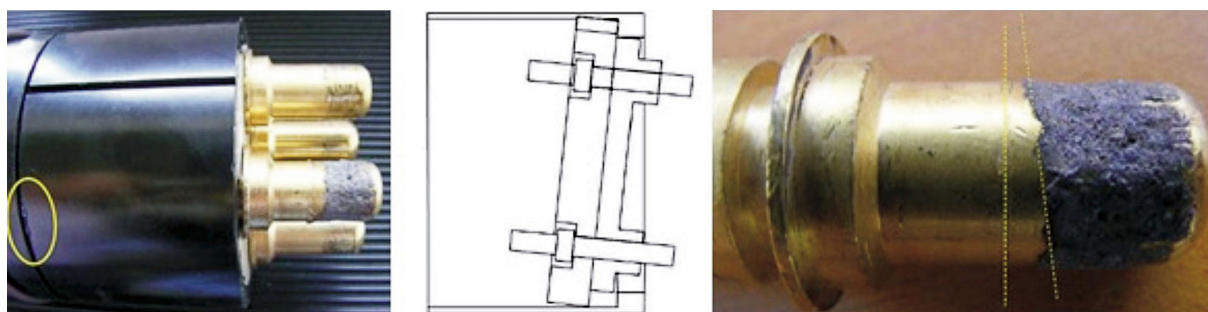
Figure 10. Detail of assembly of terminals on connector

- The four cables were of different lengths: A = 390 mm, B = 375 mm, C = 380 mm and D = 368, and in all cases were shorter than the 450 mm that they should have measured in length originally.
- The terminals installed on the cables corresponded to two different manufacturers, one pair to each. The four were valid for installation on these cables.
- Damage to the edge of the connecting plate, caused by a tool, probably a screwdriver, used as a lever.
- Incorrect positioning of the connecting plate and evidence of the entry of fluid as a result of incorrect re-assembly during a previous maintenance. The mating plate was found broken and the missing part was no longer present at the time the component expertise.

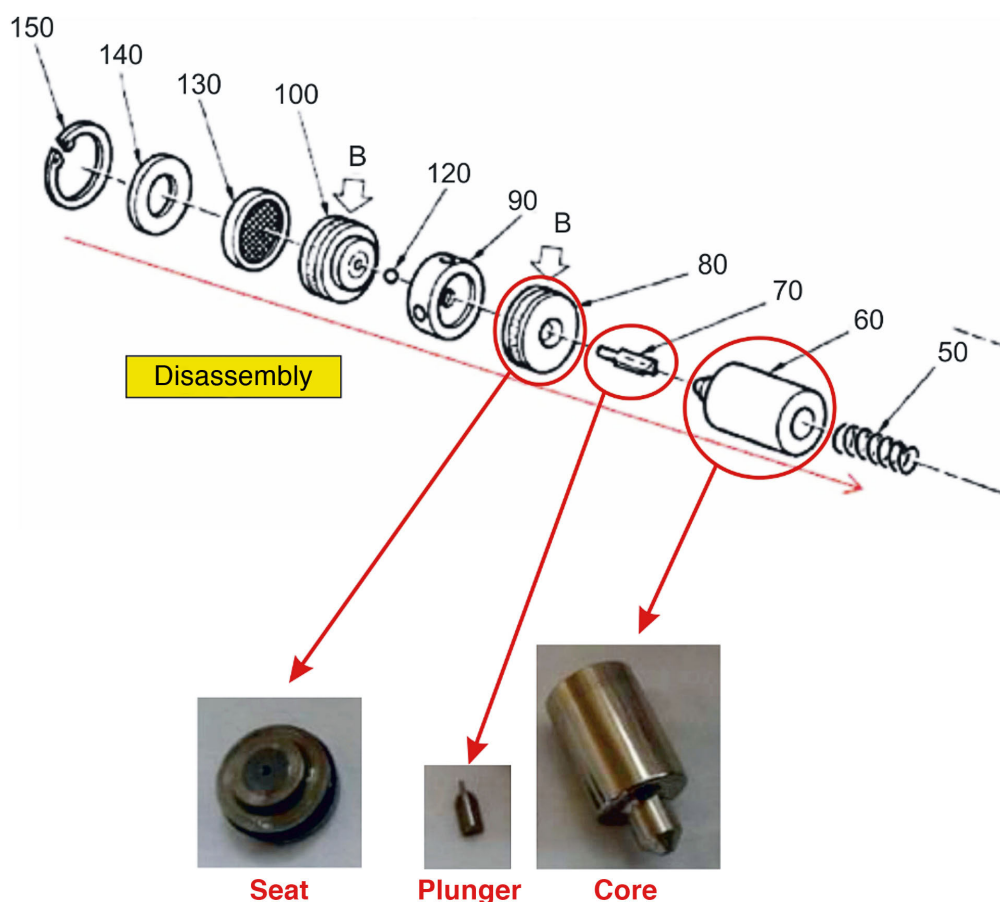
Figure 11. Internals of the HCU

The steering selector valve was disassembled, and the plunger (70 in figure 11) was found to be located alongside the core (60 in figure 11). It was not possible to determine whether it had been in this position initially or whether it had moved to it during removal of the seat (80 in figure 11) in which it is housed.

As a result of the study performed on the hydraulic control unit, it can be concluded that, on the one hand, it presented several non-conformities with respect to the

requirements of the component maintenance manual, which did not directly affect its performance, and, on the other hand, that the steering selector valve was stuck in the open position, which is consistent with the plunger not being in the correct position as a result of a previous incorrect re-assembly.
