## Report A-034/2011

Accident on 19 September  
2011, involving an Agusta  
AB-412 aircraft, registration  
EC-JRY, operated by FAASA  
Aviación, S. A., in the  
municipality of La Peza  
(Granada, Spain)

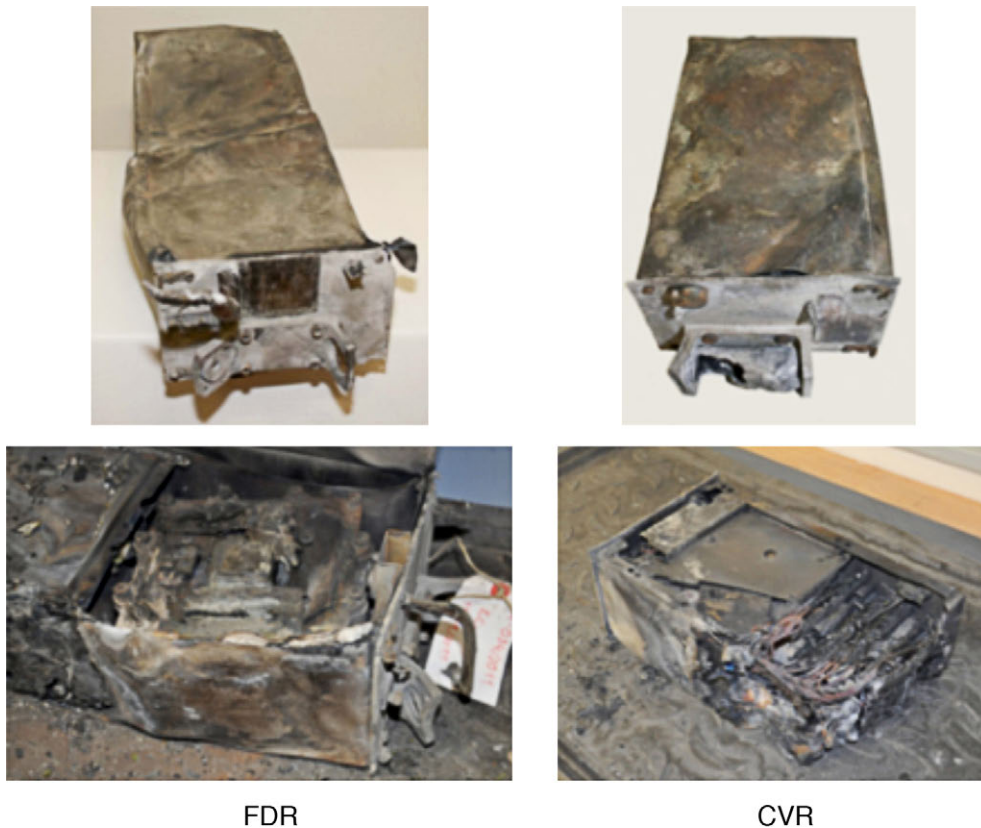
Figure 10. Condition of the flight recorders after recovery

The recorders were located alongside each other in the interior of the burned wreckage of the fuselage. They had lost their orange color and their outer casings were deformed. The fire destroyed the locator beacons and caused the data connections to the recording medium to deteriorate.

In the case of the FDR, it was noted that the twelve screws that enclose the CSMU were loose. This underscores the high temperatures to which the units were subjected as a result of the fire.

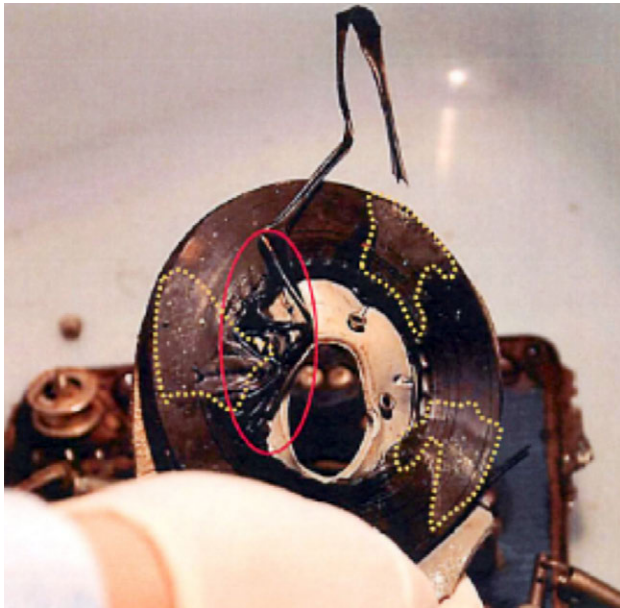
Figure 12. Condition of the magnetic tape

As for the CVR, once the CSMU was opened, the insulator on the recording medium was found burned by the fire. The magnetic tape that held the recordings had to be

reconstructed (repair, assembly and cleaning) due to the temperatures reached inside the recorder (altering the length of the tape) and the heat transferred through the metallic components on the recording device (which radially damaged three sectors of the reel). This operation was unable to recover a segment equivalent to two seconds of the recording at the end of the recording. See Figure 12.

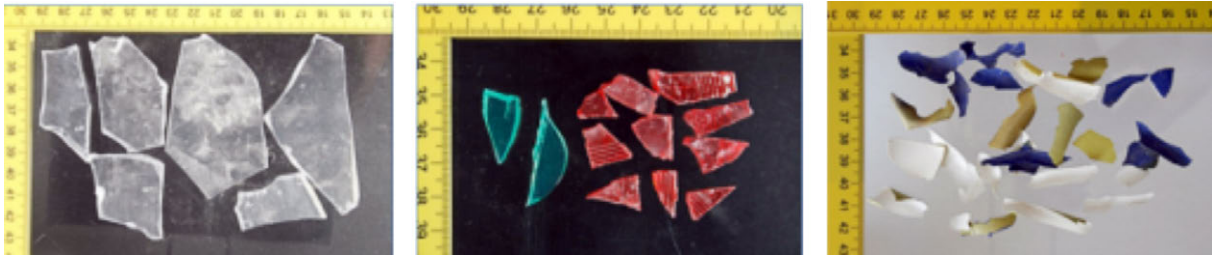
Figure 13. First debris found

The first debris field was found at the top of the hill. There, blue and white paint chips, red bits of fluted plastic, clear flat glass and rivets from the outer skin were found. All were identified to have come from the lower part of the fuselage, from the anti-collision light and from the landing light, see Figure 13.

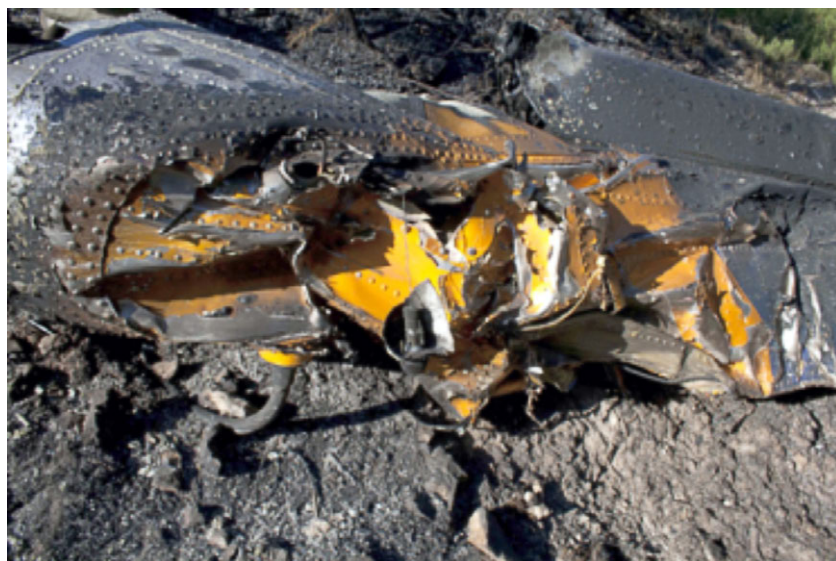
Figure 16. Impact of the tail

The tail of the helicopter had detached from the fuselage and was along the same line as the landing gear, the battery and the rock. The fracture area was molten and the driveshaft broken at several points. At the rear, in the area below the 42° box, was a strong impact mark and bits of embedded wood. The tail skid had detached, along with the tail rotor, and appeared to have broken off where it attached to the structure.

From the 42° gear box, the vertical stabilizer had pivoted and curved backwards. It was bent along the trailing edge. The two tail rotor blades also had several crease marks caused by the impact with the ground, and one of them had lost a segment of its tip some 20 cm long that, as noted earlier, was found separately from the main wreckage.

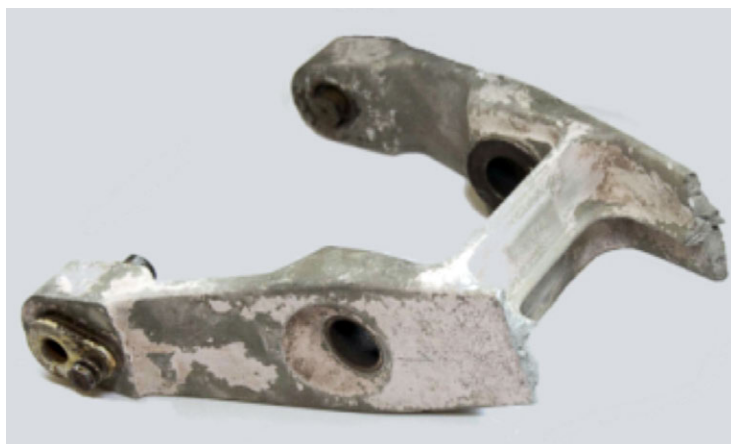
Figure 20. Collective lever

They were partially recovered from the wreckage of the transmission and control systems that comprise the aircraft's collective system, shown in figure 5. The components in the system were destroyed by the impact and the fire. The only identifiable parts were the two collective sticks, the tubes connecting the two sticks and the collective lever. Figure 20 shows the condition of this lever, labelled with the number "1" in figure 2.

A metallographic study of the two fracture points on the lever showed that the alloy in both had been partially melted by the heat. As a result, the micro-relief of the surface could not be used to identify the fracture process.

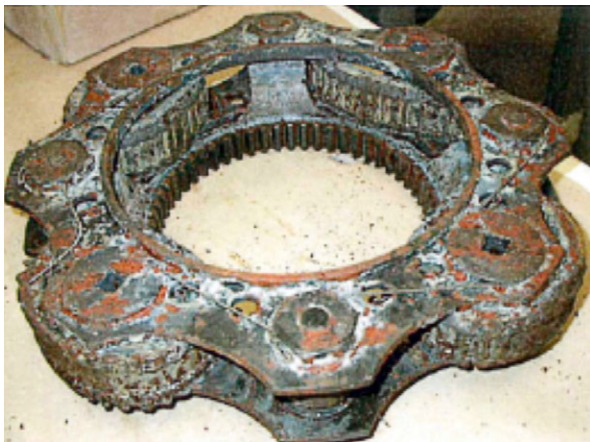
Figure 21. Condition of the lower planetary gear in the first case

The results of both events are similar and resemble those obtained for the accident of aircraft EC-JRY. Figures 21 and 22 show the damage to the lower planetary gear in both cases.

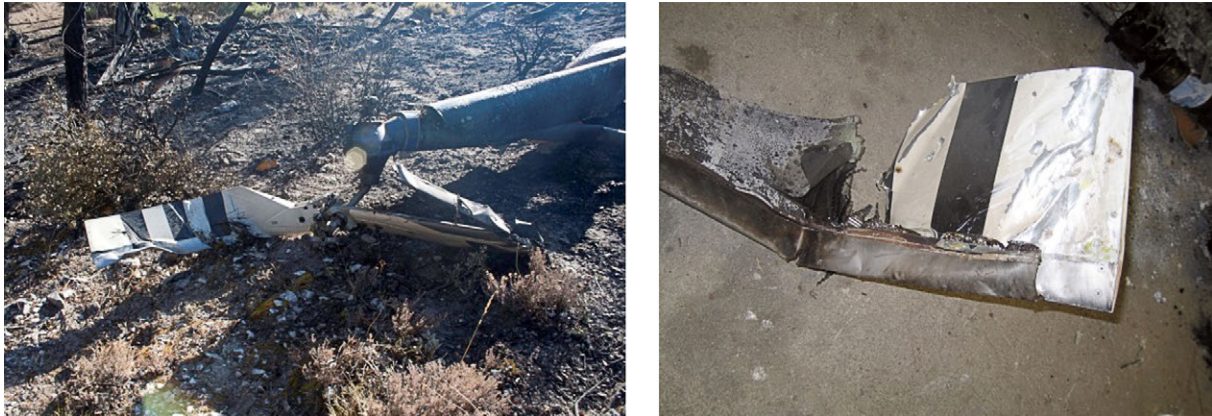
Figure 24. Tail rotor debris

The way the tail skid was bent reveals that this must have happened during the initial impact with the ground, when the aircraft was in a nose-up attitude. This also seriously affected one of the tail rotor blades, which was ejected. Figure 24 shows the condition of the tail rotor after the accident and its reconstructed state after the ejected blade was recovered.

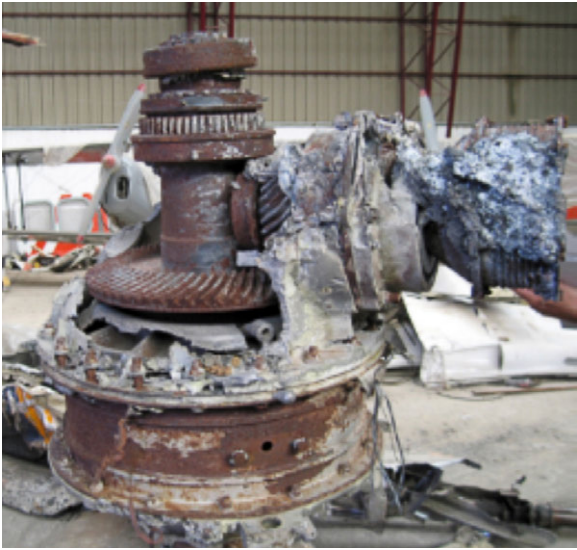
Figure 5.1. External condition of MGB

Externally it was heavily damaged from the impacts it had received, the heat of the fire and corrosion. The only original components remaining were the top part after the conical pinion on the driveshaft, which was exposed, along with the gear to the input pinion, see Figure 5.1 in Appendix 5. The external lubrication tubes and the electrical wiring were all consumed in the fire.

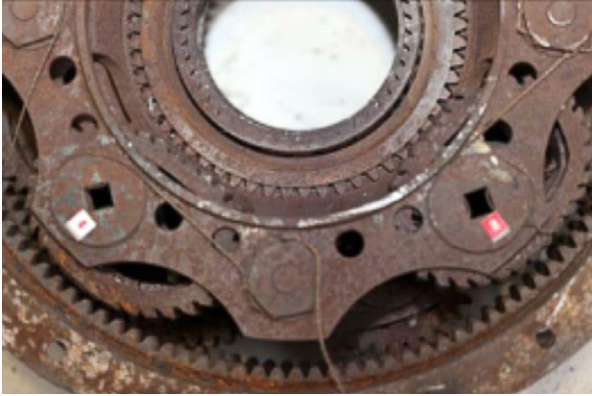
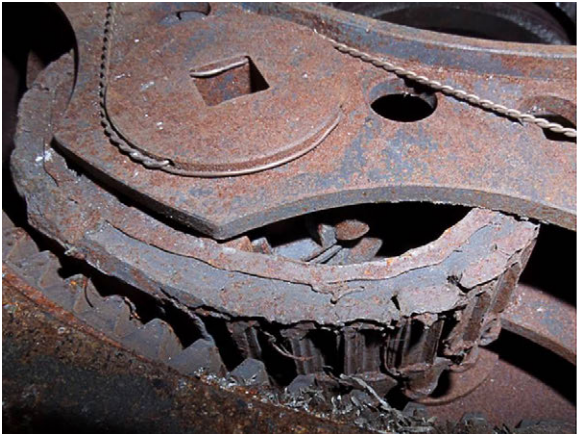
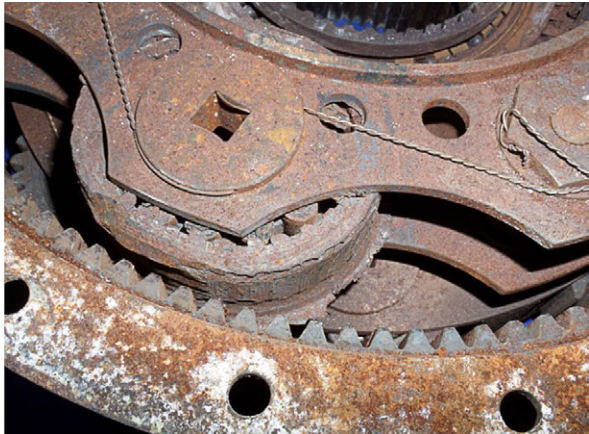
Figure 5.2. Lower planetary gear

Overall, the inside of the MGB showed signs of having been subjected to high temperatures and corrosion. The four gears on the lower planetary gear were bent, their teeth worn and bent in the direction of rotation of the gear, the bearing cages and the steel bearings were detached and bent and/or crushed inside the MGB. The crown on which the gears rotate was practically intact.

All of the damage observed was consistent with the main gearbox having been operating without lubricating oil.

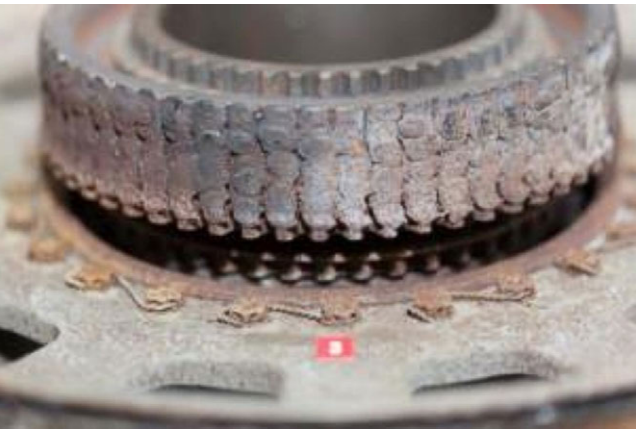
Figure 5.5. Sun gear

The damage to the sun gear was similar to that on the planetary gear, with its teeth plastically deformed all around the perimeter.

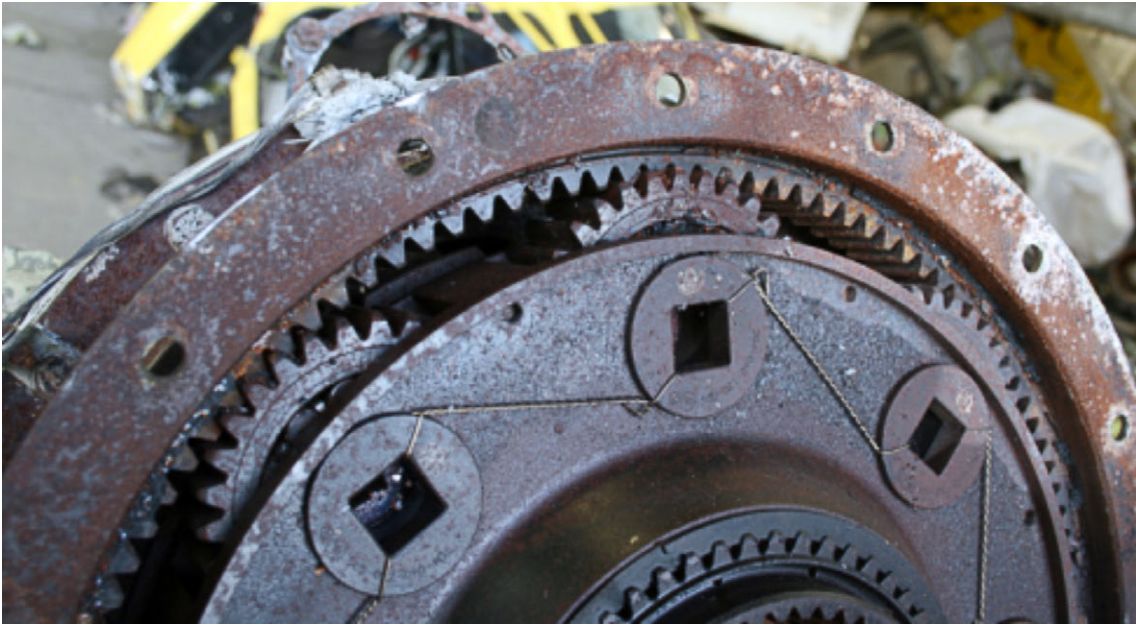
Figure 5.6. Upper planetary gear

The upper planetary gear, consisting of eight gears, only exhibited damage to some of its bearing.
