Report A-008/2013

Accident involving a BOEING B-757-300,
registration D-ABOC, operated by
Condor, at the Gran Canaria Airport
on 22 March 2013

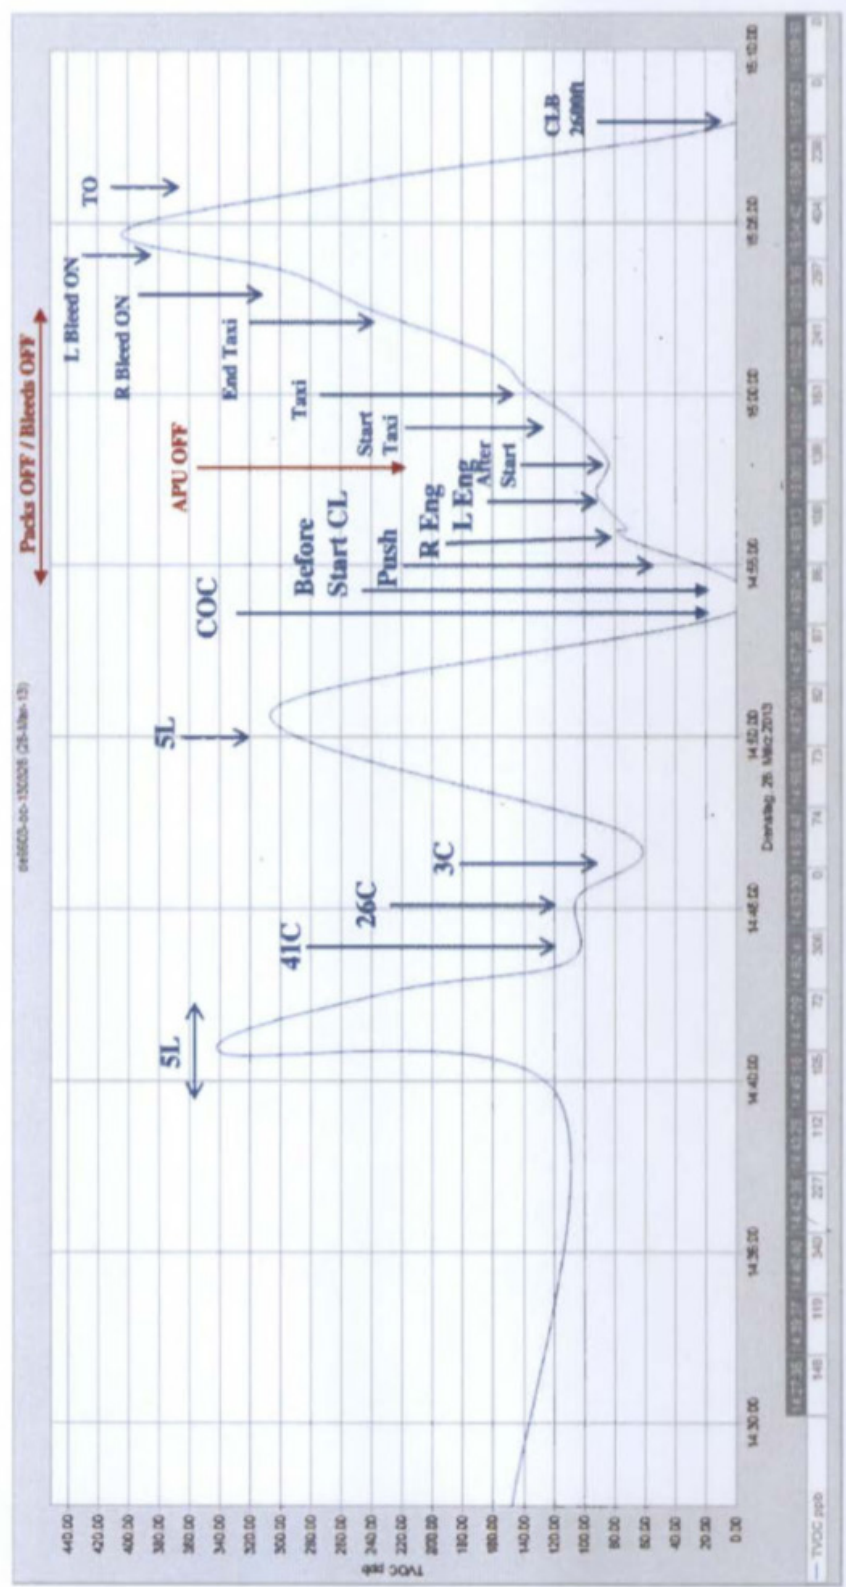
Figure 3. Graph with the TVOC readings of the Graywolf sensor from the time the crew boarded the aircraft until the initial climb phase

TVOC-Measurement on ground and until Climb-Out phase
 (note: different scale for easier differentiation)
Increase of TVOC (with Packs OFF/Bleeds OFF) correlates with perceived smell in A/C

Even so the first officer felt his tongue going numb and irritation in his throat. These same symptoms were also reported by the purser.

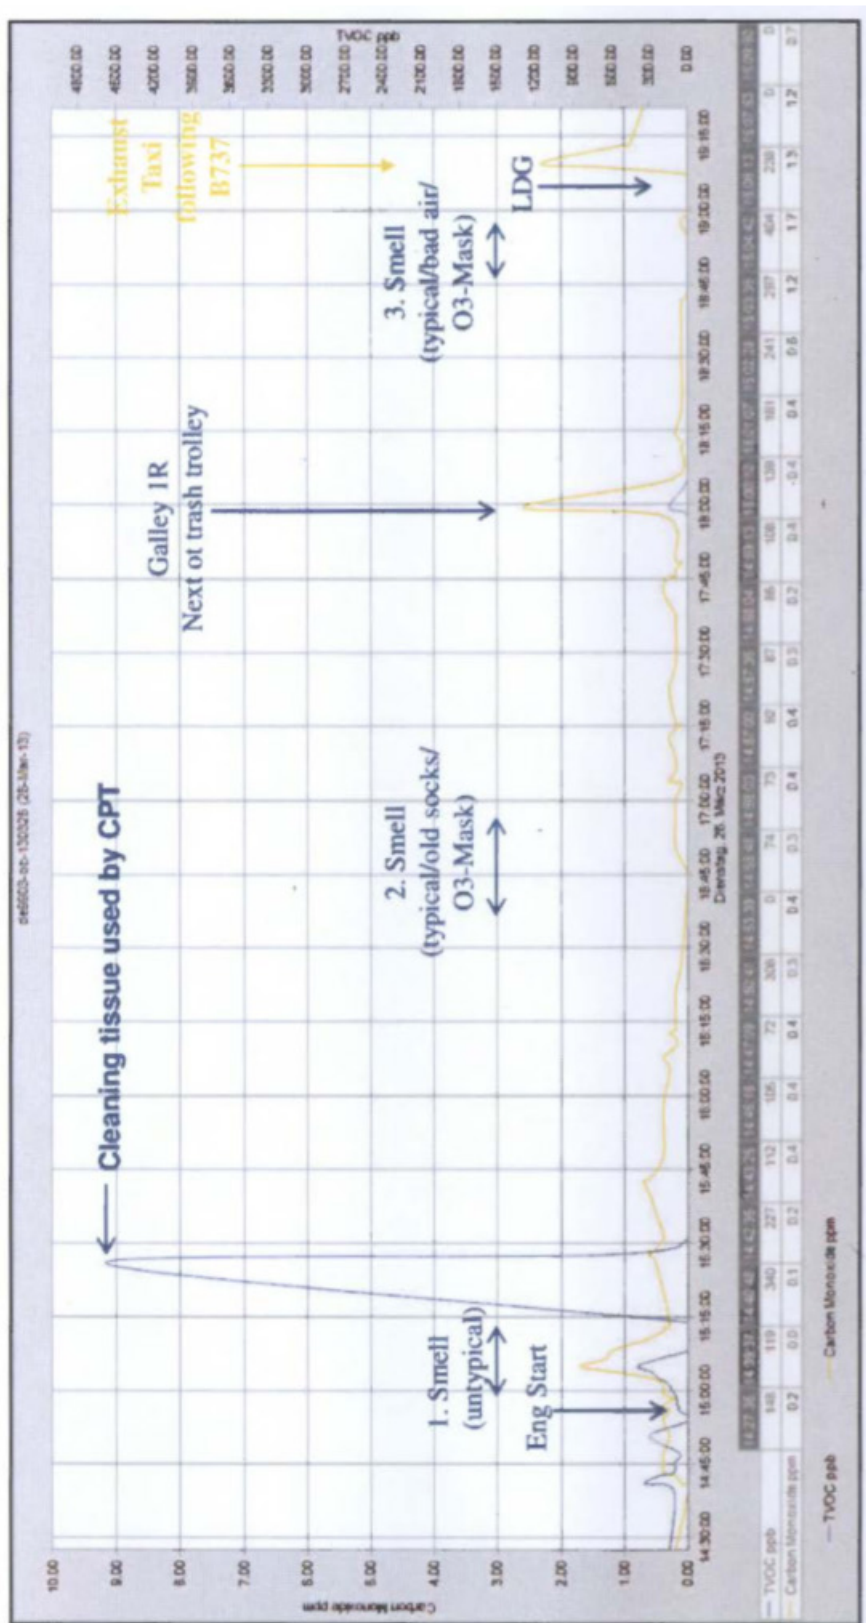
Figure 4. Comparison of TVOC and CO readings throughout the flight

The reason why the Graywolf did not give any indications during these phases could be because the odor was caused by compounds that are not ionized in the unit's probe (those with an ionization energy higher than 10.6 eV). Examples of such compounds include the following:

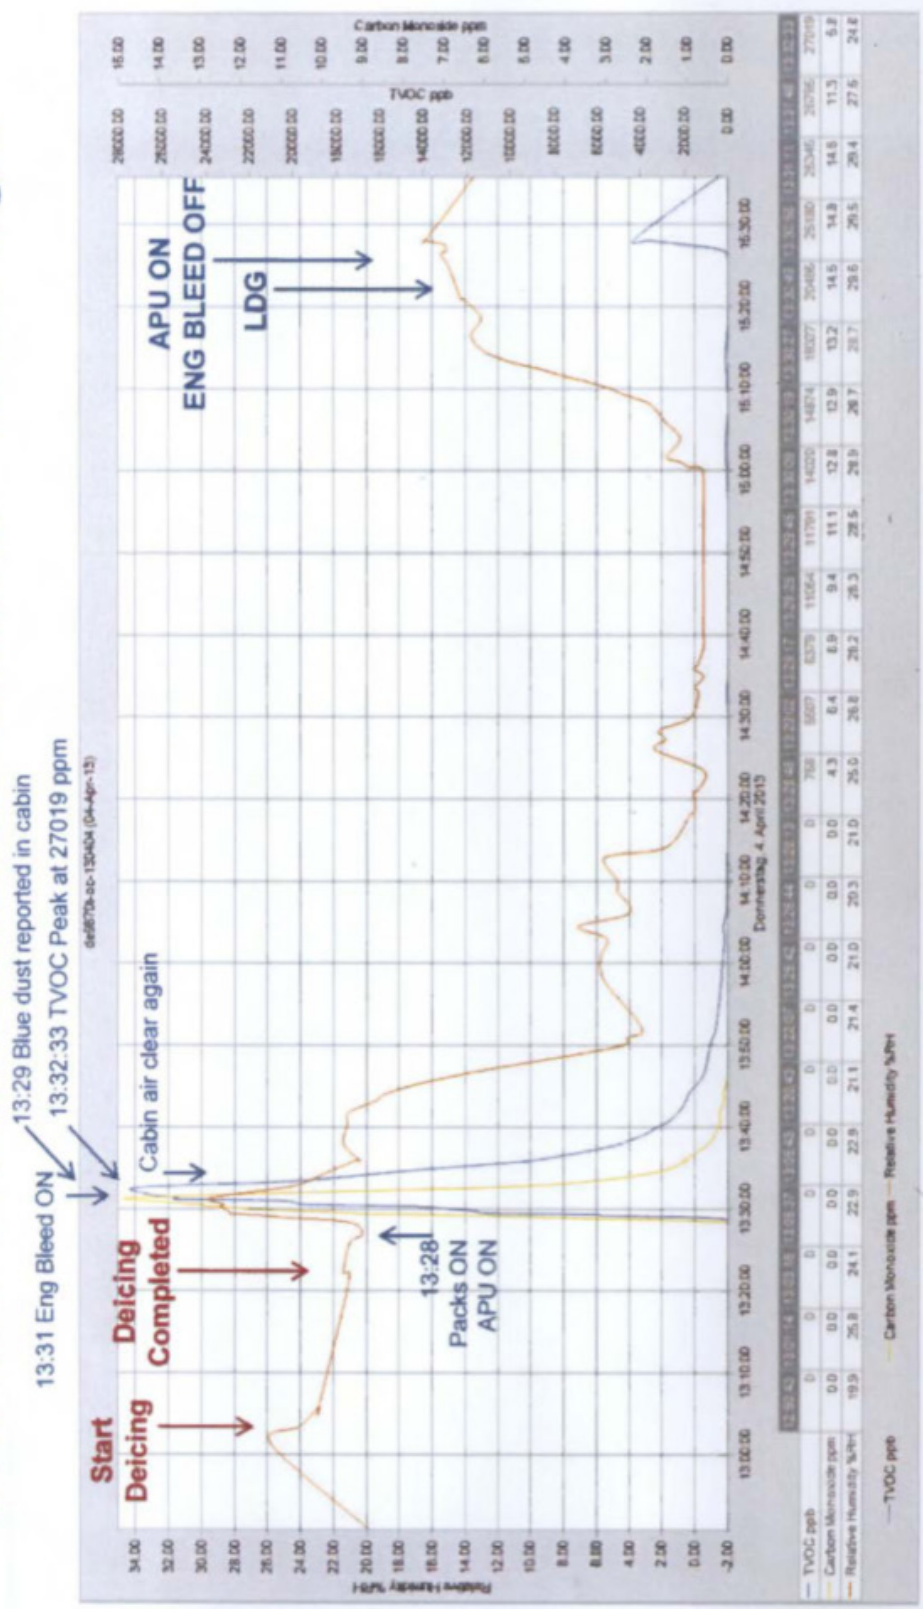
Figure 5. TVOC, CO and relative humidity readings during the flight of 04/04/13, which had undergone a deicing treatment

This time a large amount of smoke entered the cabin, both on the ground with the APU supplying the air conditioning packs, and in flight, with the air supplied by the engines. The Gray Wolf displayed a rise in TVOC values.

In light of the results of this test, the operator decided to prohibit deicing treatments with the APU running.

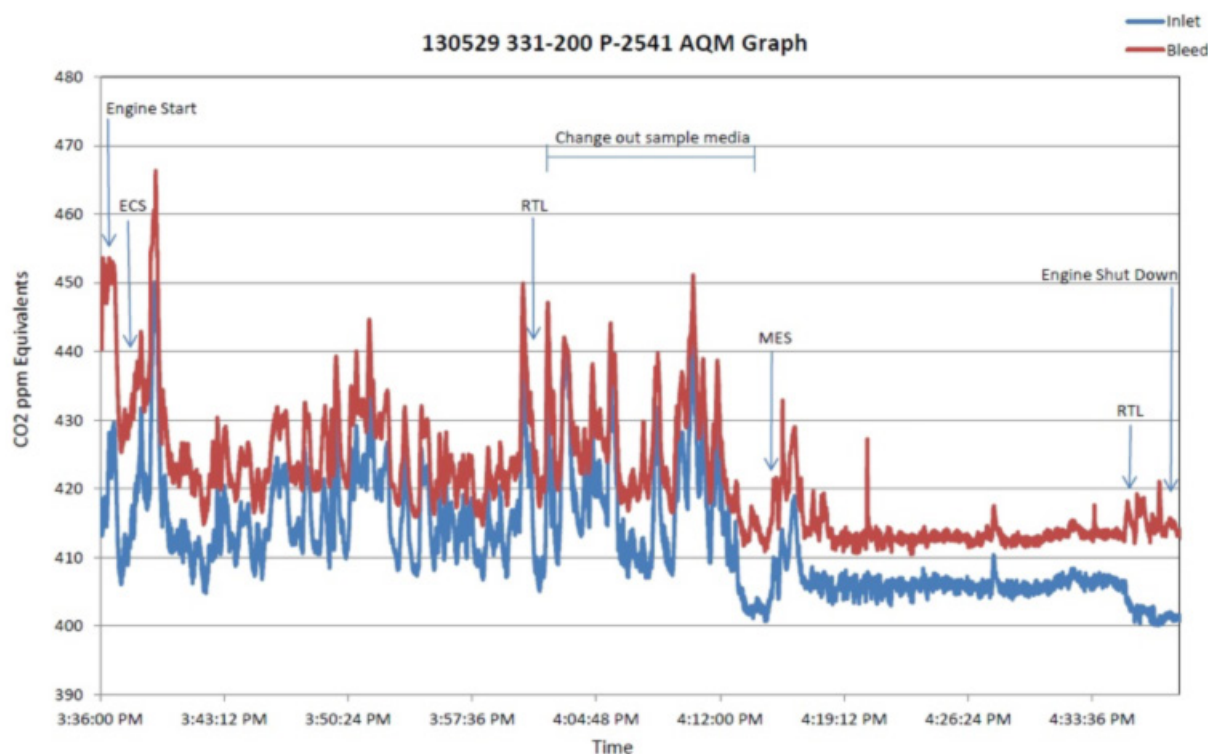
Figure 7. Results of the AQM

the odor detection threshold, which is 830 ppb for formaldehyde and 50 ppb for acetaldehyde. These values are also below 1/10 of the 8-hour total weighted average permissible exposure limit (PEL) set by the U.S. Occupational Safety and Health Administration (OSHA).

- Tricresyl phosphate isomers were detected only during the “main engine start” operation, in the 0.0090-0.255 ppb range, which is well below the OSHA-PEL, which is 6.6 ppb.
- Traces of multiple compounds and TICs⁹ were detected, with the highest levels being for isopropyl alcohol (2-propanol), acetone, butanone, toluene and carbon disulfide, all of which were below the odor perception threshold.
- The only smell reported by any of the participants was a “dirty” smell, with no reference being made to an “oily” smell.
