Report IN-009/2016

Incident involving an Airbus
A-320-232 aircraft, registration
EC-MGE, at the Bilbao airport
(Bizkaia, Spain) on 28 March 2016

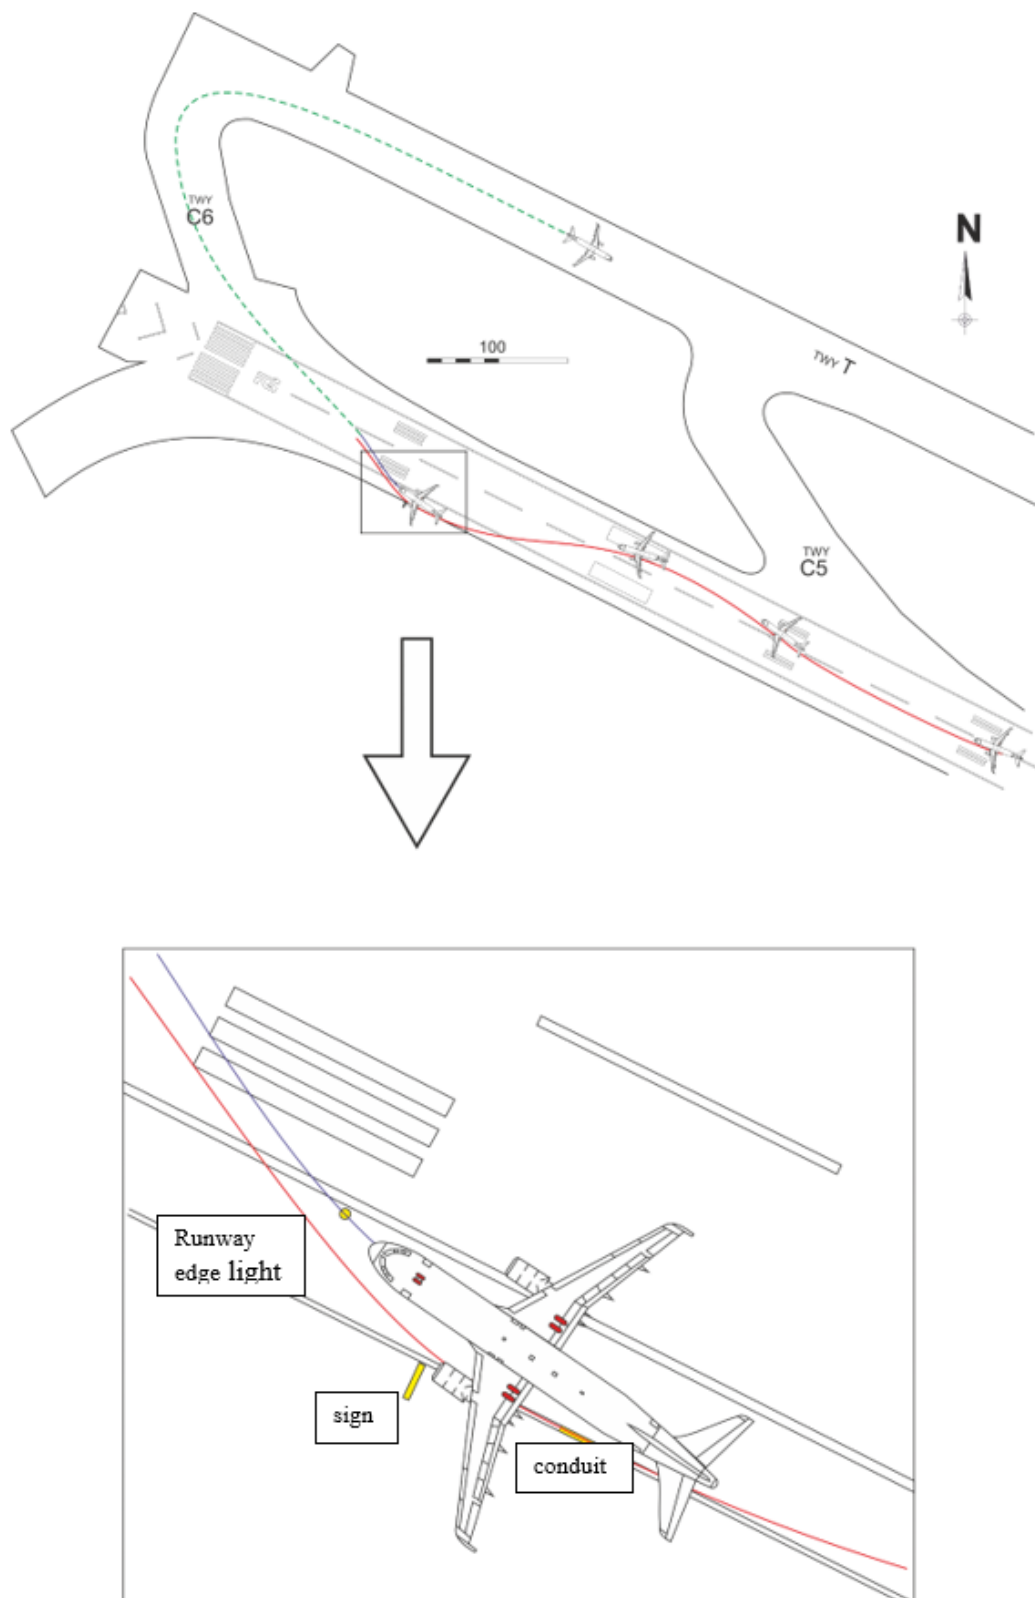
Figure 1. Diagram of the aircraft's path and location

The aircraft then landed on runway 30 at the Bilbao Airport. It was a normal landing until, during the landing run, the crew were unable to maintain the path, with the aircraft veering from side to side on the runway before eventually leaving the runway via the left shoulder between exit taxiways 5 and 6. The aircraft then momentarily taxied over an unpaved area with its left main gear before returning to the runway, which it then exited via taxiway C6. The aircraft then came to a stop on taxiway T, just before taxiway C5 (see Fig. 1).

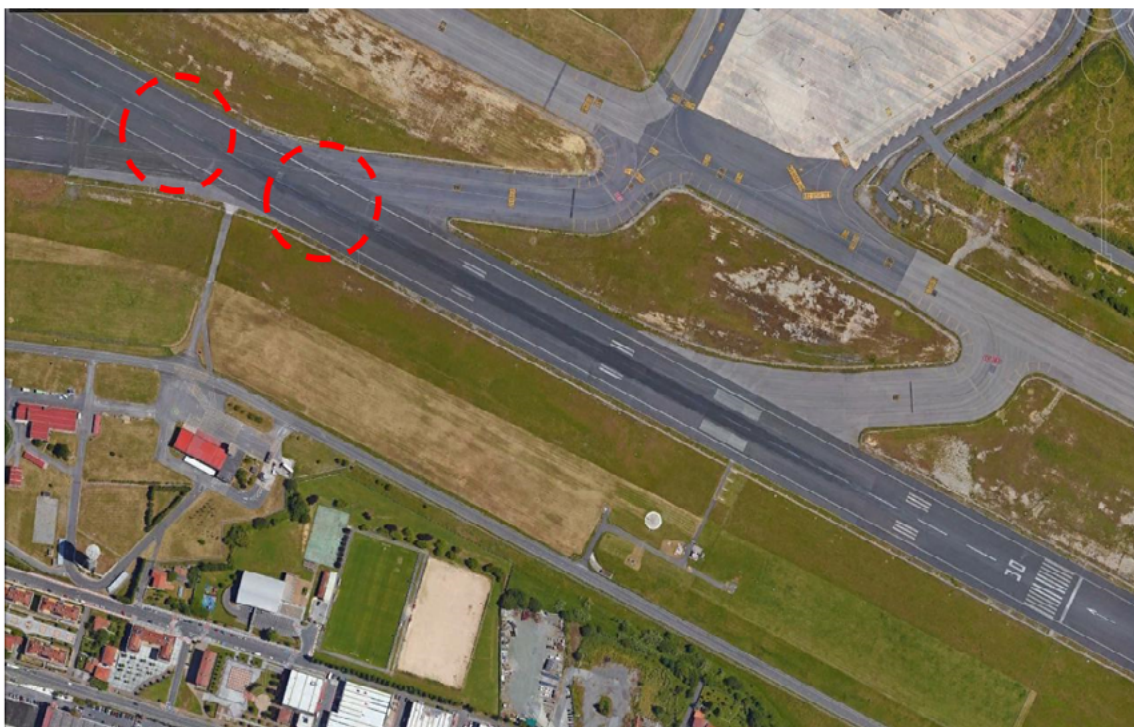
Figure 4. Photograph 1 TDZ marking, runway 30, on date of incident

To help guide the pilot to make contact with the main gear in the touchdown zone, runway 30 at the Bilbao Airport has touchdown zone markings that consist of four pairs of rectangular markings (two set of three and two sets of two) arranged symmetrically around the runway centerline and extending 600 m away from the threshold. Since the second pair of three bars coincide with the aiming point marking, only the latter is indicated in the PAPI.

Since the goal of both runway markings and lights is to delimit the TDZ, there was an inconsistency between these dimensions. As a result, a safety recommendation is issued to the certifying authority to have it standardize the distances that signal the TDZ in both systems.

REC 05/19. It is recommended that EASA amend the Certification Specifications and Guidance Material for Aerodromes Design CS-ADR-DSN so as to standardize the distances for the touchdown zone signs, whether they are markings or lights.

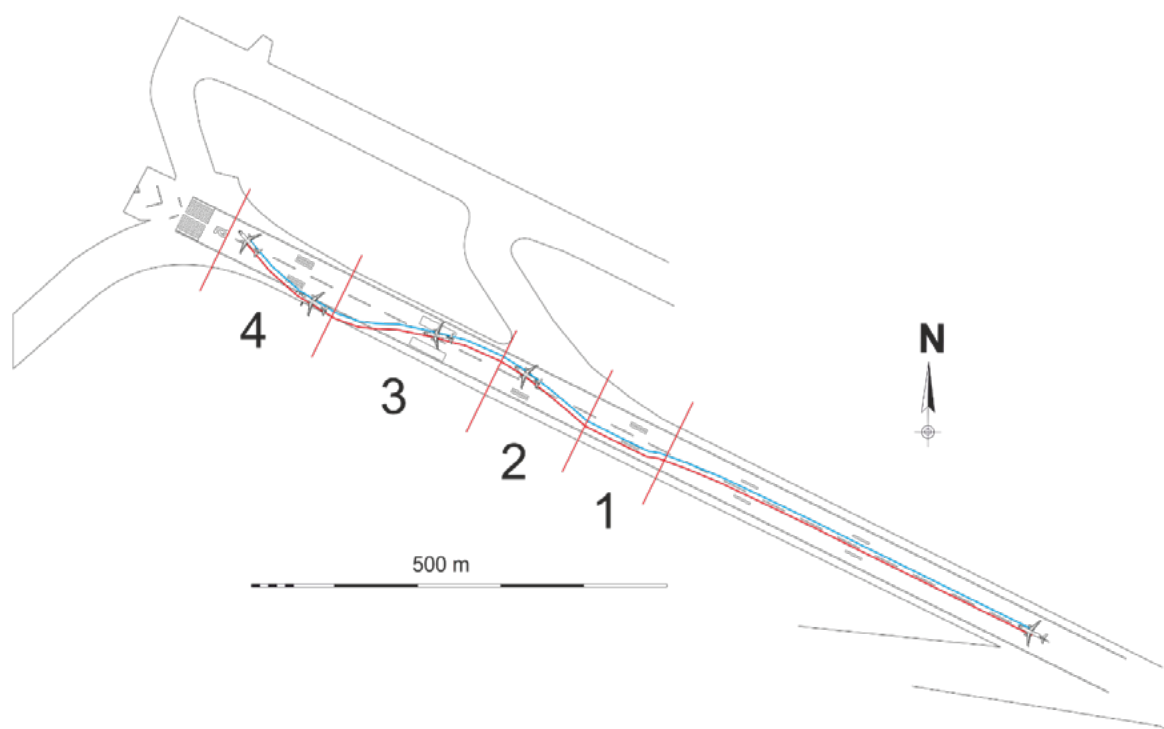
Figure 9. Segments of the aircraft's path on the runway

The aircraft then started turning to the left, with no apparent input from the crew or any abnormal system operation that could have caused it. The ground speed was 119 kt. At the time the FDR recorded a difference in the readings for the two angle of attack sensors that is consistent with a wind gust. This is not confirmed by the wind readings in the FDR, since these readings are not valid once on the ground.

by making inputs to the rudder and right brake. The fact that they overran the centerline indicates that their inputs were inadequate (either in duration or intensity), made more difficult by the variable wind gust conditions that caused the deviation in the first place.

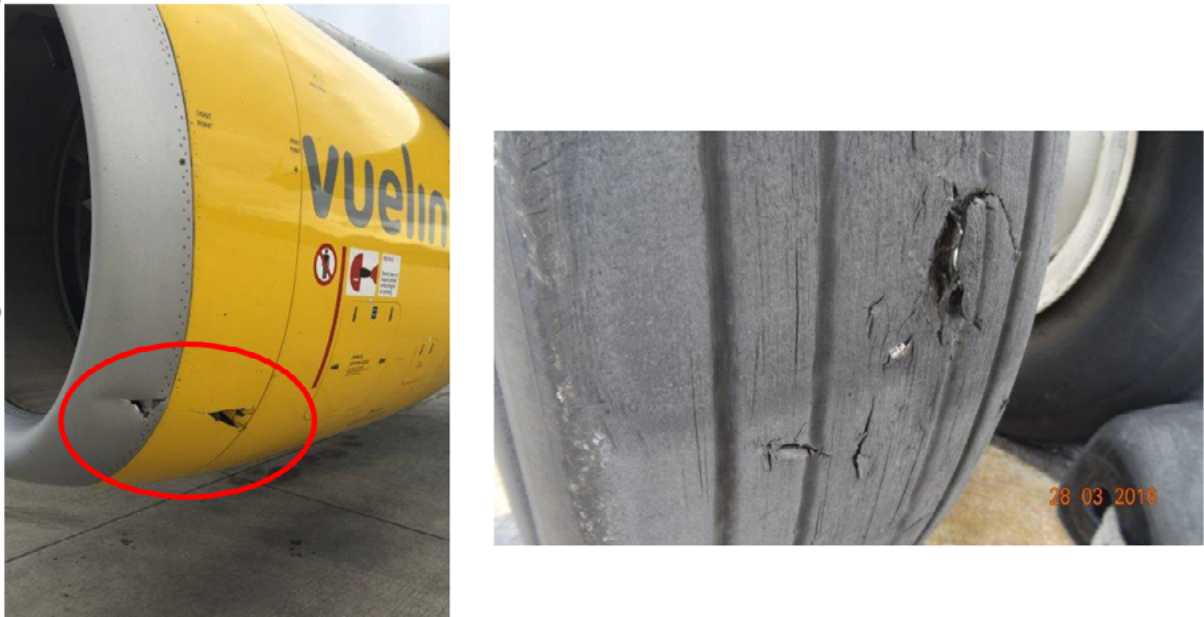
Figure 10. Damage to the aircraft

The aircraft sustained minor damage consisting of dents to the left engine cowling and detached material from one of the nose gear wheels.

As a result of its runway excursion, the aircraft sustained damage to its left engine cowling, and loss of material from a tire on the nosewheel landing gear.

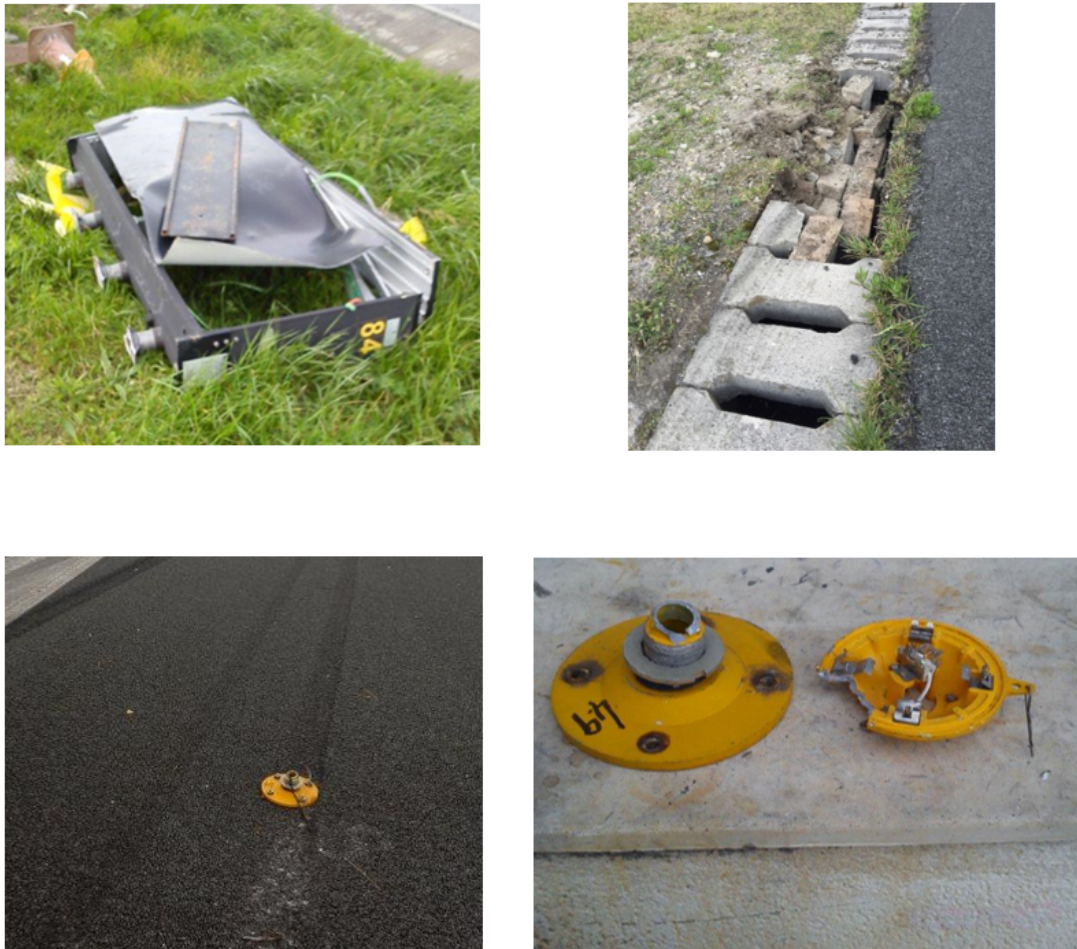
Figure 11. Damage to the airport

A runway edge light was broken, a sign indicating the runway exit to a taxiway was pulled out of the ground and broken, and a conduit along the runway edge was broken.

In addition, as the aircraft traveled on the runway, it broke a runway edge light, a sign indicating the exit to a taxiway and part of a conduit on the runway strip.
