Report IN-040/2016

Incident involving an Airbus A-319-111, registration CS-TTD, operated by TAP Portugal, on approach to the Santiago de Compostela Airport (Spain) on 10 October 2016

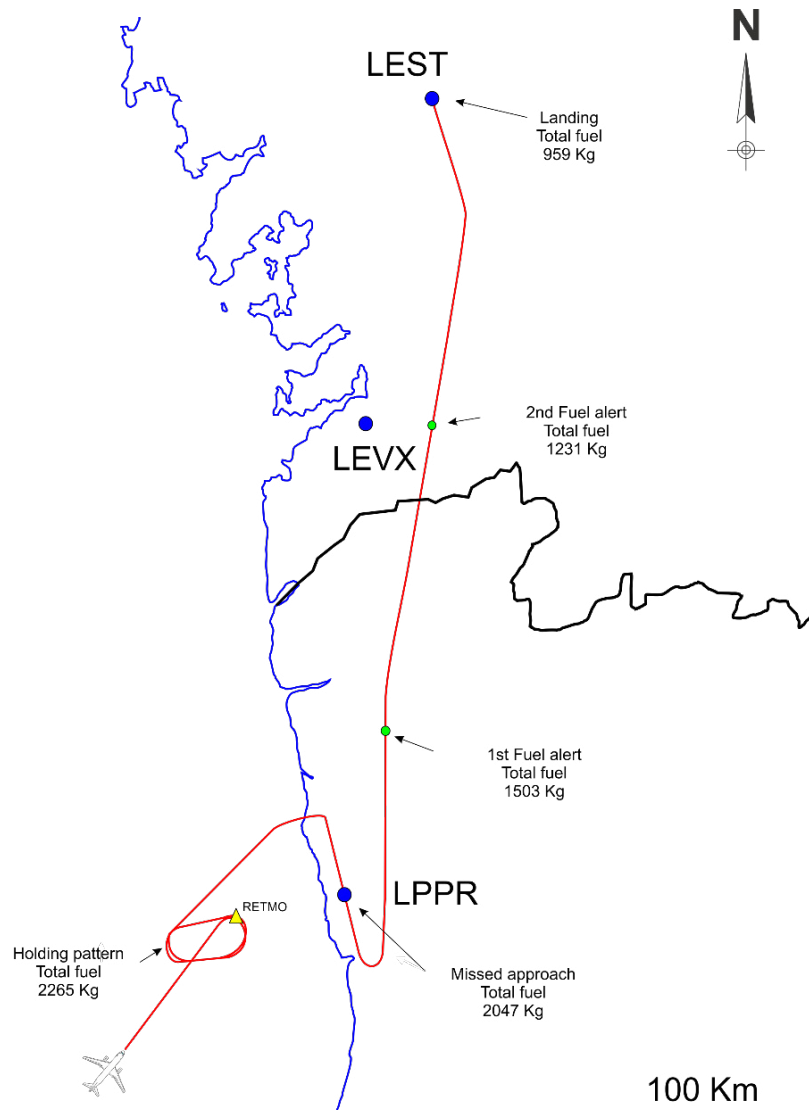
Figure 1 - Aircraft's flight path.

At 08:00:11, the crew exited the pattern and started the approach maneuver to runway 17 at the Porto Airport with 2265 kg of fuel. Two minutes later, while executing the maneuver, the crew informed approach control of their intention to proceed to Vigo should they be forced to execute a go-around.

At 08:11:44, the crew decided to go around and proceed to the planned alternate when they did not acquire the required visual reference upon reaching the approach minimums. In their message to the tower controller, they reiterated their request to proceed to the Vigo Airport.

At 08:18:28, after coordinating with Santiago approach control, the Porto approach controller reported that the Vigo Airport was at full parking capacity and that they would have to proceed to the Santiago de Compostela Airport. As a result, they were cleared direct to point NOLMU and transferred to Santiago approach.

After flying the VOR approach to runway 35 at Santiago, the aircraft landed at 08:38:20 without incident with 959 kg of fuel remaining. The crew were instructed to proceed to parking stand 04.

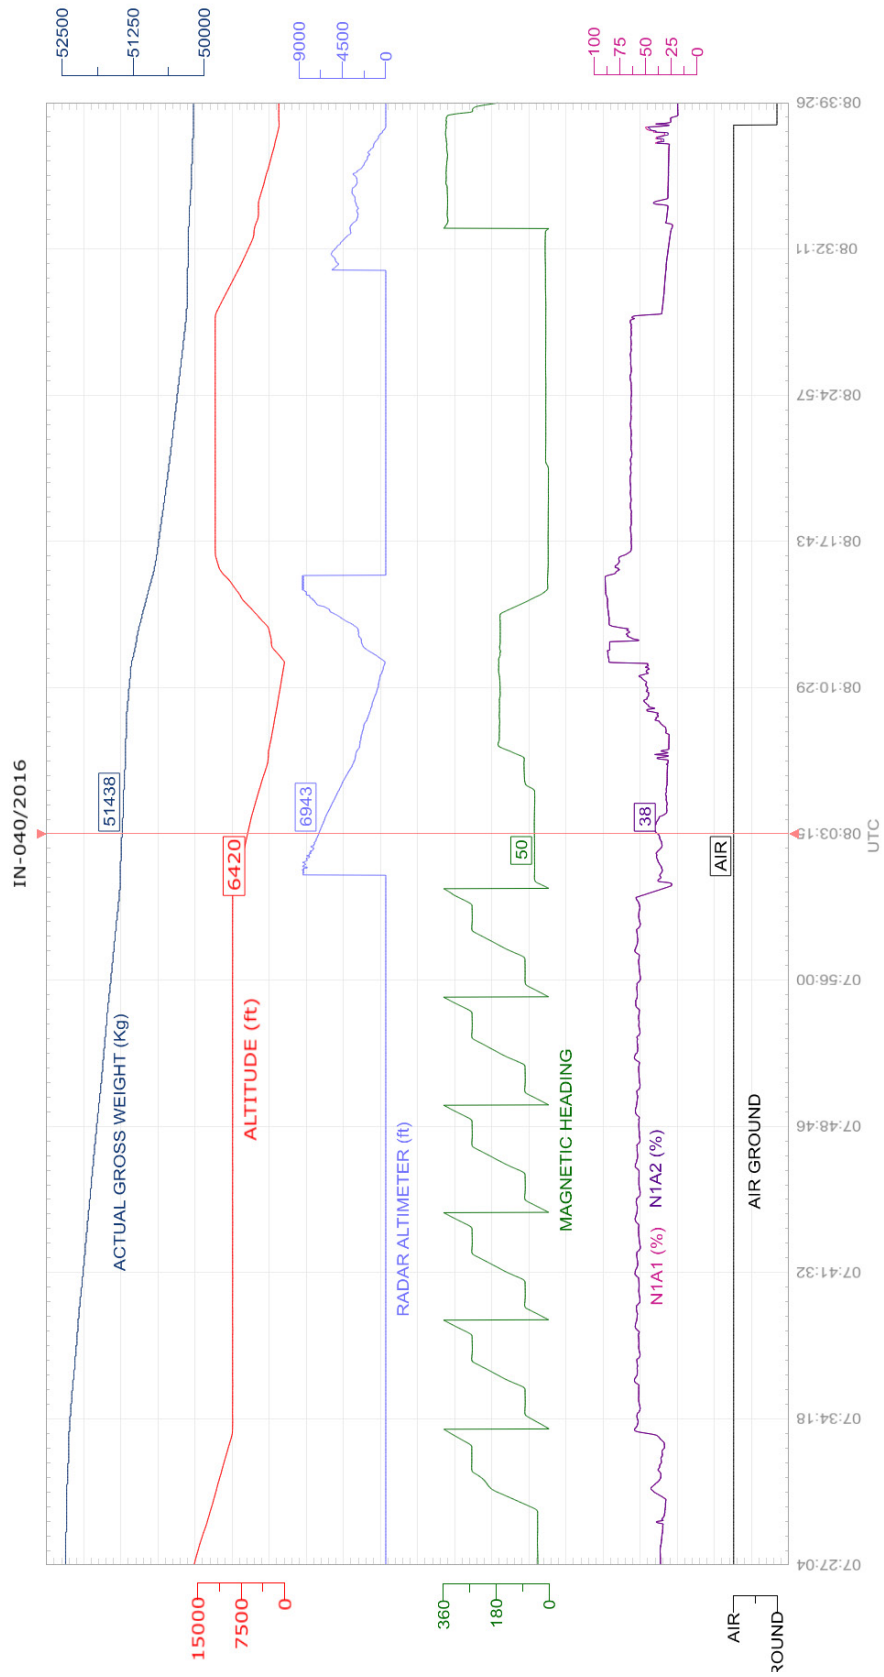
Parameters recorded in the QAR

At 08:19:15, a "FUEL L WING TK LO LVL" alert was received, indicating a low fuel level in the left wing, and at 08:25:25 a second alert was received, this time for the right tank: FUEL L+R WING TK LO LVL.

At 08:26:34, the crew, in contact with Santiago approach, declared a fuel emergency after estimating that the amount of fuel remaining upon landing would be below final reserve fuel, which the OFP specified as 989 kg.
