Report IN-017/2017

Serious incident involving a Boeing B787-900, registration N825AA, and a Cessna 172-M, registration EC-IEO, in the Madrid TMA on 8 August 2017

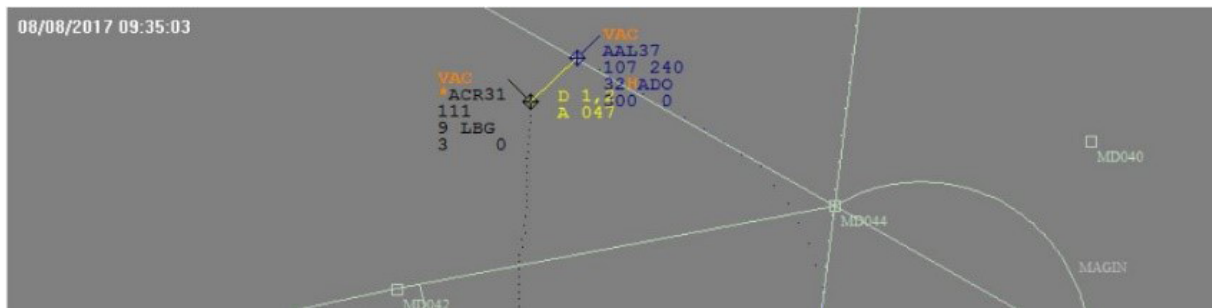
Figure 2. Image of the closest point of approach between the aircraft

The minimum separation between the aircraft during the event occurred at 09:35:03, when they came within 1.2 NM horizontally and 400 ft vertically of each other (see Figure 2).

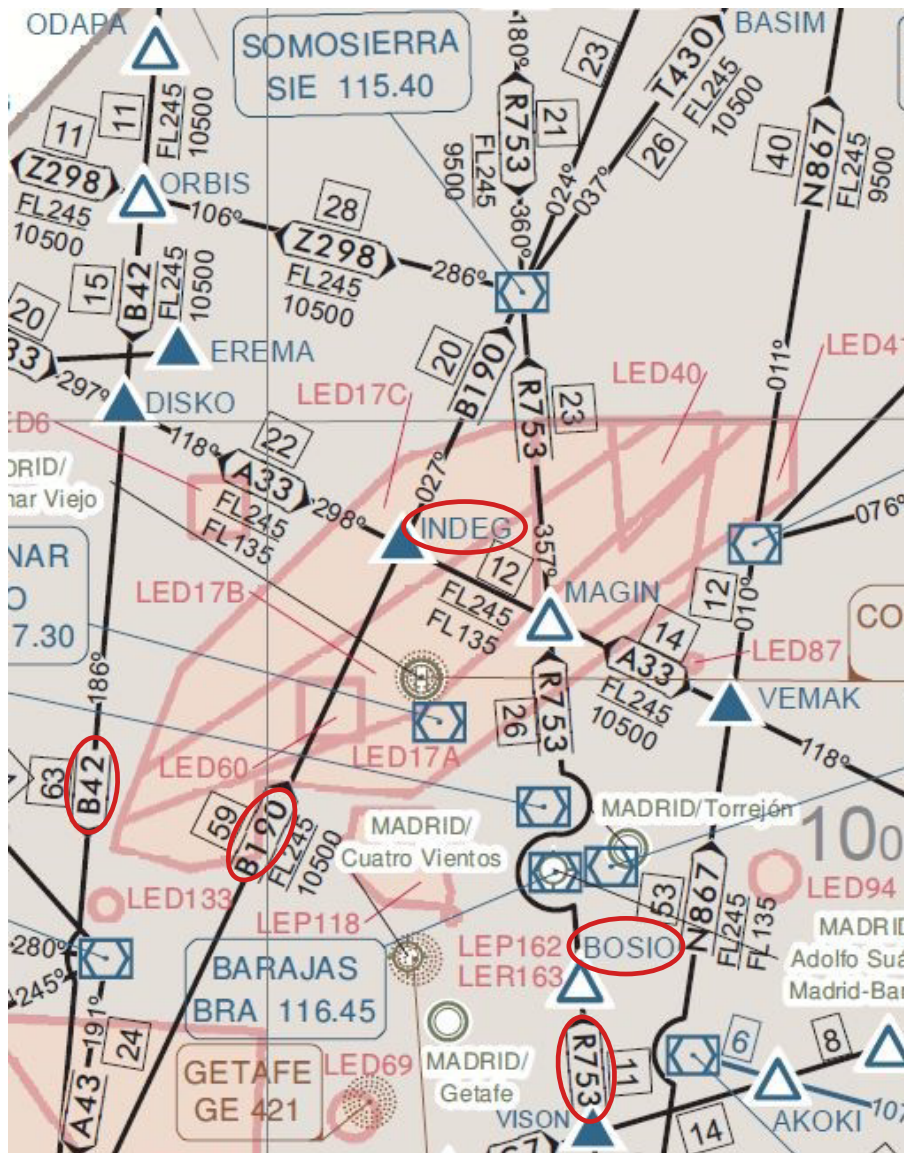
Figure 4. Extract from lower airspace chart (ENR 6.1-1), with airways B42, B190 and R753 and points INDEG and BOSIO circled in red

BOSIO is a point on airway R753 that is in the segment between the VTB VOR/DME and the SIE DVOR/DME, and is not to be filed in flight plans (see 1.8). As a result, the change made to the flight plan by the IFPS was in violation of this restriction.

REC 34/18. It is recommended that ENAIRE establish a route for aircraft taking off from the Madrid-Cuatro Vientos Airport (LECU) on northerly routes under IFR, to facilitate its incorporation to an airway and to minimize possible conflicts with other traffics in the Madrid TMA.

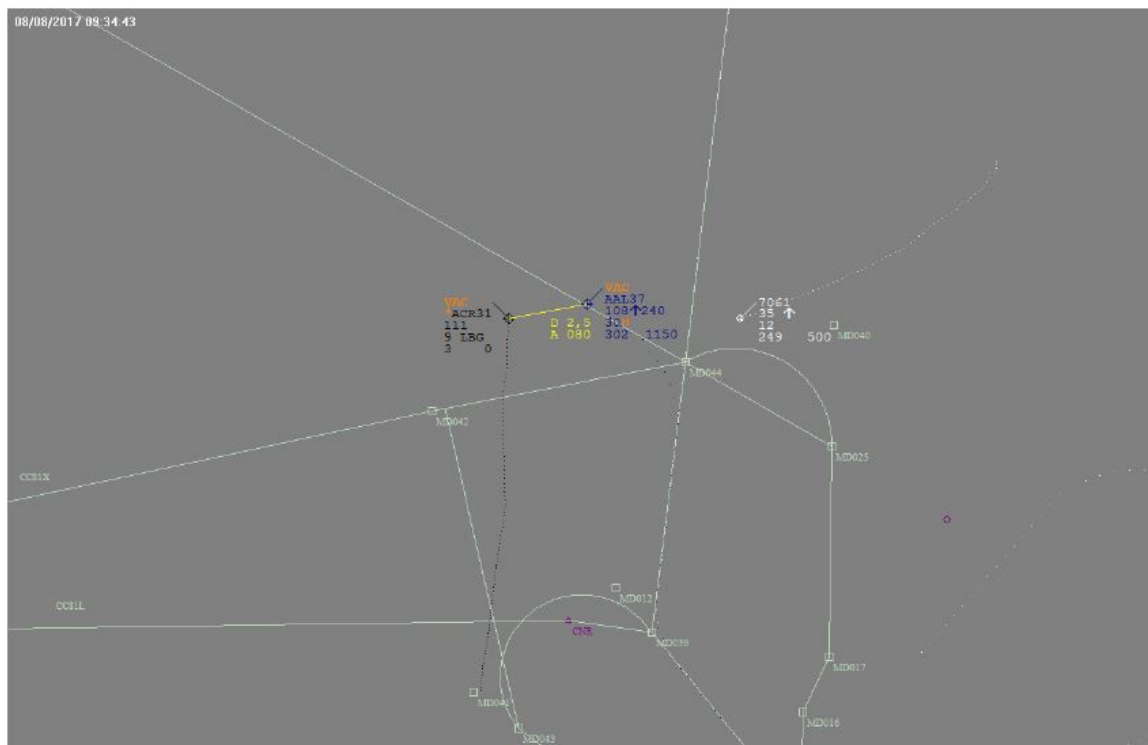
Figure 5. Image of the moment when the VAC conflict alert occurred

In the 40 seconds before the violation alert (VAC) was issued by the SACTA system, aircraft ACR31 flew a straight path and kept a practically constant altitude of 11,000 ft.

REC 35/18. It is recommended that ENAIRE revise the conflict alert prediction algorithm (STCA) in an effort to improve its ability to detect future conflict scenarios. This recommendation also includes the suitability of evaluating the viability of improving the capability of the system to use flight plan data.

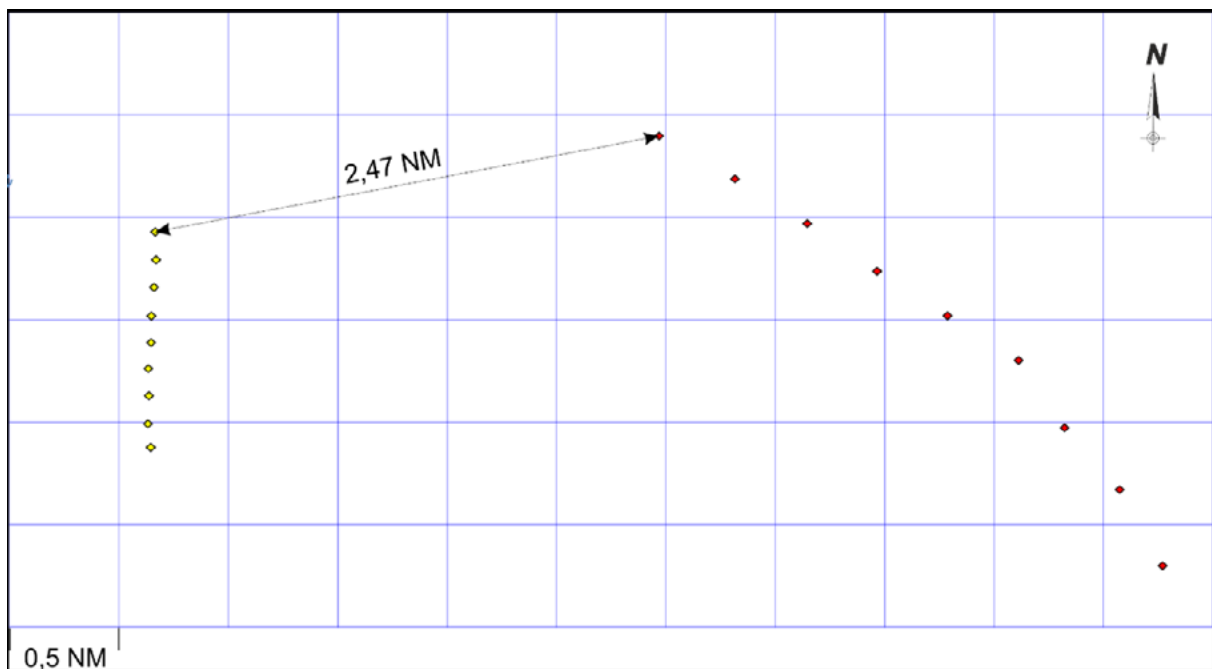
Figure 7. Radar targets for ACR31 (yellow) and AAL37 (red) from 09:34:03 UTC to 09:34:43 UTC

Figure 7 contains a graph showing the radar targets for both aircraft during this time period. In yellow to the left are the targets for ACR31, while to the right in red are those for AAL37. The gap between each target is 5 s. As this figure shows, after the target from 09:34:18, AAL37 flew in a straight path.
