## Report IN-019/2017

Incident involving an AIRBUS A321 aircraft, registration G-OZBH, and an AQUILA A-210 aircraft, registration D-EPIG, at the Menorca Airport (Balearic Islands, Spain) on 21 July 2017

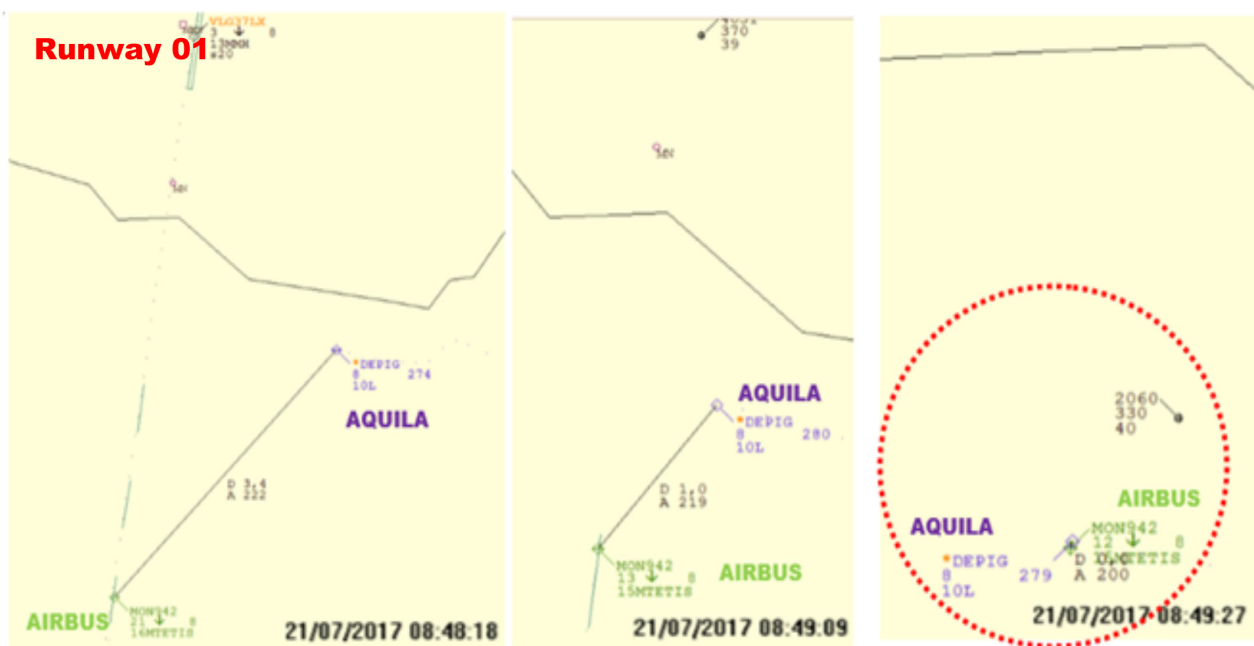
At 10:49:27, when the AIRBUS-A321 was 2.5 NM away from the runway at an altitude of 1200 ft, the AQUILA A-210 crossed without maintaining horizontal separation, crossing 400 ft below the AIRBUS-A321.

Figure 1. Crossing sequence as seen on radar display.

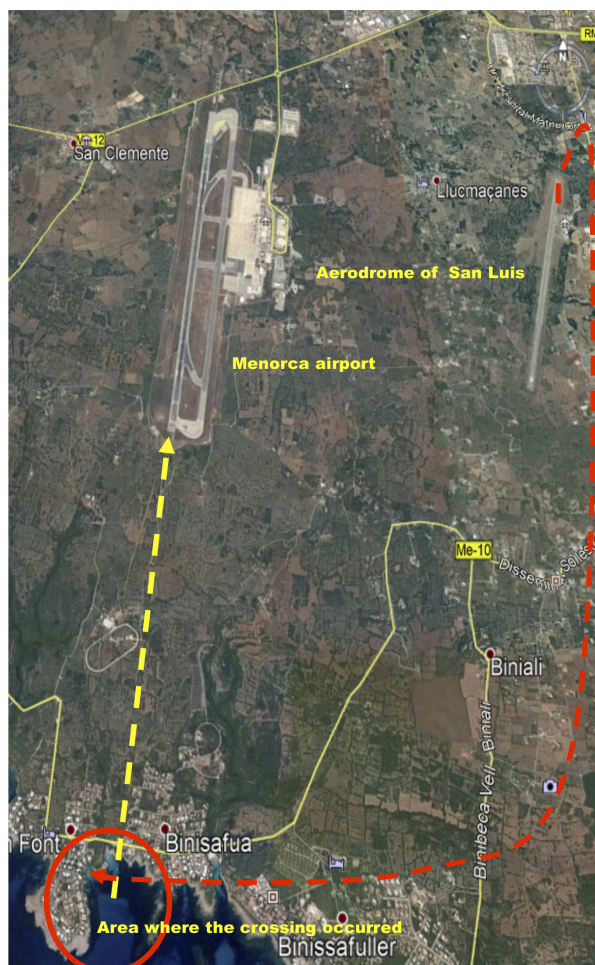
Figure 2. Crossing area.
