Report A-032/2017

Accident involving a Bell 412SP aircraft, registration EC-MMC, operated by Babcock International Group PLC, and a CASA 1131 aircraft, registration N1950M, at the aerodrome of Mutxamel (Alicante, Spain) on 30 December 2017

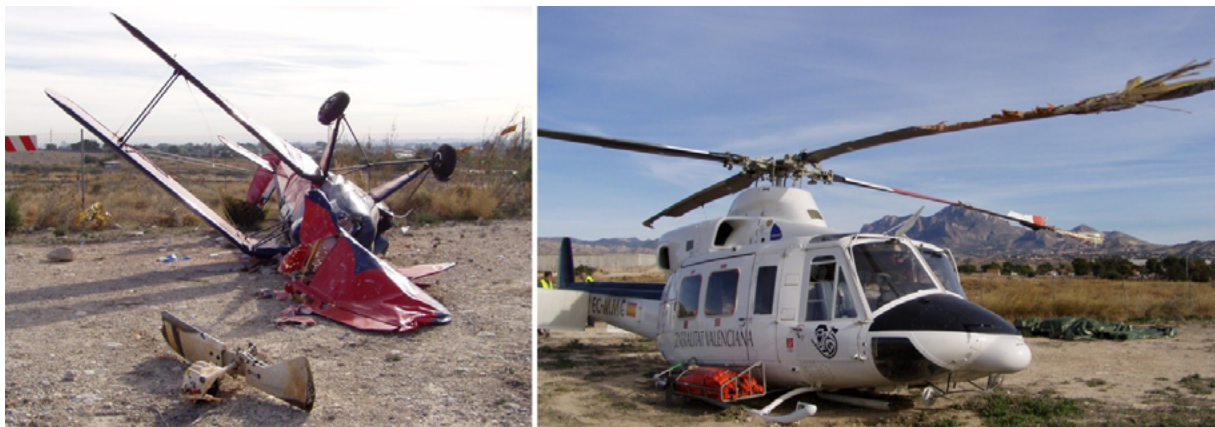
Figure 2. Aircraft after the accident

The Bücker 131 aircraft collided as it descended with the rear left of the helicopter such that both of its right wings made contact with the tail assembly, causing the tail rotor on the helicopter to break and detach. The Bücker 131 then impacted the main rotor blades, and its right wings detached. The main rotor blades broke, and the helicopter's horizontal stabilizer was damaged by the propeller on the Bücker 131.

The Bücker 131 crashed to the ground in an inverted position some 60 m away from the runway 30 threshold, damaging as it fell the metal perimeter fence of the aerodrome. It came to stop approximately facing northwest.

After the two aircraft collided, the pilot of EC-MMC managed to regain control of the helicopter, making an emergency landing with the skids impacting the ground. The pilot landed on a strip some 40 m away from the runway threshold, coming to a stop facing slightly to the southwest.

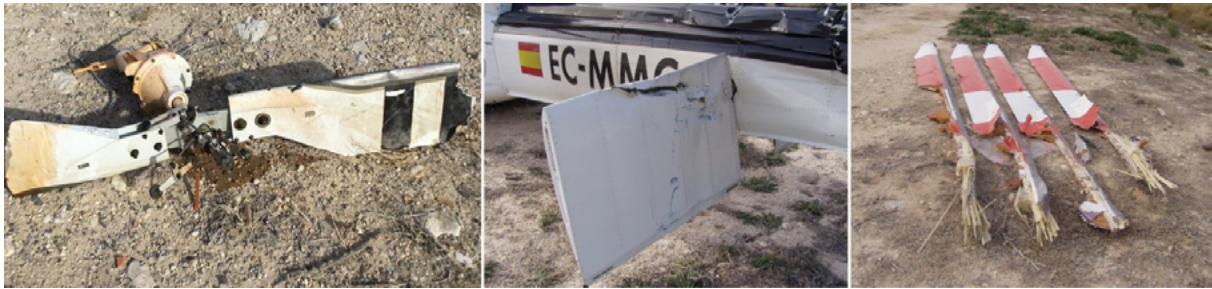
Figure 3. Aircraft EC-MMC

The collision between the two aircraft caused the tail rotor of aircraft EC-MMC to detach, the tail rotor drive shaft to break, damaged the horizontal stabilizer, tailcone and all four main rotor blades, and collapsed the skids.

The photo in Figure 3 shows the tail rotor and the condition of the horizontal stabilizer and main rotor blades after the accident.

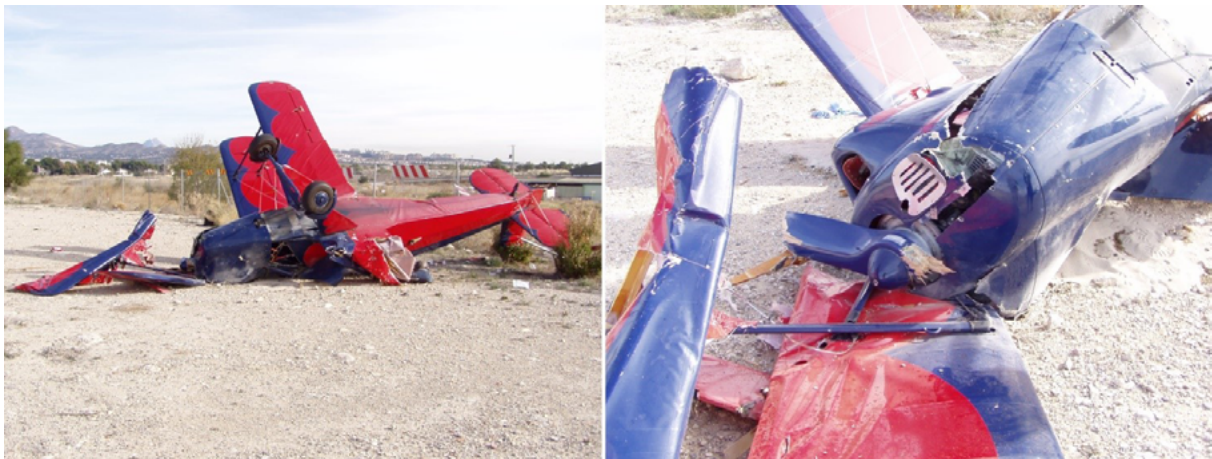
Figure 4. Aircraft N1950M

On the Bücker, the top and bottom right wings, propeller blades and engine cowling broke. There was also miscellaneous damage to the fuselage and in the cockpit.

Figure 4 shows the final condition of the Bücker.

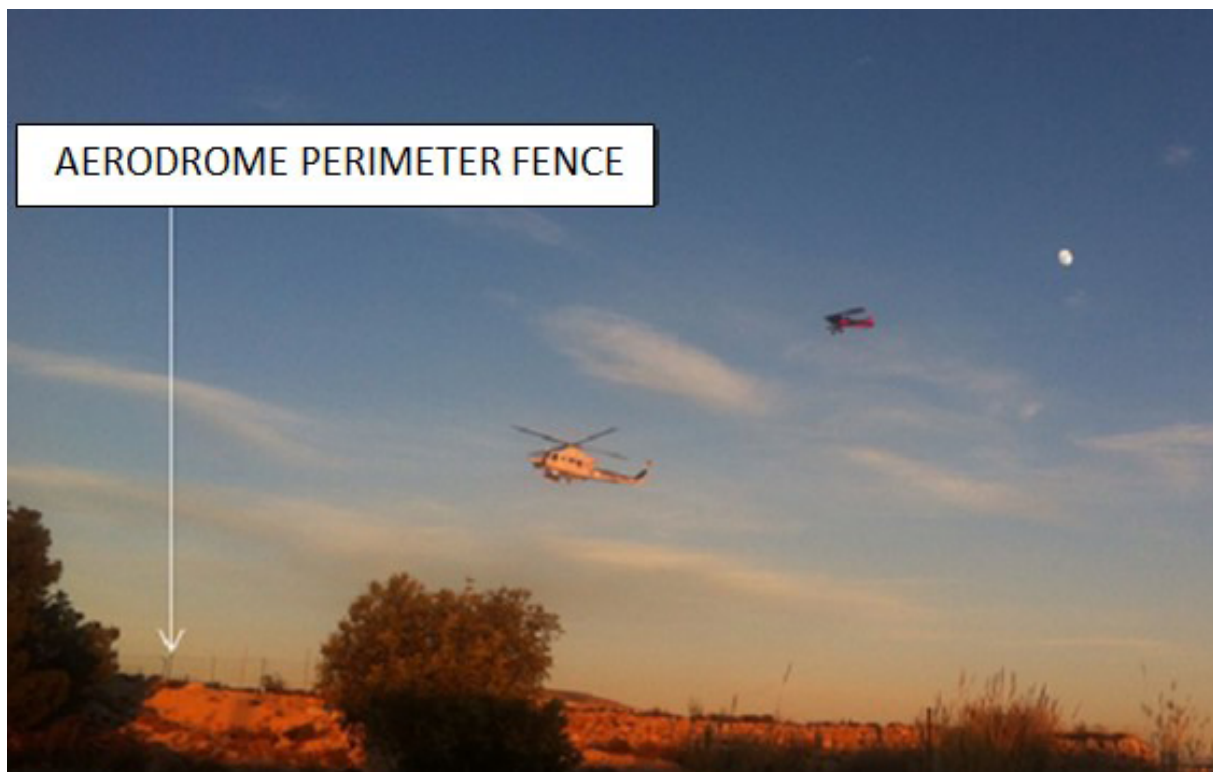
Figure 5. Positions of the aircraft on final approach

Figure 5 shows a photograph taken by eyewitnesses located outside the aerodrome grounds, specifically, south of the runway 30 threshold, moments before the accident.

The photo shows the aircraft involved descending during the final approach to runway 30.

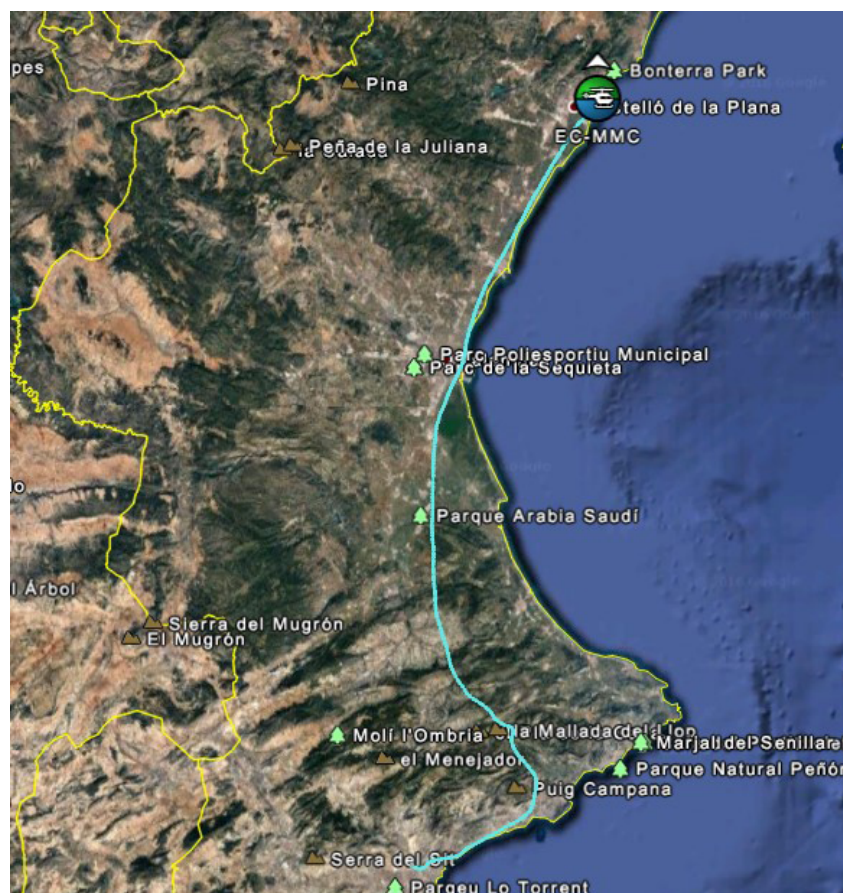
Figure 7. Track of aircraft EC-MMC

Shown in red in Figure 7 is the track followed by aircraft EC-MMC as it joined the final segment of the aerodrome pattern. The track was obtained from the fleet tracking data.

The track followed by aircraft EC-MMC shows that it directly joined the final segment of the pattern to land on runway 30, as instructed in the visual approach chart for the aerodrome.

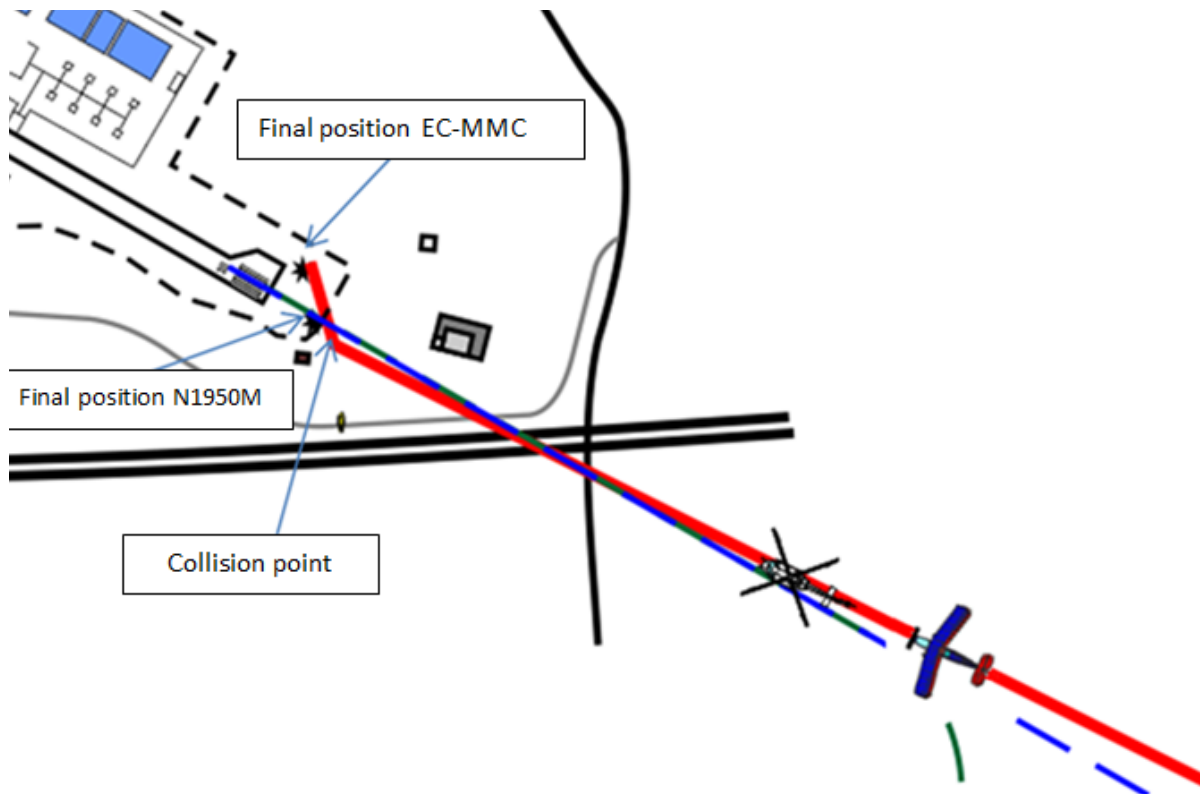
Figure 9. Aircraft on final approach to RWY30

The close-up shown in Figure 9 provides the positions of both aircraft on final approach seconds before the collision. This sequence was obtained from the fleet tracking data provided.

Also shown is the point of impact and the final positions of the aircraft after the accident.

In the moment of the collision, occurred approximately at 17:42 h, the height was 4 m, and groundspeed and course for the helicopter were 61 km/h and 294°.
