Report A-003/2018

Accident involving an Airbus A319-111, registration G-EZII, on descent into the El Prat Airport (Barcelona, Spain) on 1 January 2018.

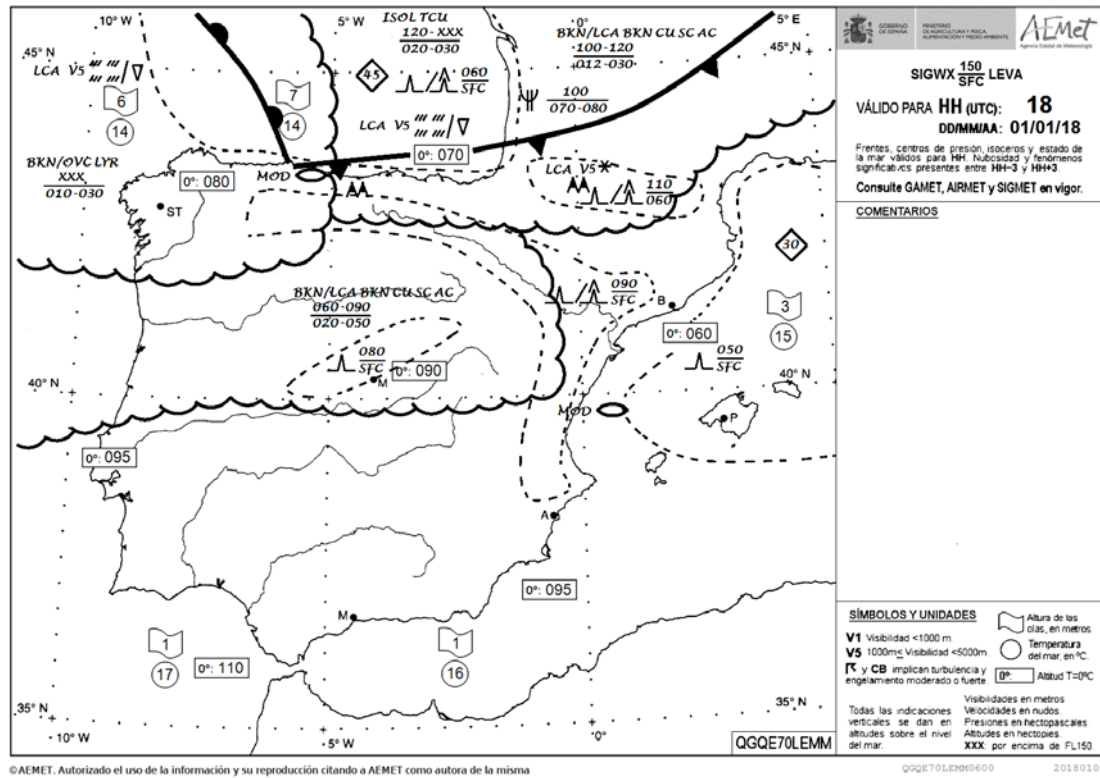
The AEMET low-level significant weather chart indicated that conditions were favorable for moderate turbulence in the area.

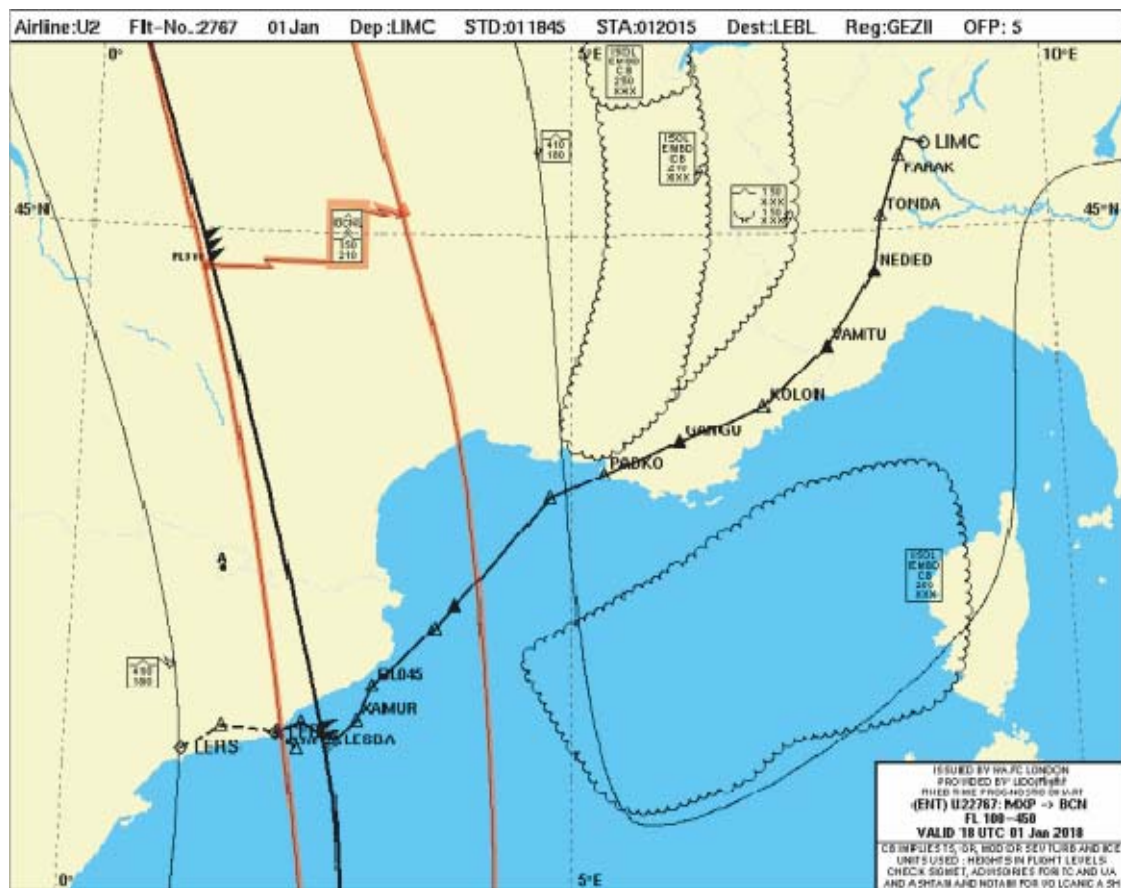
The significant weather chart was the 18:00 UTC medium-high level chart issued by the London WAFC, and showed the aircraft's flight path. This path crossed an area for which the following was forecast:

Area of moderate to occasionally strong turbulence between FL210 and FL350 along the descent route to Barcelona.

The chart shows that the flight crossed through areas with isolated cumulonimbus clouds, mixed with other clouds starting at FL100.

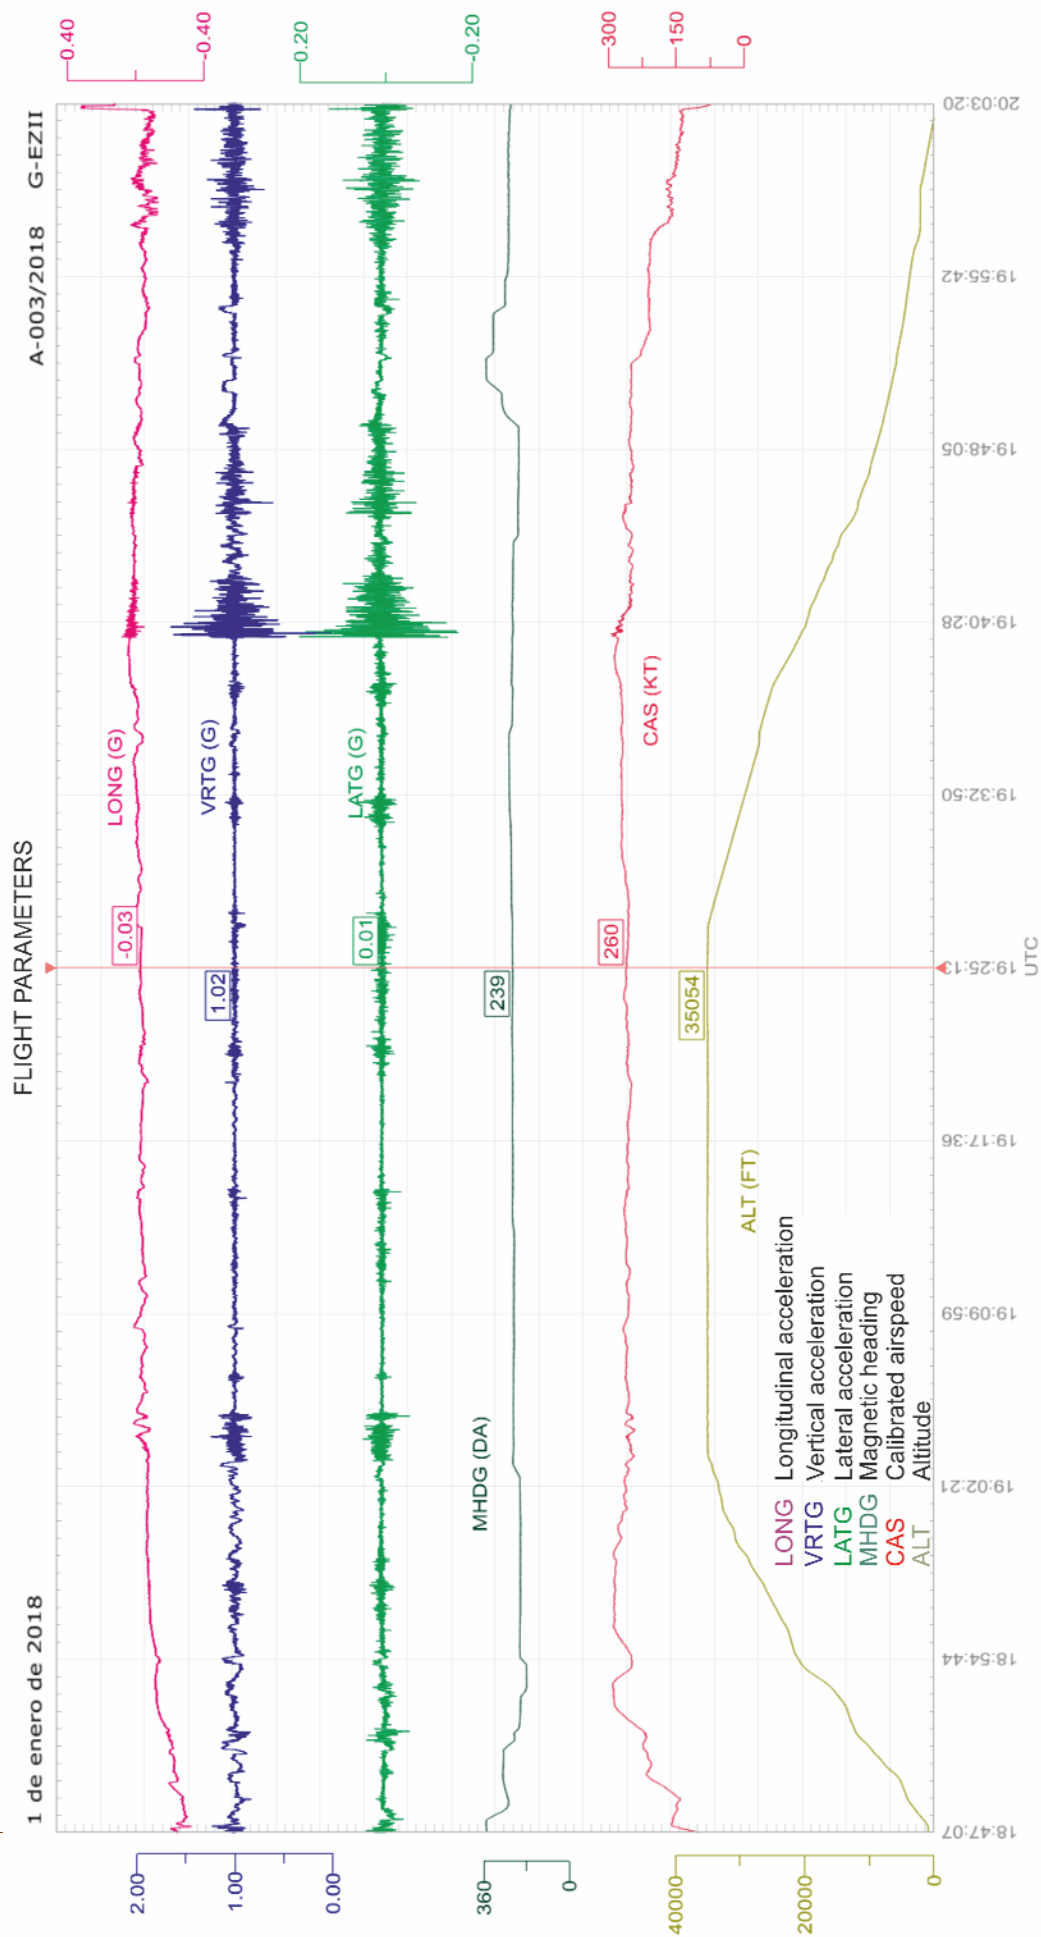
GRAPH OF THE COMPLETE FLIGHT

Based on the recorded acceleration data, the flight was rough from the start and for practically its entire duration, although the cruise segment and the start of the descent were relatively calmer.

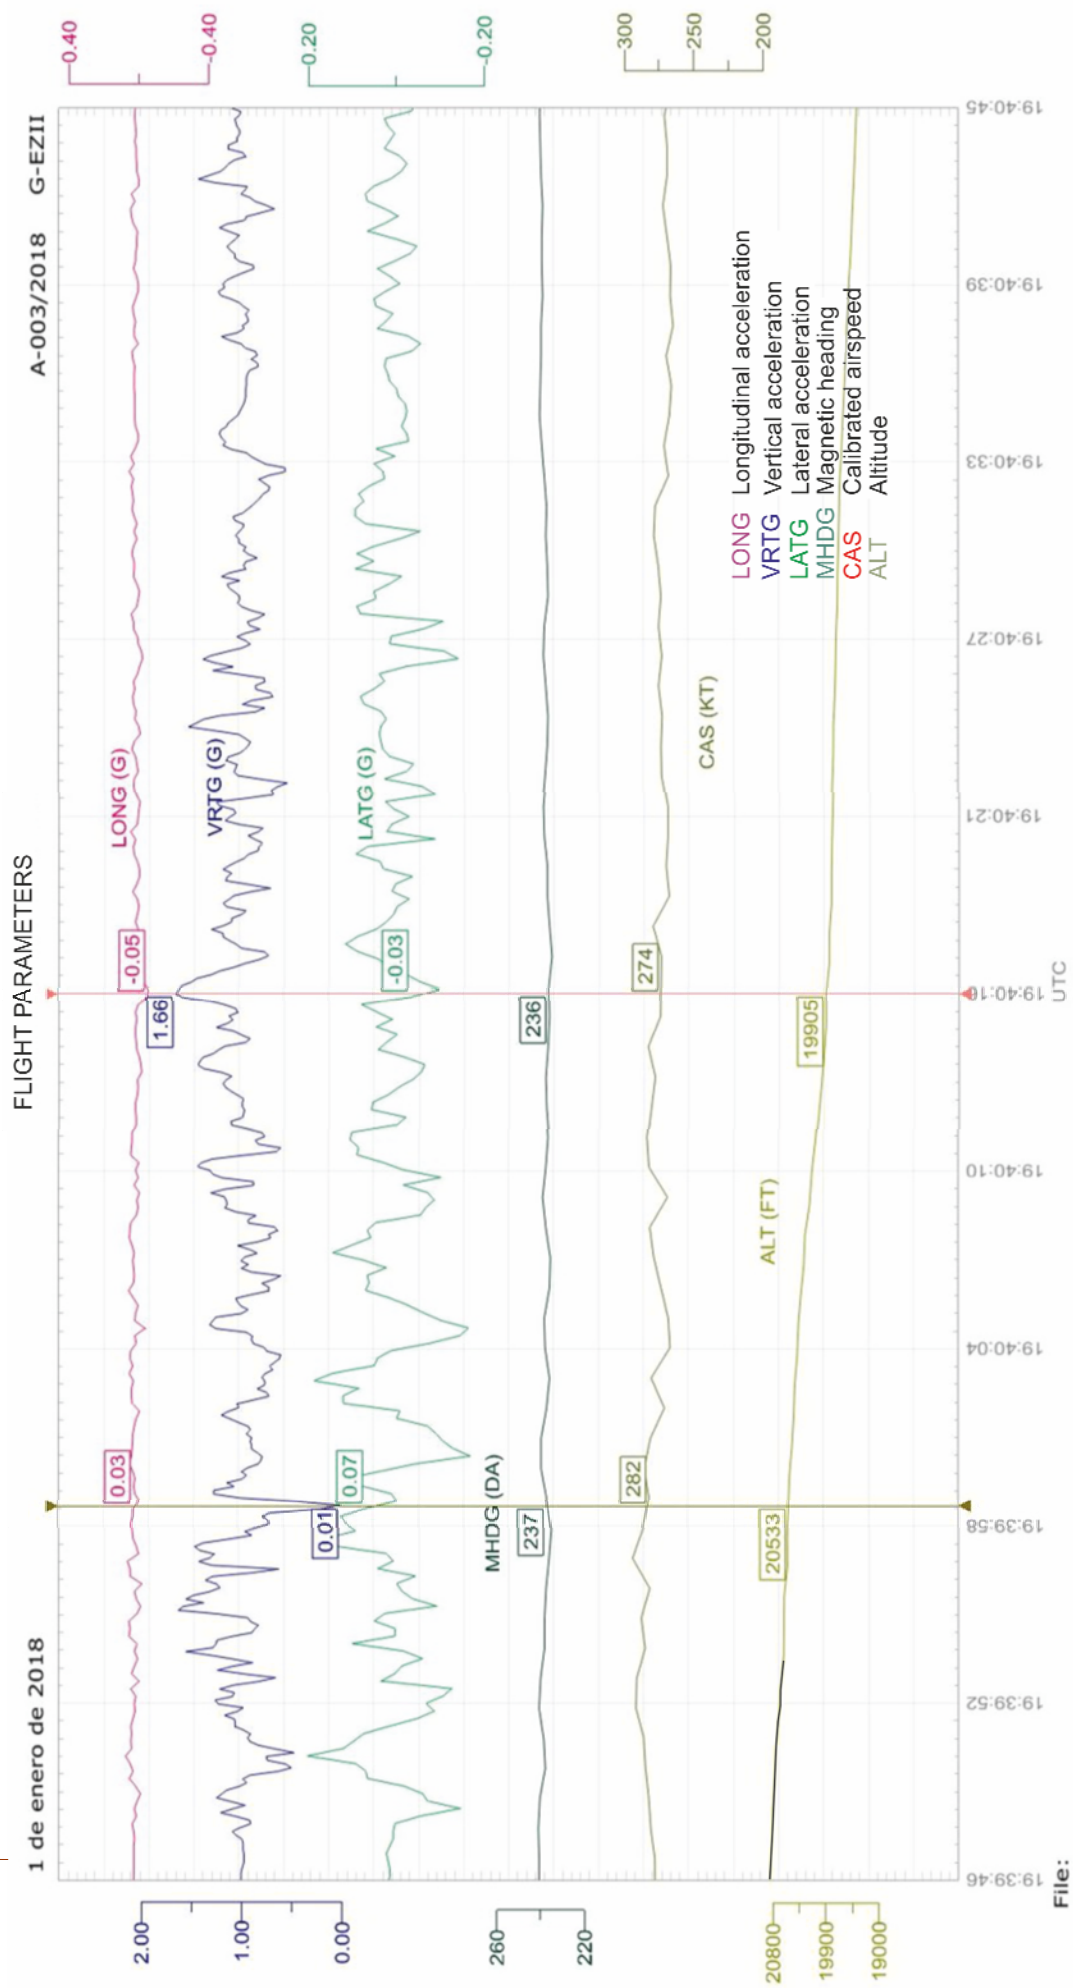
GRAPH OF THE SEGMENT OF GREATEST INTENSITY

Subsequently, in the descent phase proper, at 19:39:46 UTC, there was a constant change in both the lateral and vertical accelerations, which peaked for 18 seconds, when the g values ranged between 0.01 g and 1.66 g. During that segment, the CAS varied between 294 kt and 275 kt, and the aircraft descended from 20533 ft to 19905 ft, with the instantaneous vertical speed at one point calculated at 4560 ft/min.

The lateral acceleration also underwent constant changes, ranging in value from -0.17 g to +0.14 g.
