**COMISIÓN DE
INVESTIGACIÓN
DE ACCIDENTES
E INCIDENTES DE
AVIACIÓN CIVIL**

Report A-009/2018

Accident involving an Ultramagic H-77
balloon, registration EC-GUU, in Vic
(Barcelona, Spain) on 23 March 2018.

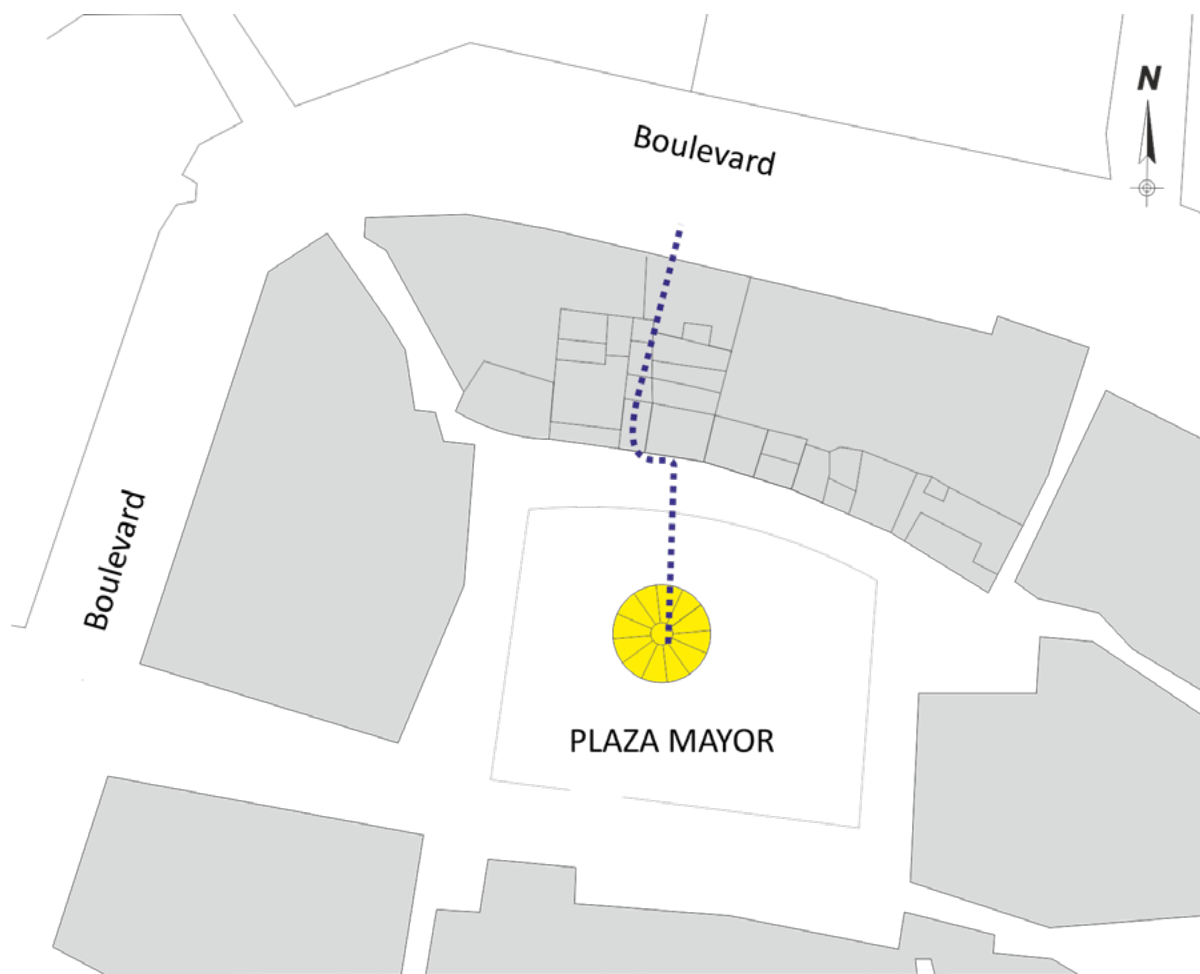
Figure 1. Initial flight path and location of the balloon

Before taking off, the balloon had been in the vicinity of the square tied to a vehicle. The balloon’s envelope was inflated and elevated without any problems, remaining stable. Once the pilot decided to take off, he released the rope and the balloon started to rise. As the basket of the balloon reached an altitude of about 4 meters above the ground, the balloon started moving to the north, propelled by the wind, such that it was unable to rise quickly enough to clear the buildings surrounding the square. The basket and envelope of the balloon impacted the wall of building no. 22 on two occasions. The first time, the basket struck the overhang of an upper balcony, and then the basket struck the eaves of the roof proper. As this happened, the envelope slid along the roof, and part of it tore when it made contact with the building’s chimney. Finally, the balloon moved laterally to the left along the ledge until it reached the adjacent building, which was not as high, thus allowing it to resume climbing.

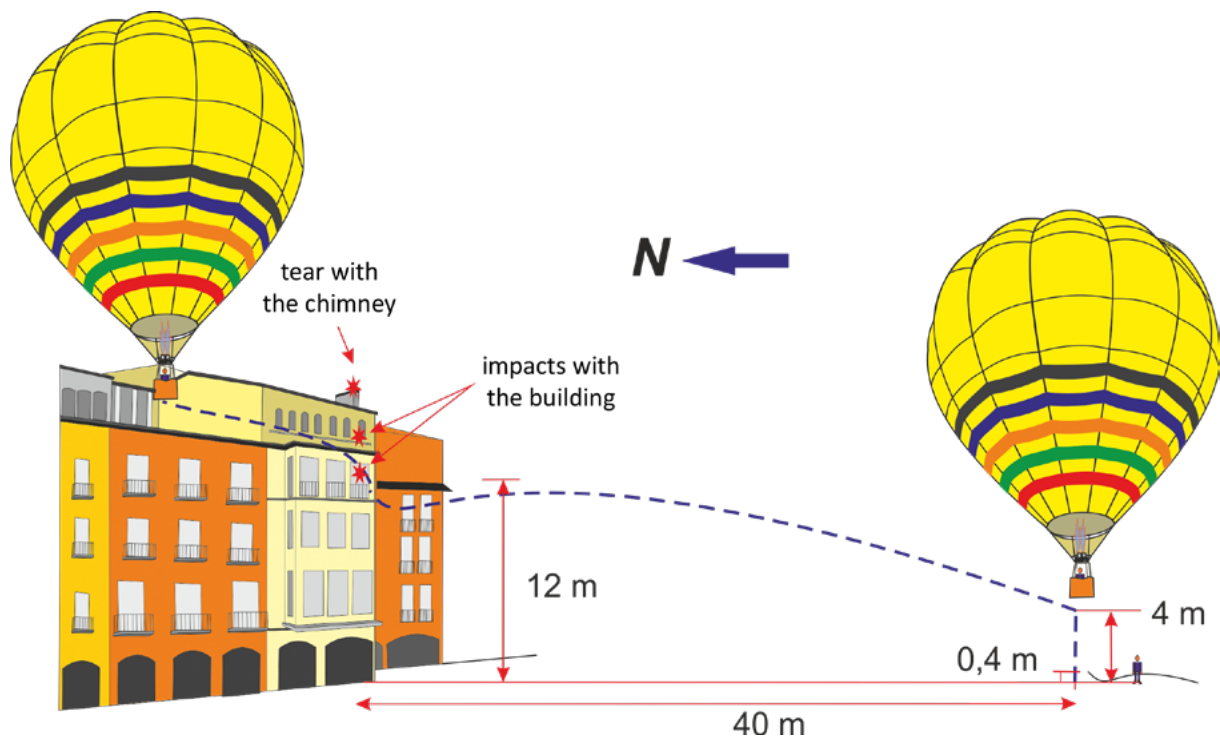
Figure 2. Croquis de Close-up of balloon

The balloon was taking from inside the Vic main square, which is surrounded by buildings of varying altitude. When it was just 4 m off the ground, it started drifting north, pushed by the wind. It had barely any upward speed.

The balloon was unable to clear the buildings, and its basket and envelope impacted the wall of building no. 22 of the square (Plaza Mayor) on two occasions. The first time, the basket struck the overhang of an upper balcony, and then the basket struck the eaves of the roof proper. As this happened, the envelope slid along the roof, tearing along either side of vertical load tape no. 12 as it made contact with the building's chimney. Finally, the balloon moved laterally to the left along the ledge until it reached the adjacent building, which was not as high, thus allowing it to resume climbing

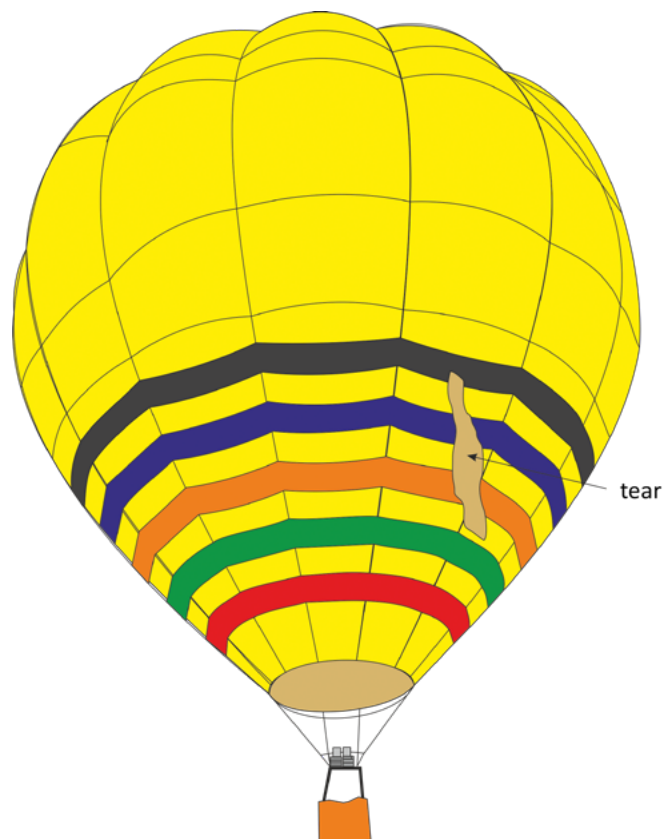
Figure 3. Location of the tear on the balloon

Five panels on the envelope were damaged, which affected two vertical gores and five horizontal sections.

As a result of the impact, five lower panels were damaged, which affected two of the twelve gores that comprise the envelope, between horizontal sections 5 and 10.

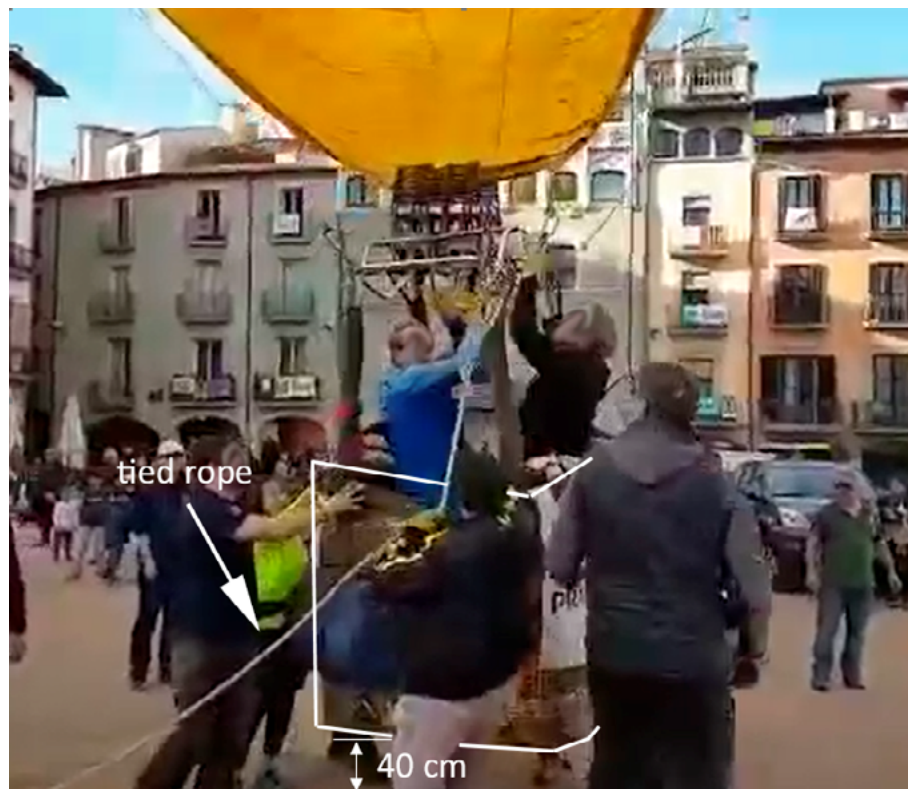
Figure 4. Frame from when rope is released

The images reveal that the pilot released the rope when the bottom of the basket was approximately 40 cm off the ground, before it tensed. Later, they show the balloon move laterally when it was at an altitude no higher than about 4 m.

As the images recorded during the takeoff revealed, the rope was released with the basket just one meter off the ground and the rope completely slack. This does not allow taking advantage of the balloon's maximum climb speed. Then, at an altitude of less than 4 meters, the balloon moved to the side, pushed by the wind and barely able to climb. If to the full 20.7-m height of the balloon we add the 4 m of altitude above the ground, this shows that only the top part of the envelope cleared the height of the buildings when the balloon began to experience an apparent loss of lift caused by the wind.

The accident was caused by the improper performance by the pilot of the takeoff maneuver.

REC.- 53/18. It is recommended that the balloon manufacturer, Ultramagic, amend its Flight Manual to include relevant information on taking off in a balloon from enclosed spaces in windy conditions.

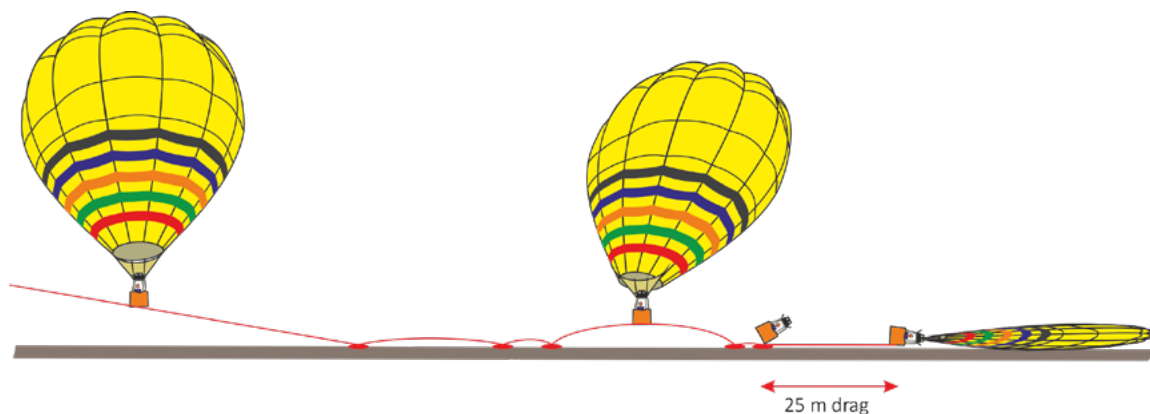
Figure 5. Sketch of balloon landing maneuver

The video shows a smooth maneuver on a crop field that was completely flat and clear of obstacles. After touching down for the first time, the basket bounced twice before flying a few centimeters above the ground. There was then a final contact with the ground, after which the balloon dragged for some 25 m before coming to a stop.
