Report A-028/2018

Accident involving a
SCHLEICHER ASK-13,
registration EC-LPT, at the
aerodrome of Santo Tomé del
Puerto (Segovia) on 7 July
2018

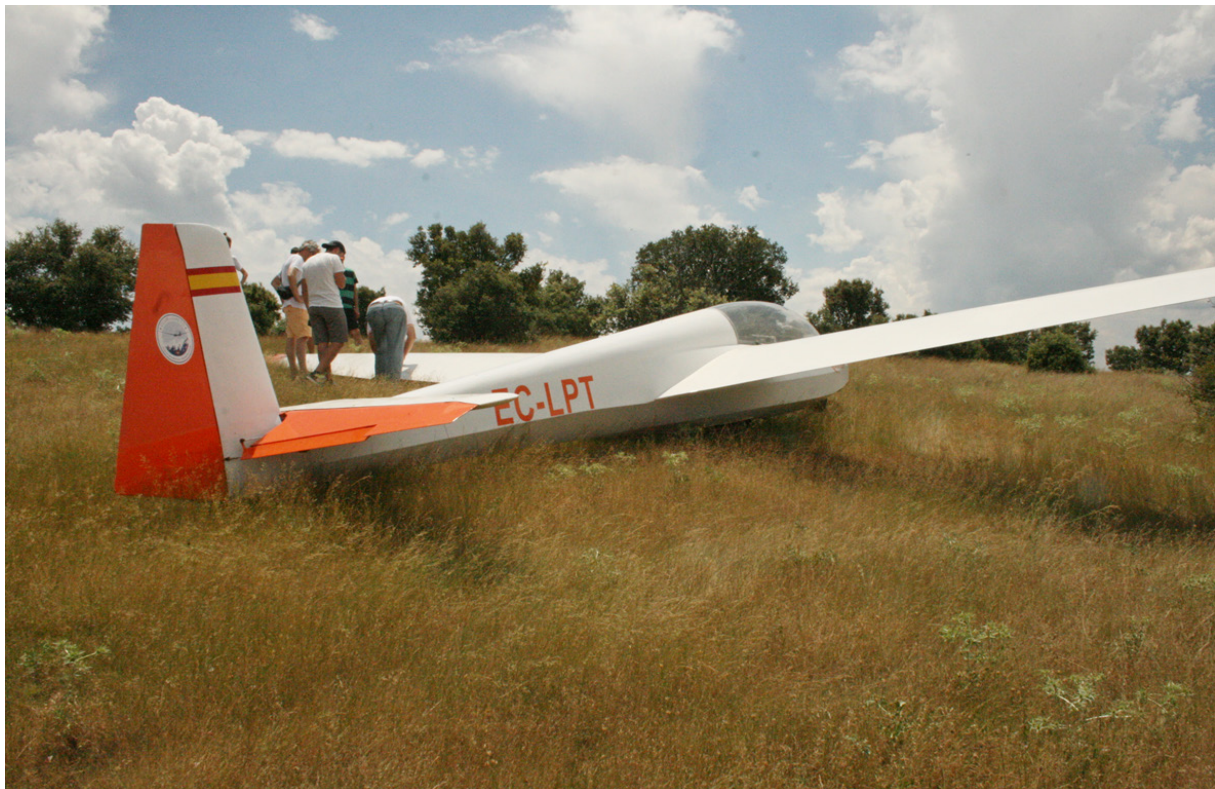
When he was at an altitude of about 1 m, the right wing struck a small oak tree and the airplane landed sideways, resting on its main gear, with the left wingtip touching the ground.

The airplane stopped approximately 5 m after contacting the ground, coming to rest at a 90° angle with respect to the runway centerline.

Figure 2. Photograph of the final position of the aircraft

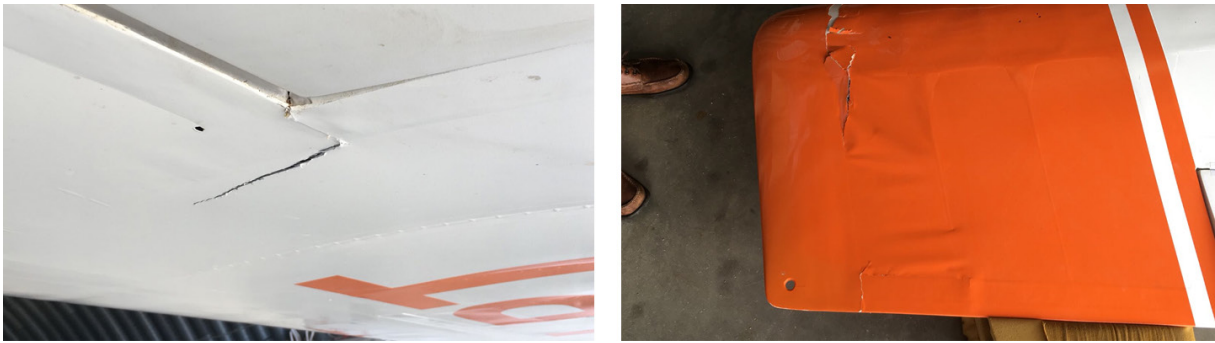
Only the left wing was damaged by the impact. This wing had a crack on its lower surface, close to the area with the registration marking. Both the upper and lower surfaces of its wingtip were also visibly damaged, though more so on the upper surface.

Figure 3. Damage to left wing
