**COMISIÓN DE
INVESTIGACIÓN
DE ACCIDENTES
E INCIDENTES DE
AVIACIÓN CIVIL**

Report A-002/2019

Accident involving a PIPER
PA-28R-201 (Arrow III) aircraft,
registration G-OARI, on Mount
Ernio in Errezil (Gipuzkoa)
on 9 January 2019

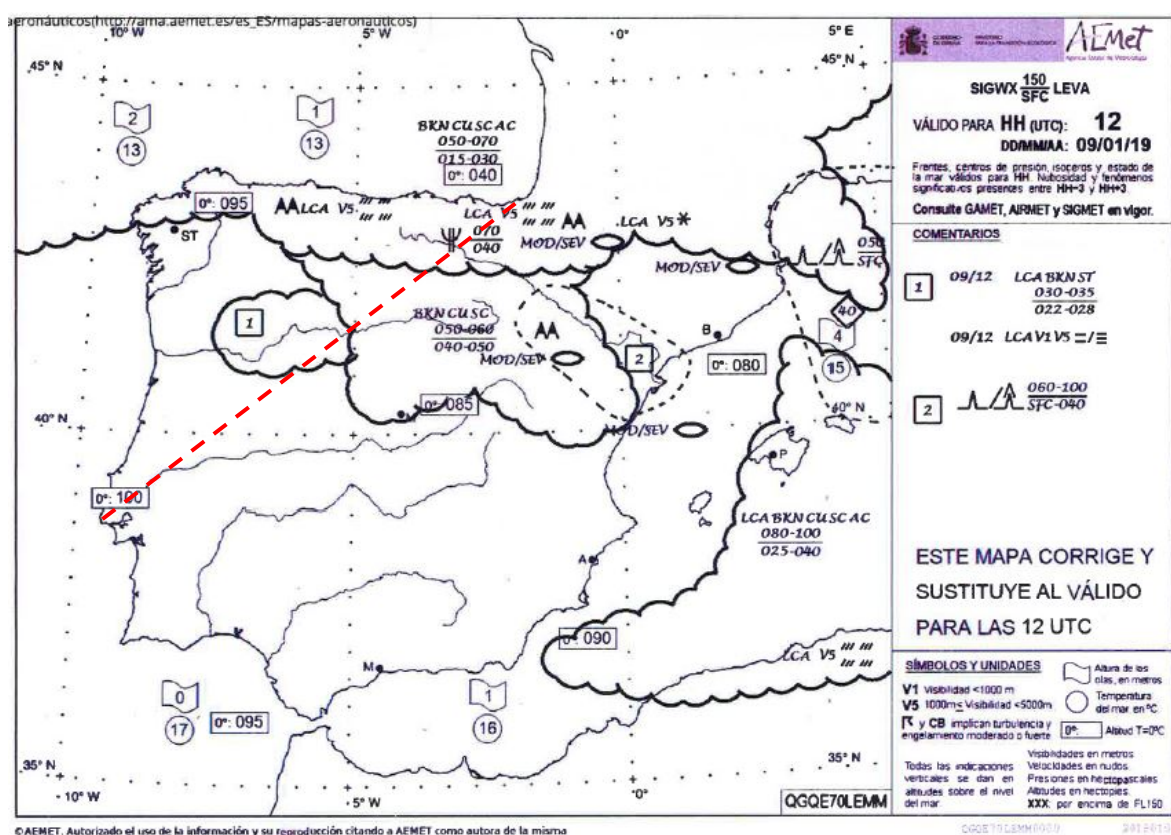
Figure 2. Low-level significant weather chart

The only difference between the two maps involved a part of the Mediterranean sea. Figure 2 shows the SIGWX that replaced the one issued initially. Drawn atop this chart is a dashed line connecting the start and end points of the flight in order to highlight the planned flight path.

The weather conditions that were anticipated for the Cantabrian coast clearly called for the presence of adverse weather phenomena. These included reduced visibility at 5000 m due to rain; abundant clouds consisting of cumulus, stratocumulus and altocumulus clouds with bases from 1500 to 3000 ft and tops from 5000 to 7000 ft; mountain obscuration and mountain waves; moderate icing from 4000 to 7000 ft; and a freezing level located at 4000 ft.

Given these weather conditions, the possibility of completing the flight to the San Sebastian Airport in VMC was, quite simply, remote.

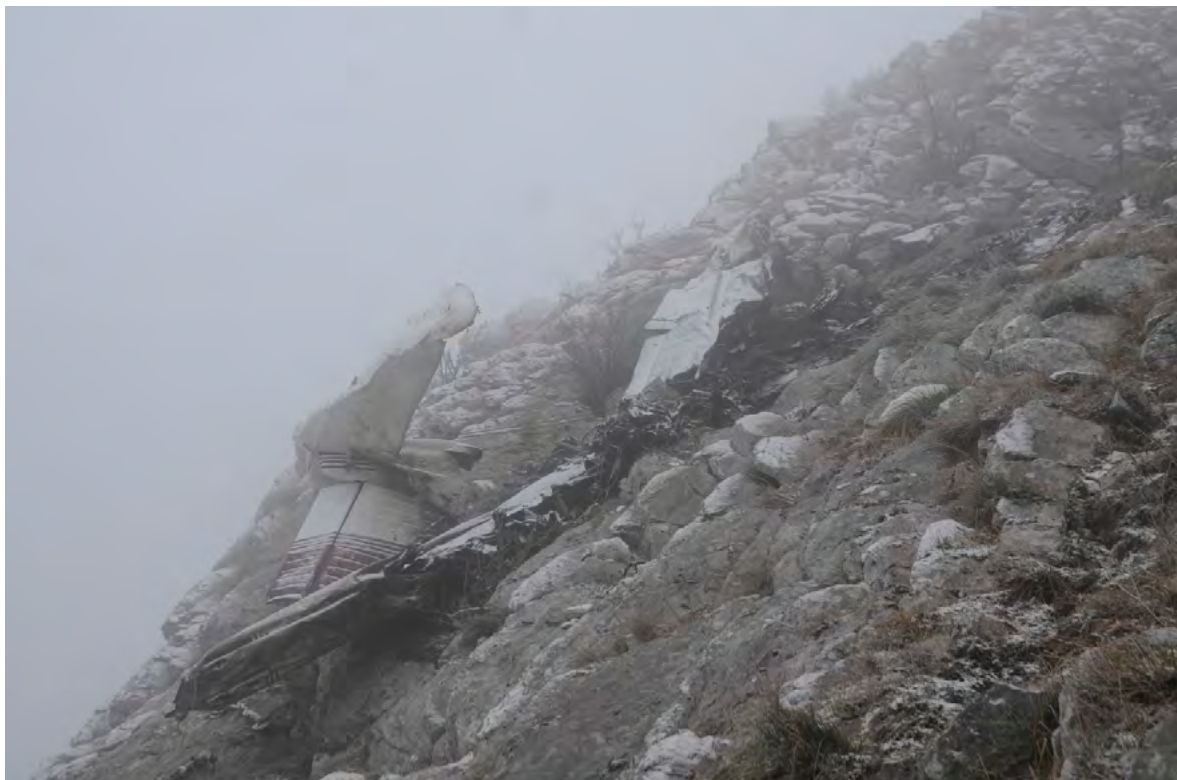
Figure 8. Photograph of the main aircraft wreckage

The photograph in Figure 8 shows the main aircraft wreckage. This photograph was taken in the afternoon on the day of the accident. It shows that the area was completely shrouded by low clouds. There was even a thin layer of snow on the ground.

The mountainside where the wreckage was found was quite steep and free from vegetation. As a result, the wreckage was highly unstable and prone to sliding easily. To keep this from happening, the regional Basque police (Ertzaintza) had secured the wreckage with ropes tied to rocks.

The only components that were found relatively complete were the two wings and the tail section. The fuselage had been almost entirely consumed in the fire that broke out after the impact.

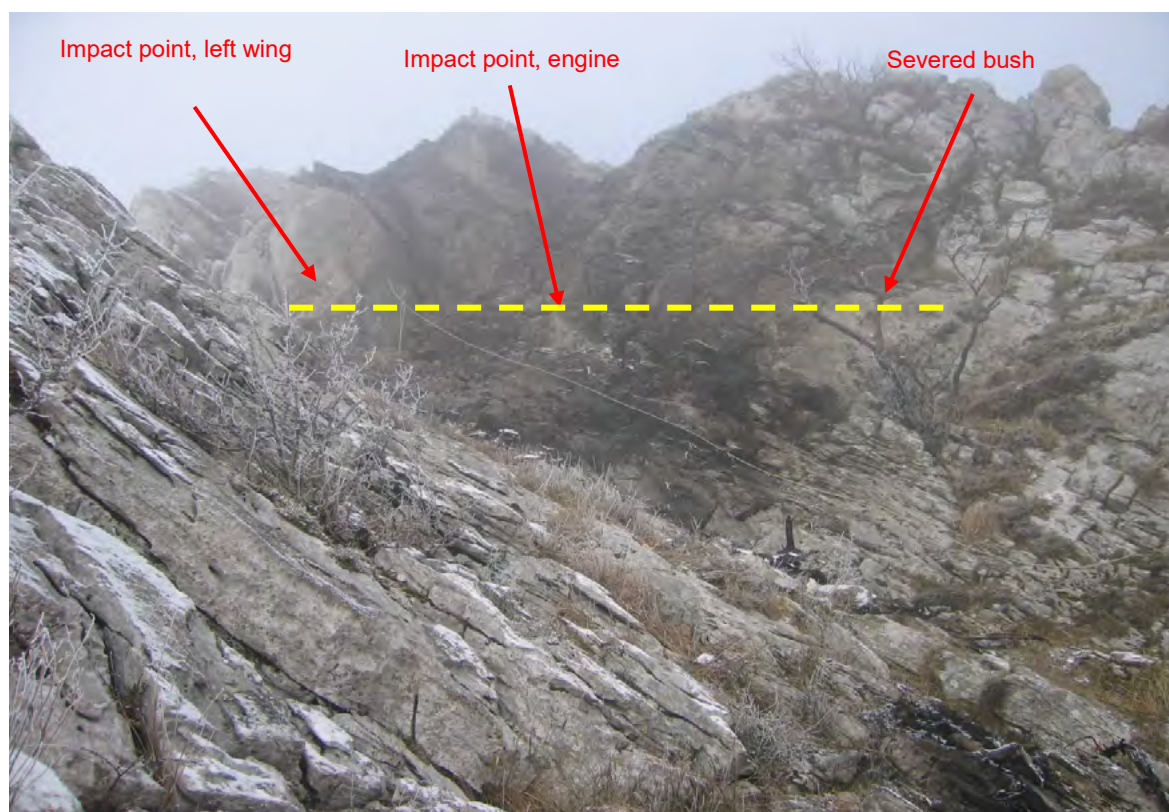
Figure 9. Photograph of the hillside where the aircraft crashed, taken from the location where the main wreckage was found

There was a ditch with smaller components and burned debris uphill, up to the beginning of a section of rock that was almost vertical (Figure 9). No cockpit instruments or controls were found save for an artificial horizon and a piece of one of the two control wheels. Some fragments from the cylinders and other engine components were found, as were the two propeller blades. Both blades were damaged, but one was more so. It had lost its outer half, approximately, and it exhibited plastic deformations and other marks consistent with a high-energy impact.

The fire had affected the entire area from the main wreckage to the wall that the airplane had impacted.

On this wall and about 2 m above its base, there was an area where the rock was lighter in color. Upon closer inspection, it was evident that this lighter color was due to an impact. Very close to this point, two metal tube segments were found.

Some 6 m away from the impact point and to the left, the wall formed a rocky outcrop that showed signs of a recent impact. The shape of this outcrop was similar to the triangular impact shape of one of the wings. The terrain located on the other side of the outcrop (with respect to the impact point) was examined, and remnants of paint from the aircraft as well as red glass fragments were found there.

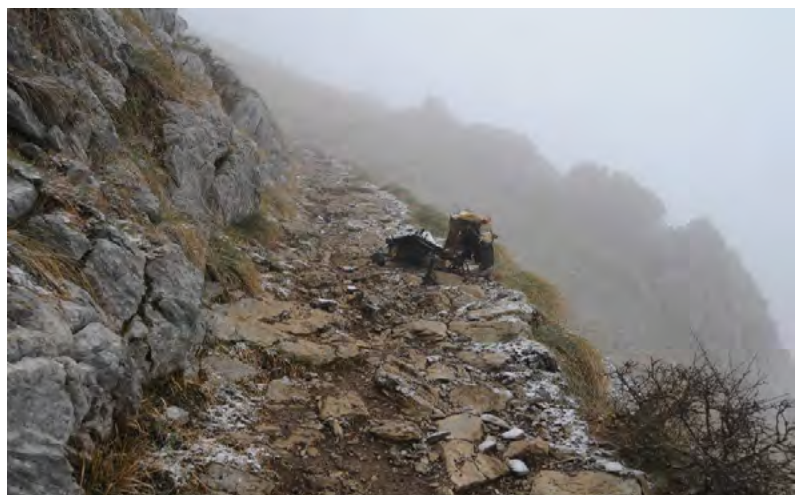
Figure 10. Photograph of the seat on the path that leads to the summit of Mount Ernio

After walking a little over 1 km on this trail, they found a seat.

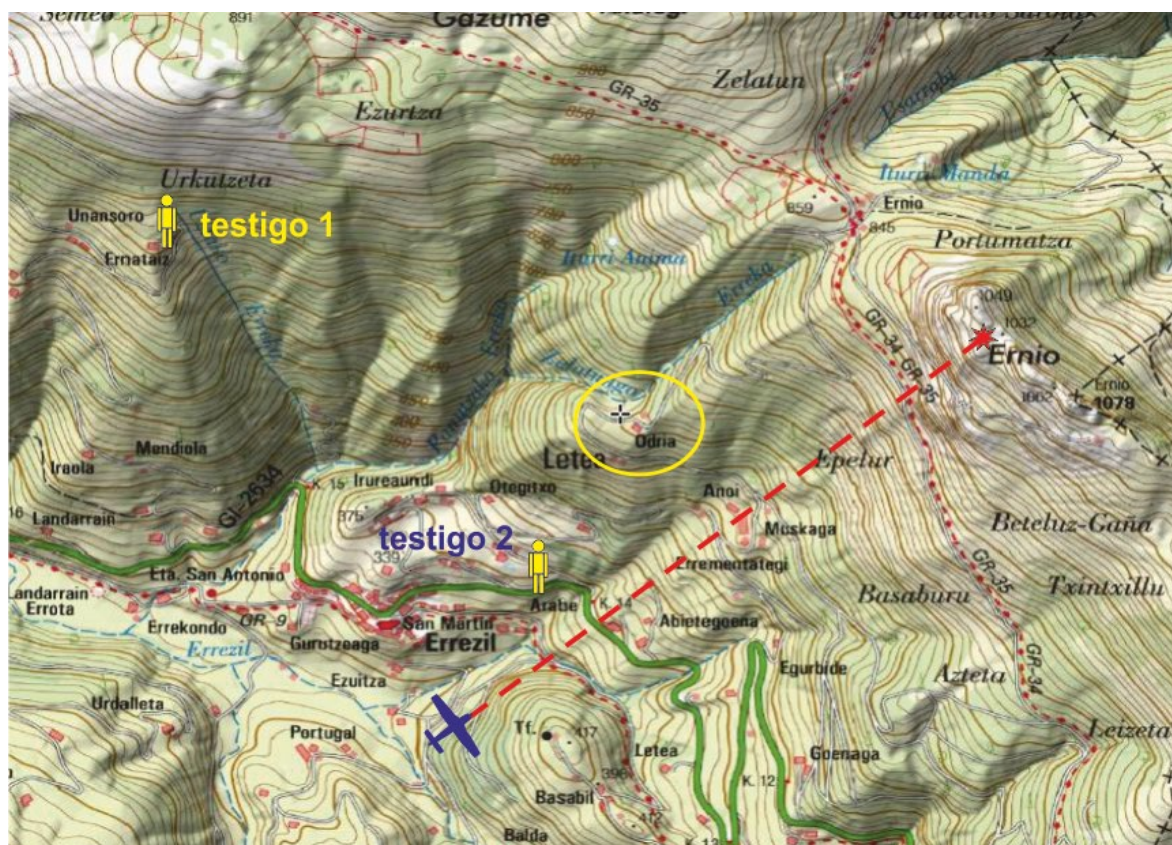
Figure 11. Contour map of the accident site, showing the location of the eyewitnesses and the Hamlet of Odria, as well as the aircraft's flight path

This video shows the individual climbing on a trail when, at one point, the sound of an aircraft engine is heard. The individual moves the camera and points it at the sky to record the airplane. This reveals a completely overcast sky. The aircraft is not visible at first; in fact, the audio in the recording contains this individual's voice saying something that sounded like "I can't see it". But at a certain point, lasting less than a second, the airplane does come into view before it is again obscured by the clouds.

The engine is heard for an additional 40 seconds, until something that sounds like an impact is heard.
