Report A-002/2020

Accident involving a DIAMOND
DA20-A1 aircraft, registration
EC-JLN, in front of El Altillo beach
on the island of Gran Canaria
(Las Palmas de Gran Canaria),
on 19 January 2020

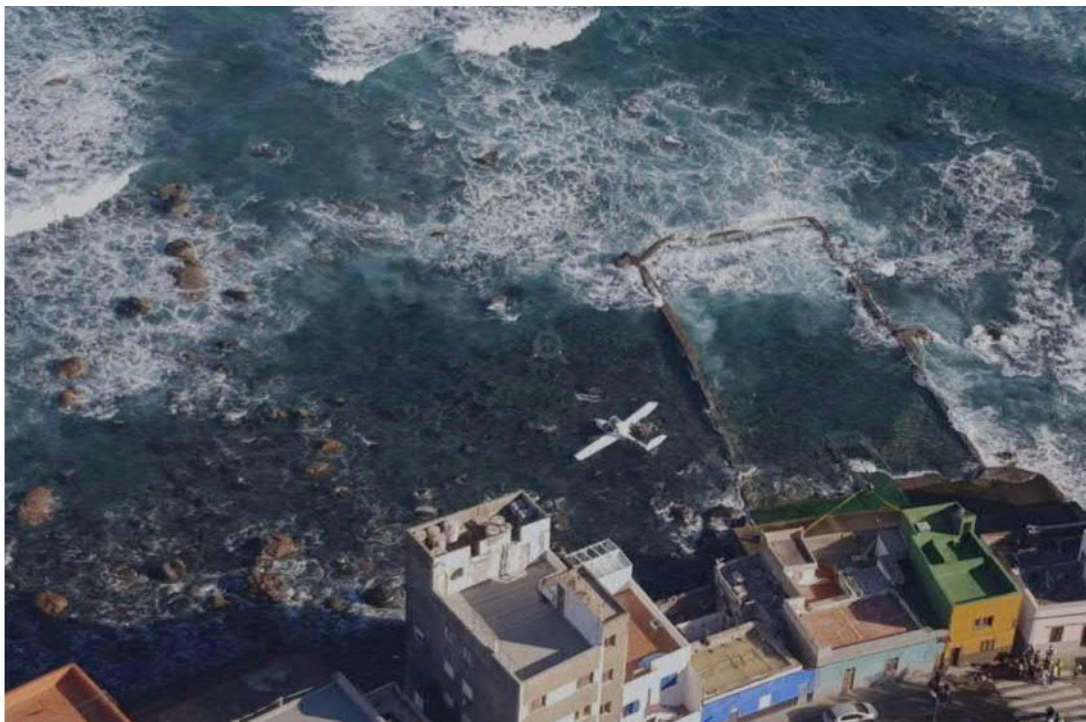
The waves and currents gradually shifted it towards land until it was just a few metres from the shoreline (see figure 5). As a result, the aircraft was recovered with a crane.

Figure 5. Aerial photograph of the aircraft in the sea, close to the point where it landed

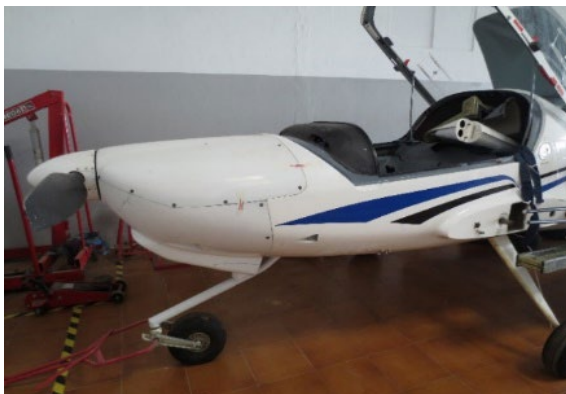
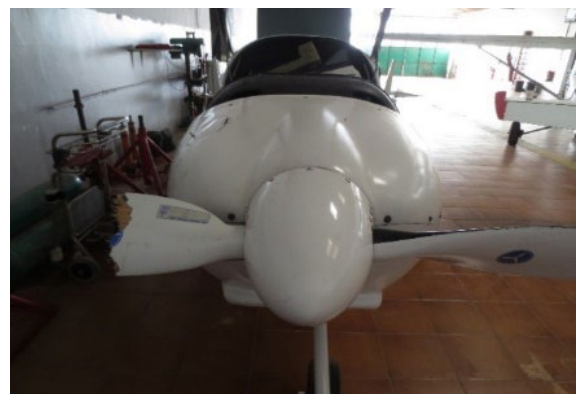
They found no evidence of any impact, breakage or damage on the aircraft's skin (see figure 6). Nor did they find traces of oil or any other fluid on the skin or the windshield.

Figure 6. Photographs of the front part of the aircraft

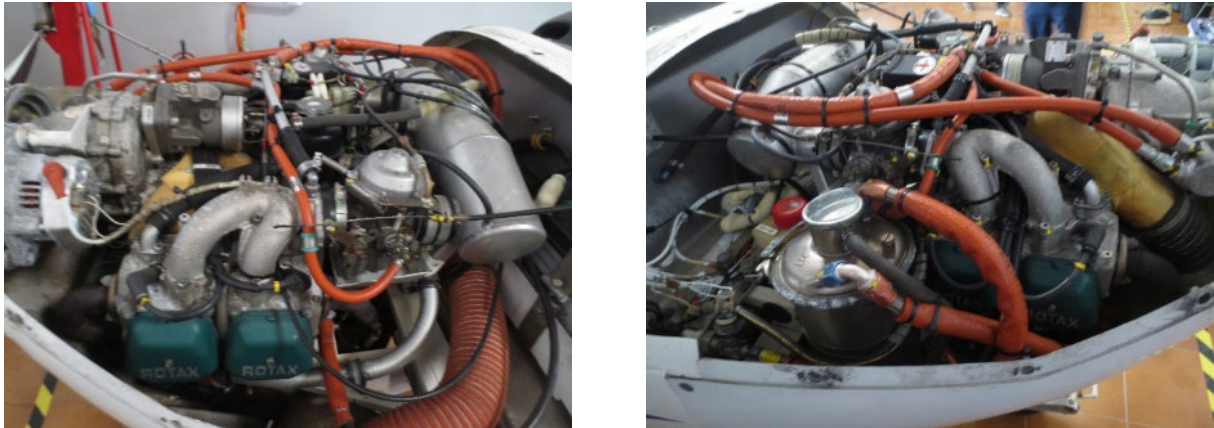
All the cowlings were removed from the engine compartment. The engine and its systems appeared to be in a satisfactory condition.

There were no traces of oil. The lubrication system was checked: tank, pipes, radiator, filter, etc., with everything appearing to be in satisfactory condition. There were no breakages or potential leakage points. The inspectors used the dipstick to check the oil level in the tank, noting that it didn't show any oil at all.

Figure 7. Photos of the engine compartment: left side (left photo) and right side (right photo)

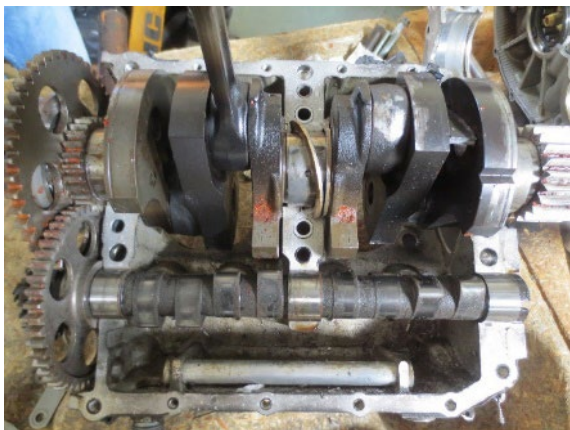
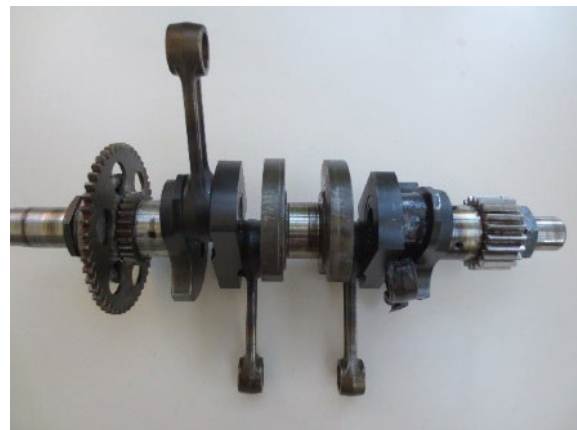
Abundant salt deposits had been left by the seawater that had penetrated the engine.

Figure 8. Photograph of the inside of the crankcase (left) and the crankshaft (right)

The crankshaft and camshaft appeared to be complete and correctly supported on their bearings (see figure 8 - left).

The condition of the camshaft was as expected for the engine's hours of operation. No signs of abnormal wear or insufficient lubrication were observed.

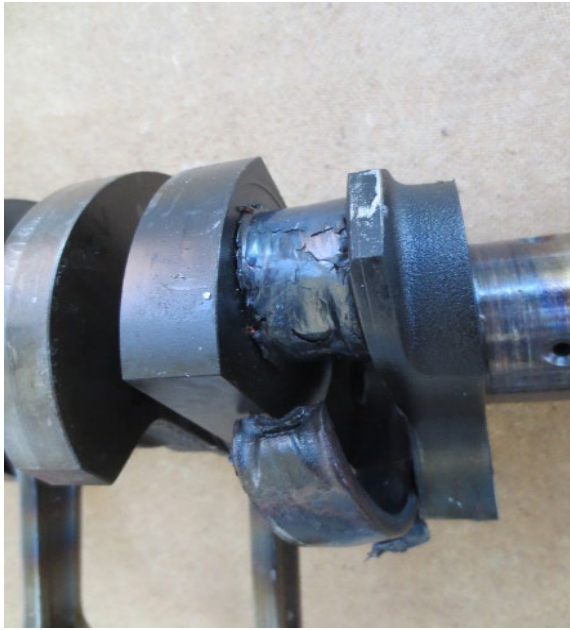
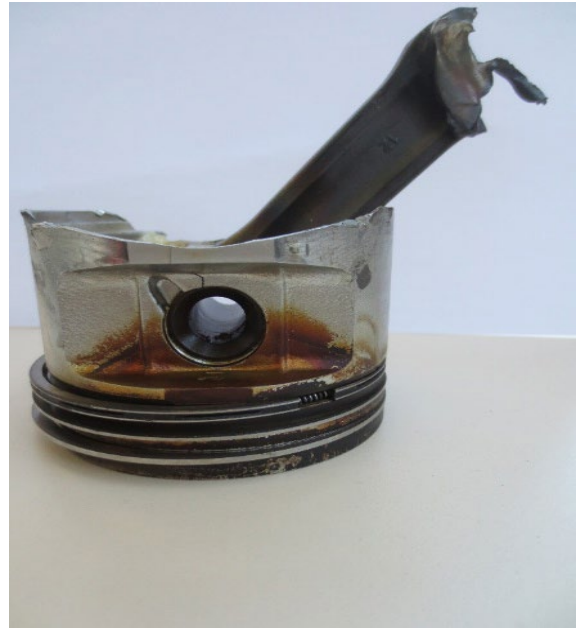
Figure 9. Photograph of cylinder no.1's crankpin, with one part of the connecting rod (left) and piston no.1 with the other part of the connecting rod (right)

The connecting rod of piston no. 1 was in two pieces: one remained bolted to the piston, and the other was housed in the crankshaft's crankpin. It's useful to note that the connecting rods in this type of engine are made in one piece and mounted on the crankshaft during its assembly, which is compound by a series of components.

The connecting rod fragment that remained attached to the crankpin displayed evident signs of stretching and deformation. In fact, a part of this fragment had come out of the crankpin and ended up between the crankshaft and the crankcase, blocking the crankshaft.

The engine inspection revealed that the connecting rod of piston no.1 had broken into two pieces at the point where the head joins to the body. One piece was attached to the crankshaft, and the other to the piston (see figure 9).

Except for the fracture zone where plastic deformation was observed, there were no appreciable deformities on the piece attached to the piston, which included the foot and the body of the rod.

The head end of the connecting rod attached to the crankshaft displayed signs of excessive stretching and plastic deformation, which are characteristic of a creep failure due to elevated temperature conditions.

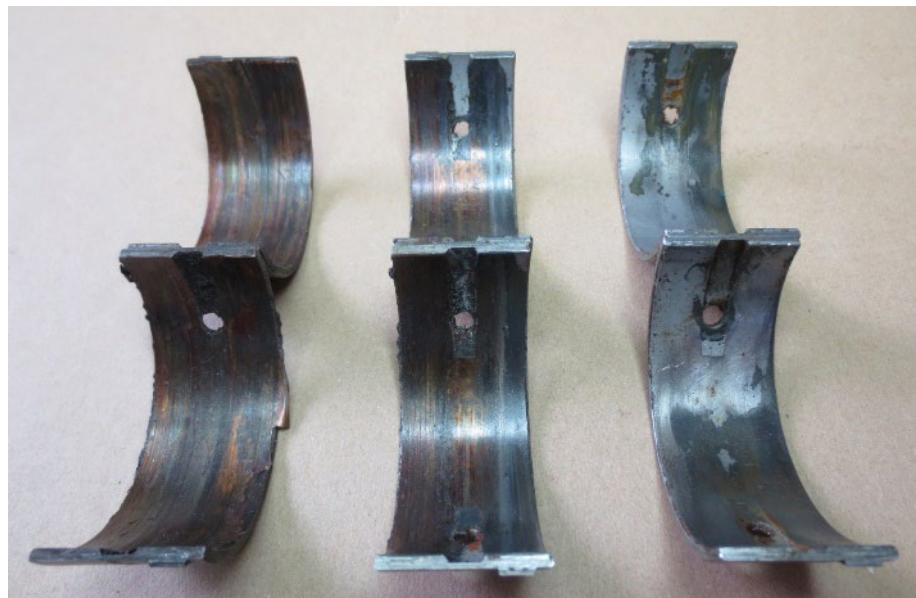
Figure 10. Photograph of the crankshaft bearings (left front support, central centre support and right rear support)

The front crankshaft support bearing showed signs of severe wear. Some of the material had melted and got into the lubrication holes, where it had solidified, blocking three of the four holes.

The centre support bearing also showed signs of heavy wear, but less so than the front bearing. Like the front bearing, some of the material had melted and seeped into one of the lubrication holes, solidifying inside.

The rear support bearing showed only minor friction damage. However, it had been noticeably corroded by the seawater. All four lubrication holes were completely clear.

This theory is further supported by the examination of the condition of the crankshaft support bearings. All of them showed signs of damage and evidence of having reached high temperatures, which is consistent with a lack of lubrication.

Furthermore, the examination of the bearings revealed a certain level of gradation in damage severity, the rear bearing being the least damaged and the front one being the most affected.

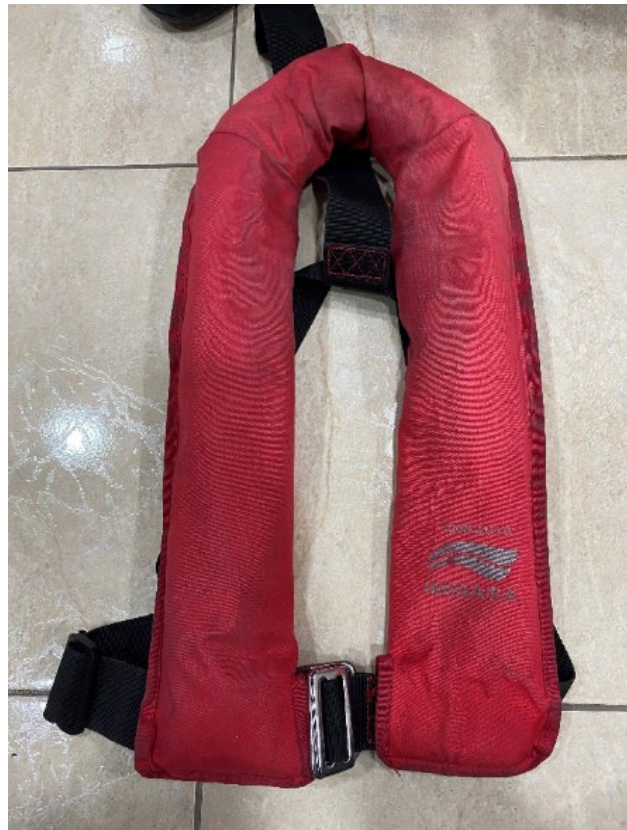
After the event, the life jackets were recovered. The inspectors found that, on the one worn by the passenger, which is the one that didn't inflate, the two activation indicators were red. This indicates that it had been previously activated in both automatic and manual modes.

On disassembling the device, the CO₂ cylinder that activates the inflation was found to be perforated.

Figure 11. Photograph of the Imnasa 150N Auto life

The inflater device was replaced with a new one of the same make and model, and it was activated manually. The life jacket inflated normally and remained inflated without losing pressure.

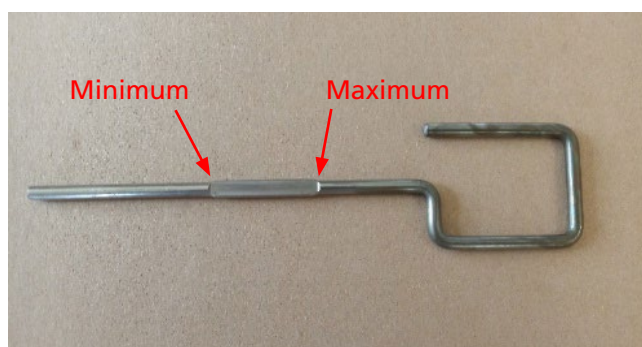
It's also possible that errors were made when reading the oil level on the dipstick. It wouldn't be out of the question for any oil trace on the dipstick to be identified as the oil level when, in reality, it was made by oil splashes or rubbing against the tank walls on removal.

Figure 12. Oil level dipstick

Whatever the cause, there seems no doubt that the oil level checks performed on this aircraft, at least since the last oil change, were incorrect. The consequence of this was that the falling oil level went unnoticed, allowing the oil volume to drop to a point where there wasn't enough to lubricate all areas of the engine.

Situations such as the one described above pose a threat to the operational safety of aircraft. Therefore, to prevent this situation from reoccurring in the future, a safety recommendation is issued to the ATO that operated the aircraft, which should review and, where appropriate, amend its operational procedures to ensure the oil-level checks in aircraft equipped with this type of engine meet the standards of uniformity and reliability required to guarantee correct readings.
