**COMISIÓN DE
INVESTIGACIÓN
DE ACCIDENTES
E INCIDENTES DE
AVIACIÓN CIVIL**

Report A-004/2017

Accident involving a Socata
TB-20 Trinidad aircraft,
registration D-ECJP, in
Sierra de Tejeda,
Canillas del Aceituno (Málaga)
on 29 April 2017

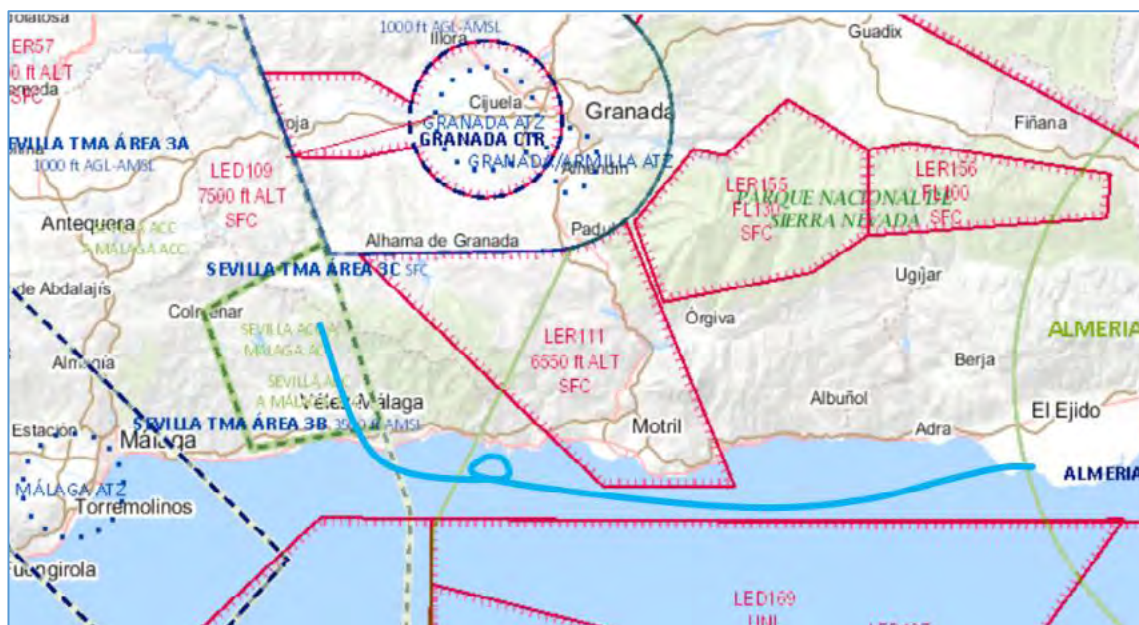
Figure 1: Flight path

The blue line in Figure 1 shows the final part of the flight path. In the first part, until LEAM, the aircraft maintained an altitude of about 1000 ft.

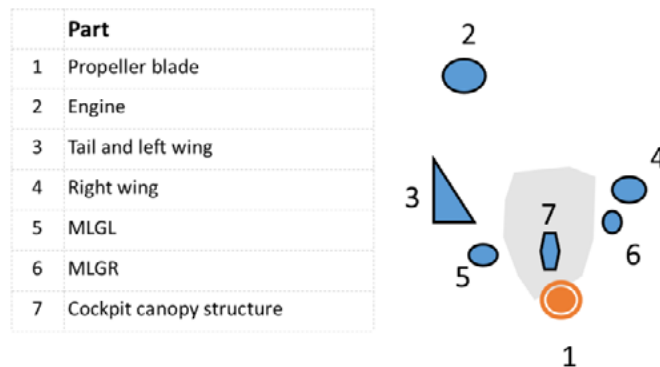
Figure 7: Positions of the main wreckage

The aircraft wreckage was found scattered on a slope with a 28° gradient at an elevation of 1718 m (5636 ft), rising in the direction of flight. The first impact point contained debris from the propeller and, fanning out, other aircraft parts, with the engine, at 23 m, being the furthest away. Spreading out from this first point was an area affected by the fire caused by the fuel contained in the tanks. Figure 7.

A shrub located some 5 m before the impact point exhibited recent signs along its top of having been horizontally sheared.

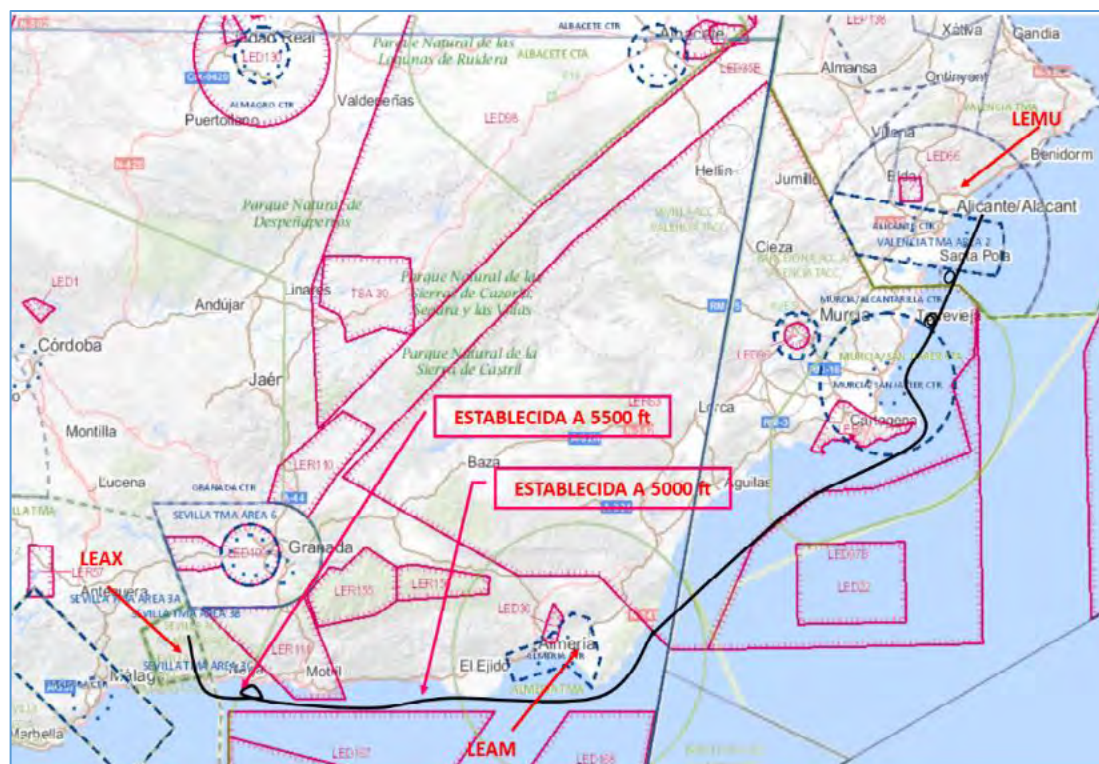
Figure 8: Reconstruction of the aircraft's flight path

Figure 8 shows the flight of aircraft D-ECJP from LEMU to the accident site based on radar information. The figure shows that the aircraft flew along the coastline, avoiding restricted areas LER111, LER155 and LER156.

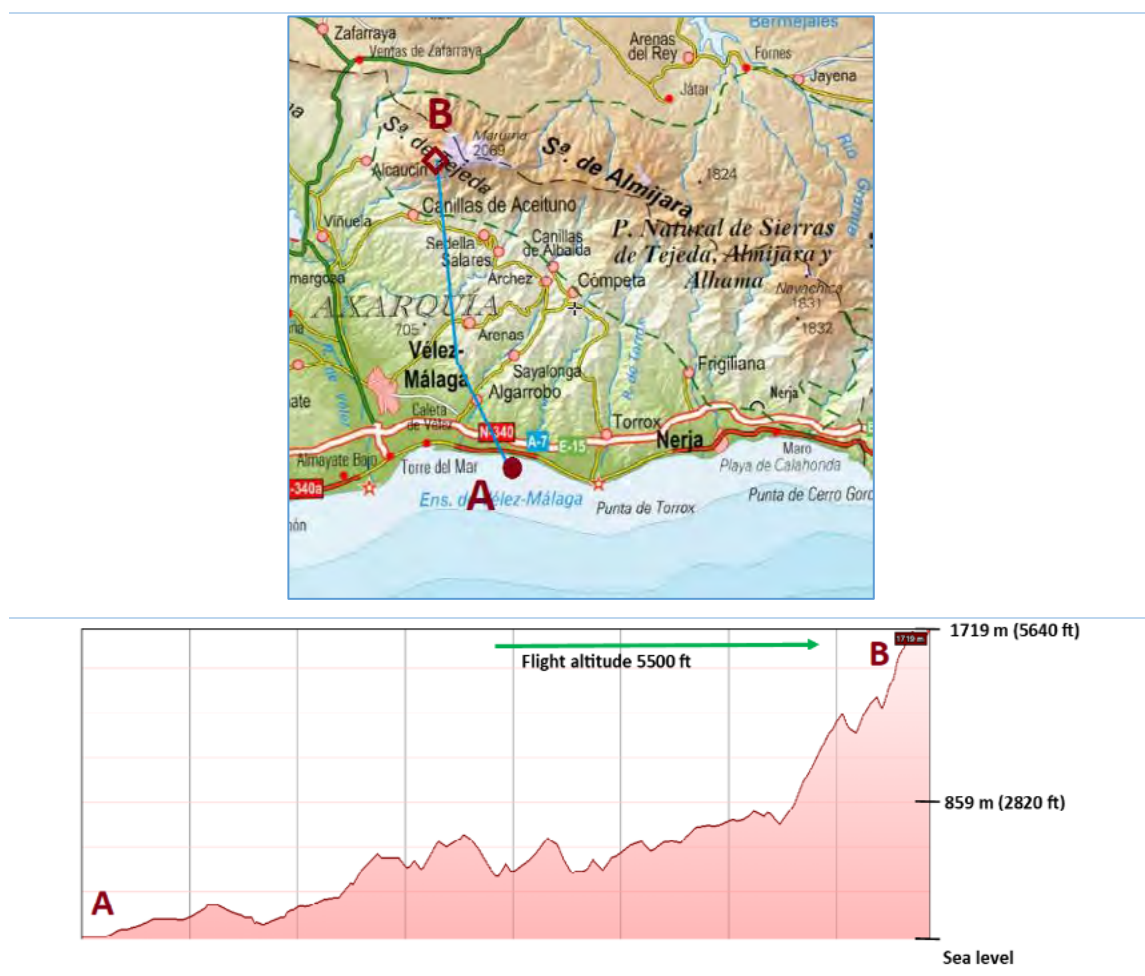
Figure 9: Location of crash site and terrain profile

Figure 9 shows the geographic location of the aircraft's final flight path, level at an altitude of 5500 ft. The terrain slopes up constantly up to the elevation where the wreckage was found. The highest foothills in the Sierra de Tejada closest to the site are to the right of the flight path, with a maximum elevation of 2069 m (6775 ft), and continuing to the southeast with elevations of 1824 m (5984 ft) and 1832 m (6010 ft) practically to the sea.

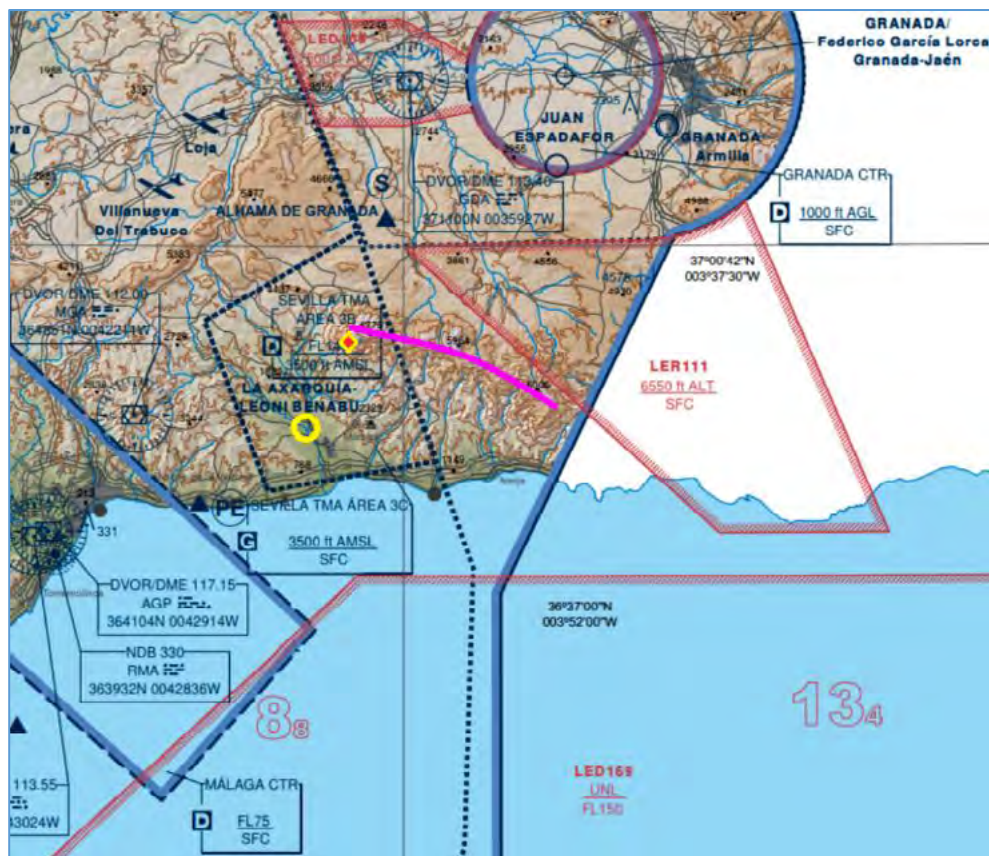
Figure 11: Visual chart of the area

Figure 11 shows, using the visual chart published in the AIP Spain for the area, the position of LEAX (yellow circle), where one of the aircraft landed; the accident site (yellow diamond); the foothills at an elevation of 6775 ft (purple line); and point S (Alhama de Granada) on the LEGR visual approach chart.
