**COMISIÓN DE  
INVESTIGACIÓN  
DE ACCIDENTES  
E INCIDENTES DE  
AVIACIÓN CIVIL**

## **Report A-004/2018**

Accident involving a Boeing 737-8AS aircraft, registration EI-EKI, operated by Ryanair, in the Canaries airspace (Spain) on 10 February 2018

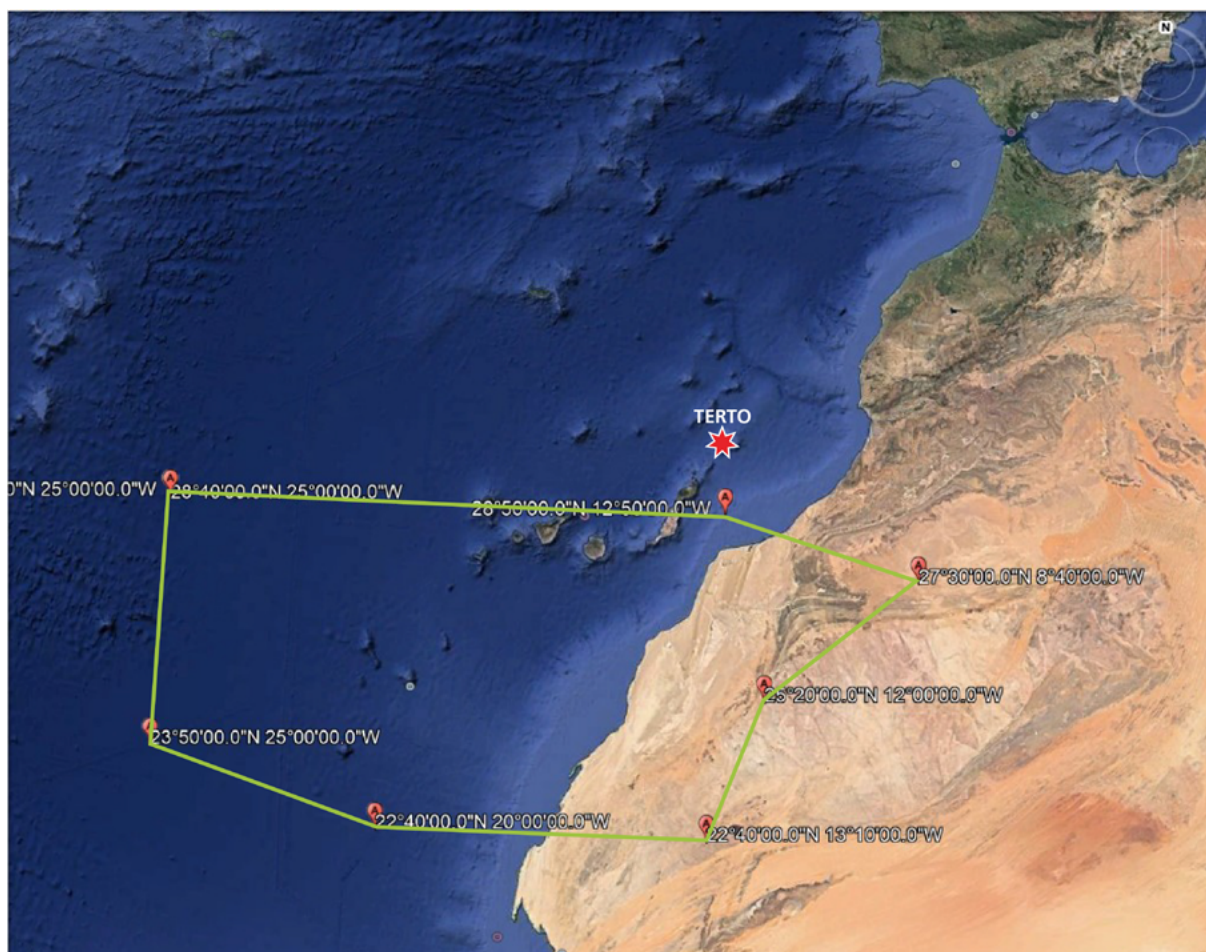
**Illustration 1.** Location of waypoint TERTO and of the polygon inside which severe turbulence was forecast

Therefore, the presence of severe turbulence in the vicinity of the accident, even if not exactly at waypoint TERTO, was probable.

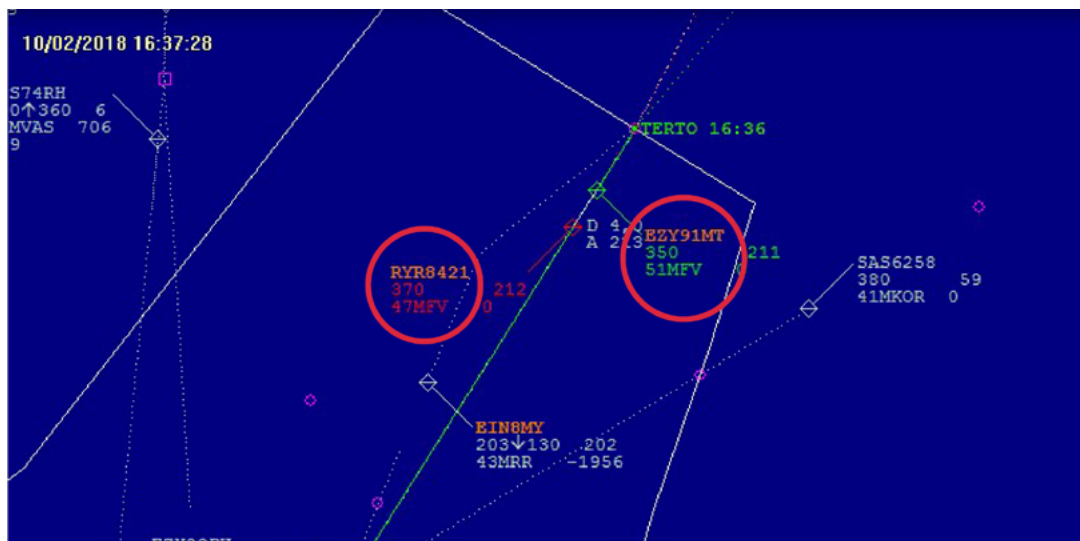
The following image shows the position of the Boeing 737-8AS aircraft, with callsign RYR8421, and of the aircraft with callsign EZY91MT, at 16:37:28. The

controller identified a potential conflict with the latter and interrupted the descent maneuver of the Boeing 737-8AS.

Illustration 2. Position of the aircraft at 16:37:28

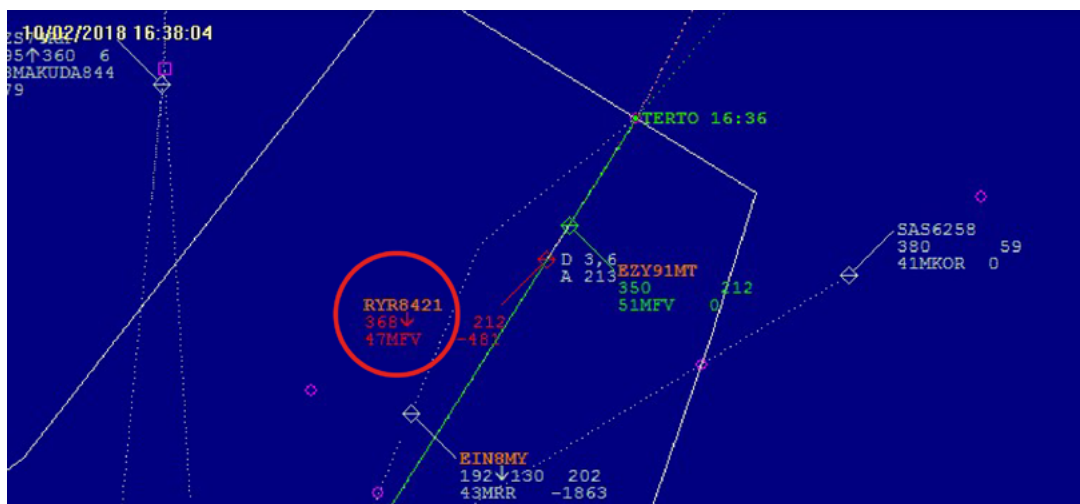
Later, at 16:38:04, the Boeing 737-8AS aircraft with callsign RYR8421 was descending from FL370 and crossing through FL368:

Illustration 3. Position of the aircraft at 16:38:04

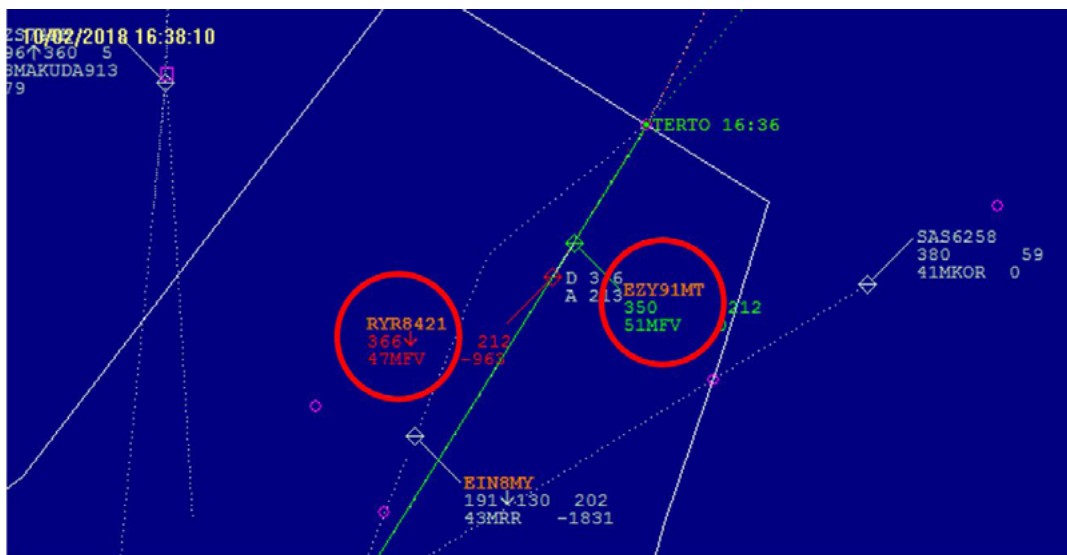
A few seconds later, at 16:38:10, the Boeing 737-8AS with callsign RYR8421 was still descending and crossing through FL366.

Illustration 4. Position of the aircraft at 16:38:10

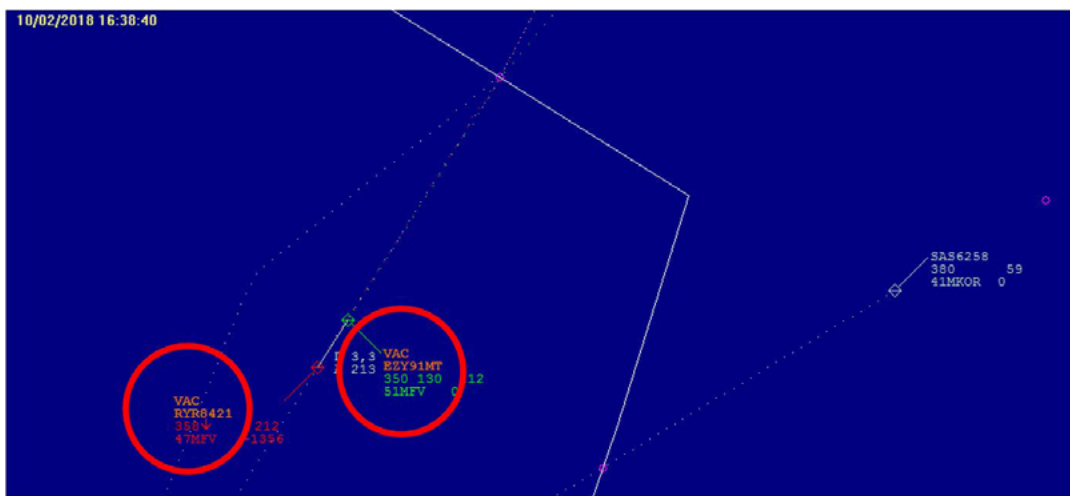
At 16:38:40, the Boeing 737-8AS with callsign RYR8421 was crossing through FL358. Although the aircraft is shown on the radar display as descending, an analysis of the radar data reveals that in reality the aircraft had been climbing since 16:38:33, when the aircraft reached its lowest altitude, which was FL357.

Illustration 5. Position of the aircraft at 16:38:40

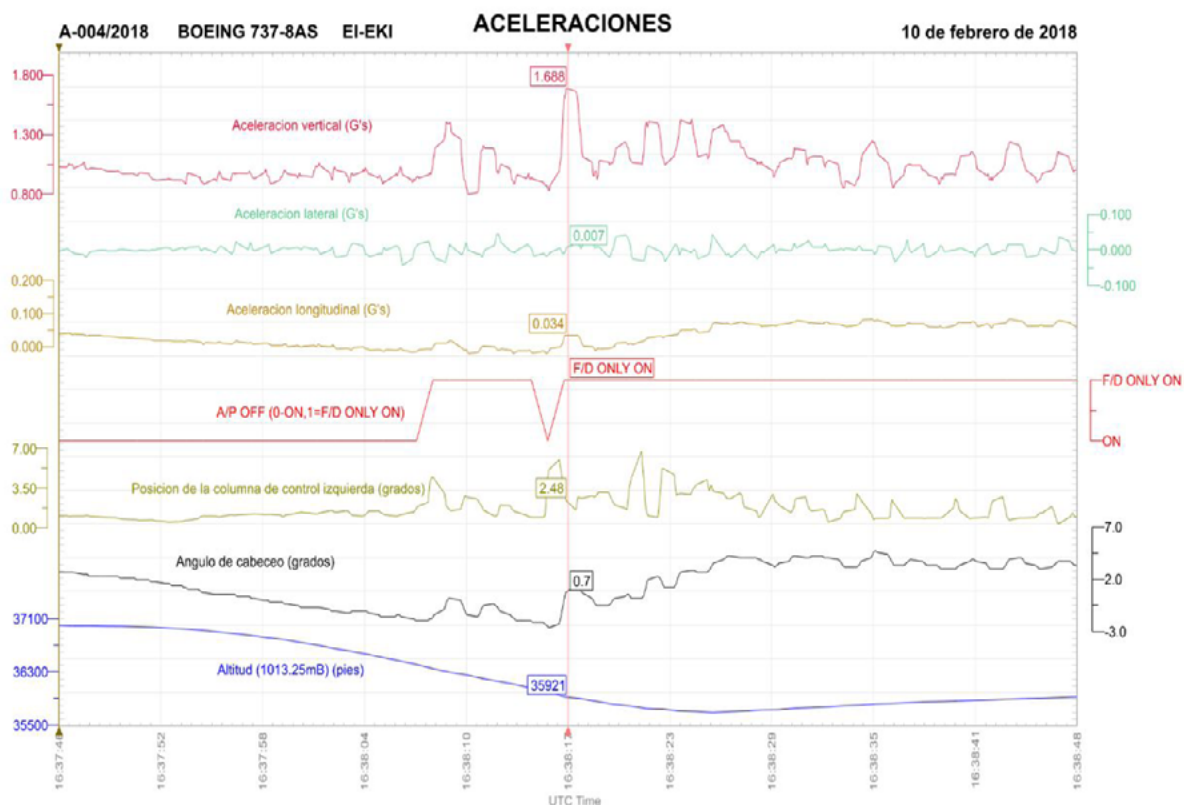
Illustration 6. Flight Data Recorder's data

At 16:38:07, the autopilot was placed in ALT HOLD mode and disengaged one second later. At the time, the aircraft was crossing through FL364 at a vertical rate of -3600 ft/min<sup>2</sup>.

At 16:38:08, an input to the pitch control column was recorded, with the pitch changing from 1.38° in the previous second to 4.51° at that instant. This resulted in the pitch attitude increasing in one second from -2° to 0°, and generated a peak vertical acceleration value of 1.409 g. The descent rate fell instantly to -2340 ft/min.

At 16:38:15, the autopilot was engaged in ALT HOLD mode. This action resulted in an increase in the position of the control column to 6.02°, which translated into an increase in pitch angle from -2.3° to 1.6° over the course of one second, causing the vertical acceleration to spike once more, this time to 1.69 g.

Subsequently, at 16:38:21, the crew again increased the position of the control column to 6.77°, producing a third peak in vertical acceleration, to 1.41 g.

The control column was eased back for a fourth time to 0.94°, followed by an increase to 4.68°, yielding a fourth peak in the vertical acceleration, to 1.43 g, at 16:38:24.
