**COMISIÓN DE
INVESTIGACIÓN
DE ACCIDENTES
E INCIDENTES DE
AVIACIÓN CIVIL**

Report A-008/2021

Accident on 19 March 2021
involving a CESSNA 172 aircraft,
registration EC-FJS, at Casarrubios
del Monte (Toledo, Spain)

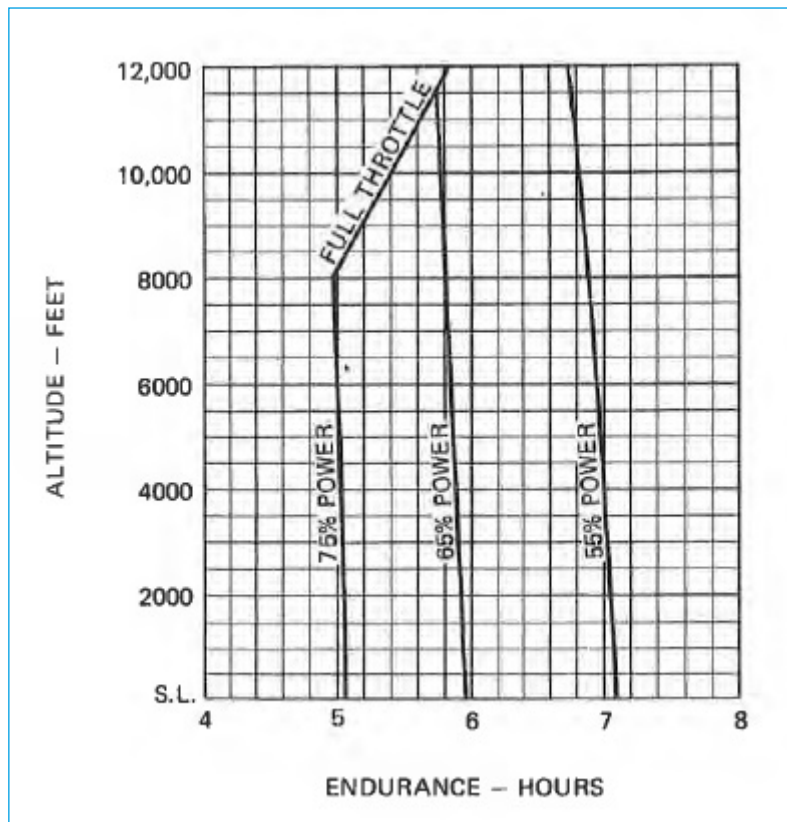
Figure 2. Range at different power settings

Figure 2 shows that with these types of tanks, the aircraft can fly at 55% power for around 7 h.

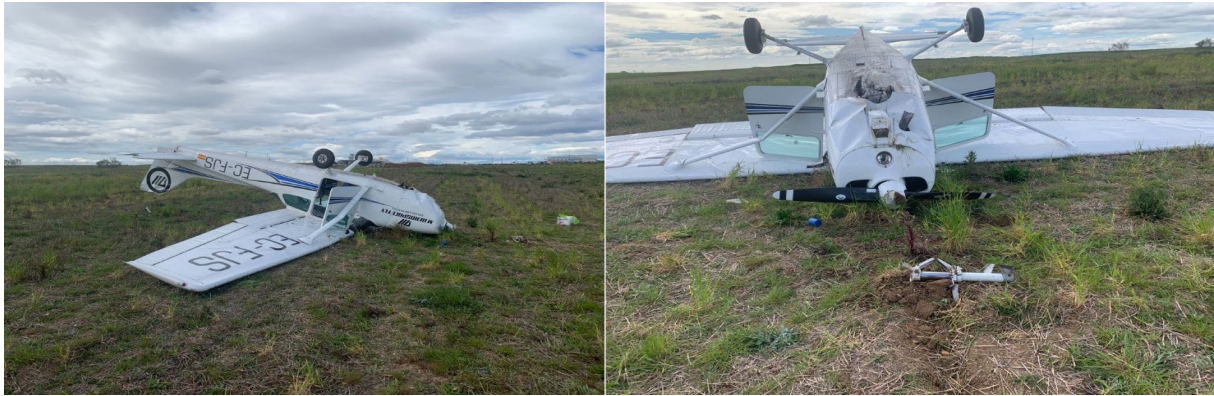
Figure 7. Final position of the aircraft

The accident caused the nose leg to collapse, creases in the fuselage and wings and damage to the vertical stabiliser and rudder.

The nose leg had detached, and there were track marks on the ground made by the landing gear and the impact of the propeller cone.

According to the head of the school, fuel was seen spilling from the tanks, although the amount of fuel remaining in the aircraft at the time of the landing is unknown.

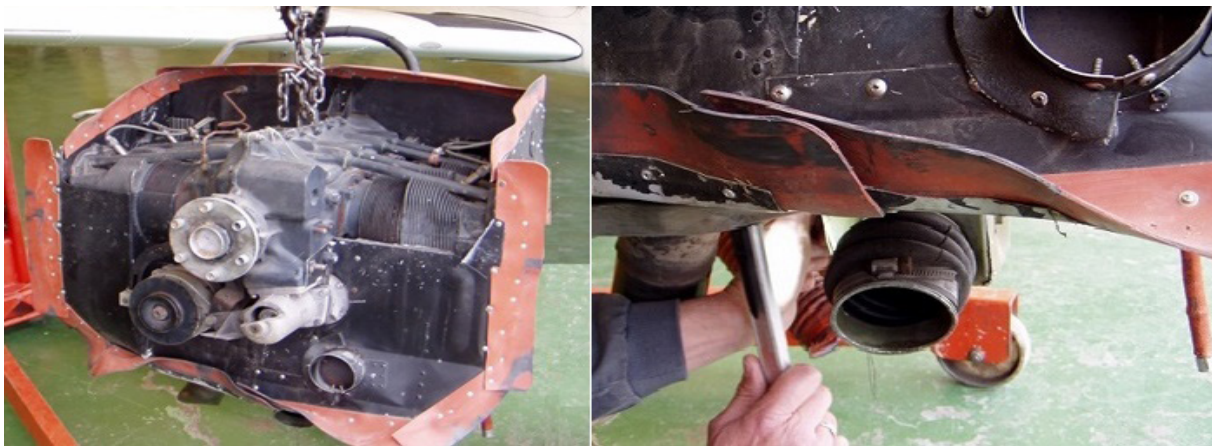
Figure 8. Engine and carburettor heating air intake

The aircraft engine was removed for an external visual inspection which found nothing unusual other than the presence of soil due to the impact when the aircraft overturned.

Traces of fuel were found in the carburettor tank. The carburettor heating system was deformed by the impact, but its various parts (butterfly valve, rubber gasket, throttle shaft roller bearings) were in good condition.

Images of the engine and carburettor heating system are shown in Figure 8.

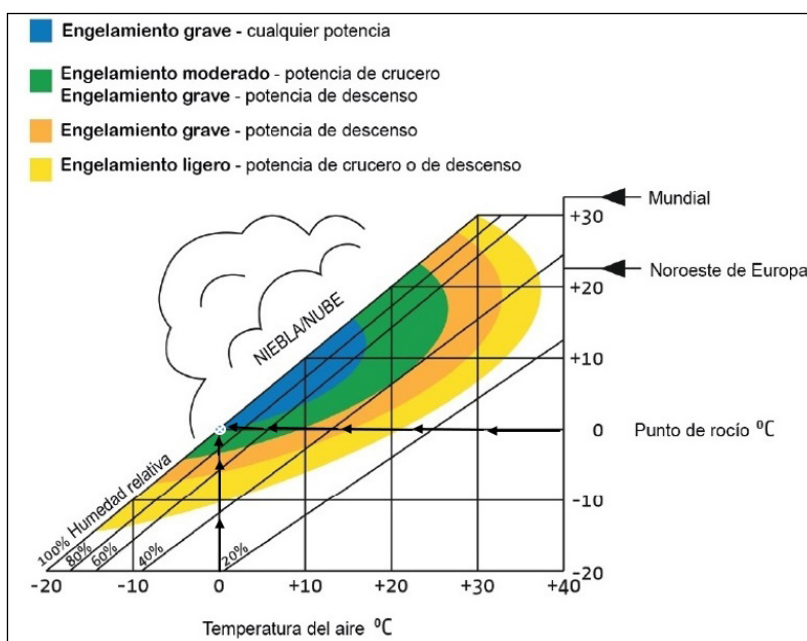
Figure 9. Graph showing the potential for ice formation in the carburettor

The hazardous weather map in Figure 4 shows ISO 0 at FL045 in the area and around the time of the accident. The graph indicates that for air and dew-point temperatures of 0°C, there is a possibility of moderate ice formation while cruising and serious ice formation when descending (green zone).

The crew reported that the engine began misfiring over the River Tagus at 4500 ft. This was followed by a reduction in power, resulting in a gradual loss of altitude. The hazardous weather map in Fig 4 showed ISO 0 in the area at FL45, and the METARs indicated a dew-point of 0°C. Therefore, according to the graph shown in Fig. 8, the conditions at the time were favourable for carburettor icing.
