TECHNICAL REPORT

A-008/2022

**Accident occurred to aircraft CESSNA
FA 150K, registration D-EATU, on
February 16, 2022 in Las Cabezas de
San Juan (Sevilla, Spain)**

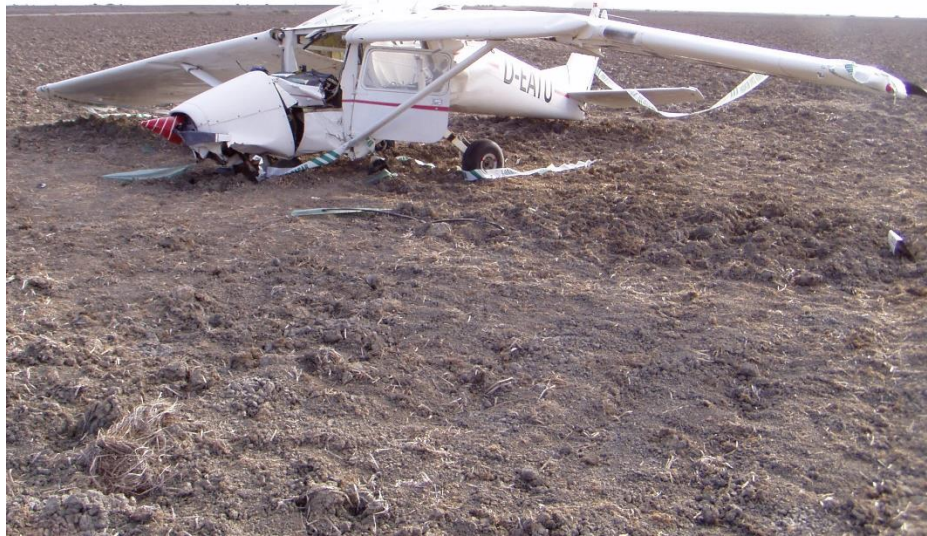
Figura 3. Aircraft at the crash site

In the image of Figure 3 it can be seen its final position.

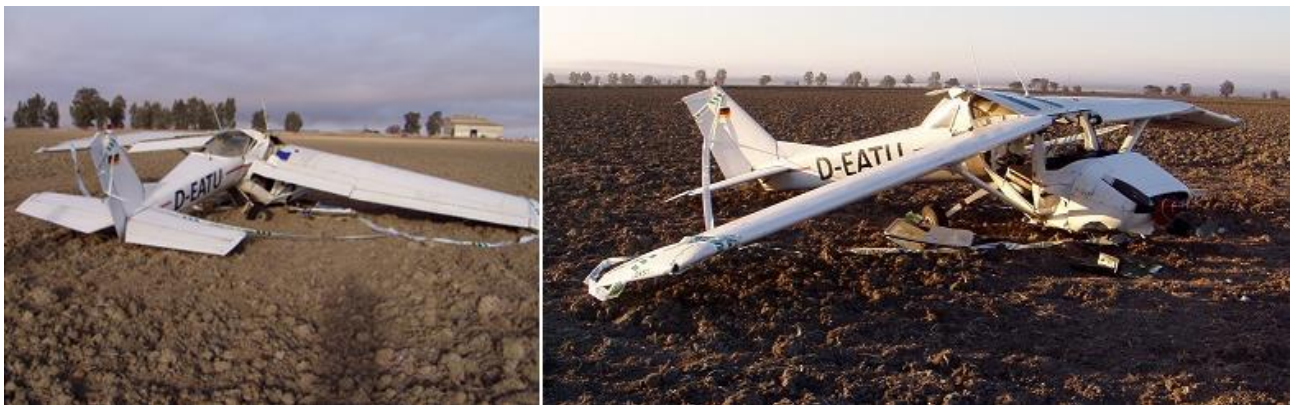
It was observed that the flap movement spindle, located on the right wing and driven by an electric motor, was in the position of flap retracted. The left flap, driven by cables and pulleys, was extended as a result of the impact. Both wings had been bent downwards by the vertical impact suffered with the ground, having the left wing fractured at the root.

Figura 4. Damages in aircraft

The images in Figure 4 show the condition of the aircraft, with both wings deformed by the impact.

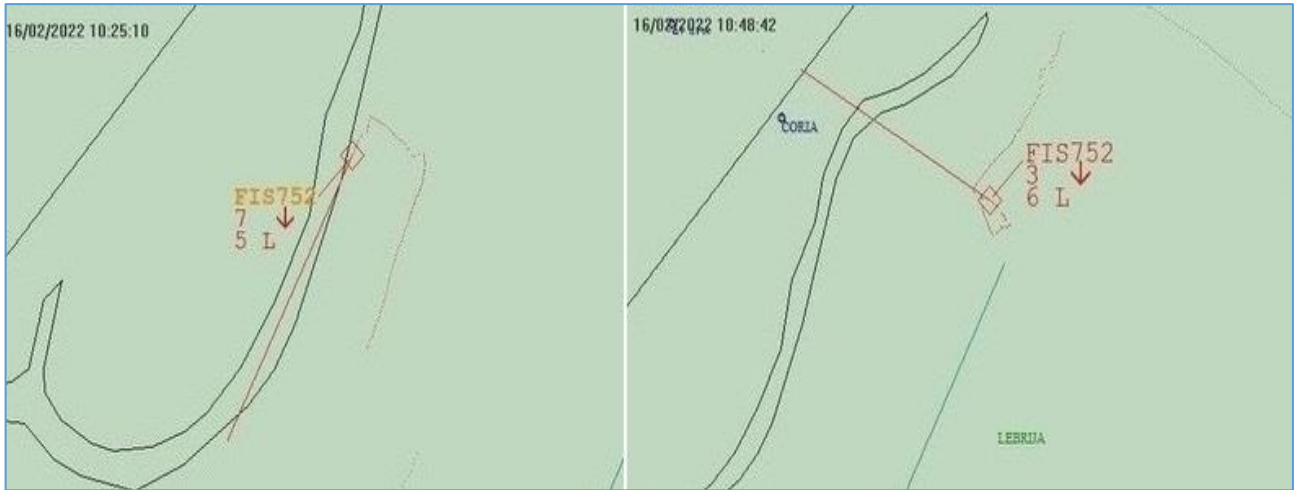
Figura 6. First and second descent FIS752

Figure 6 shows radar images of the flight, with callsign FIS752, descending at 11:25:10 h and 11:48:42 h (local time), before missing radar coverage at 700 and 300 ft altitude respectively, to reappear later in ascent.

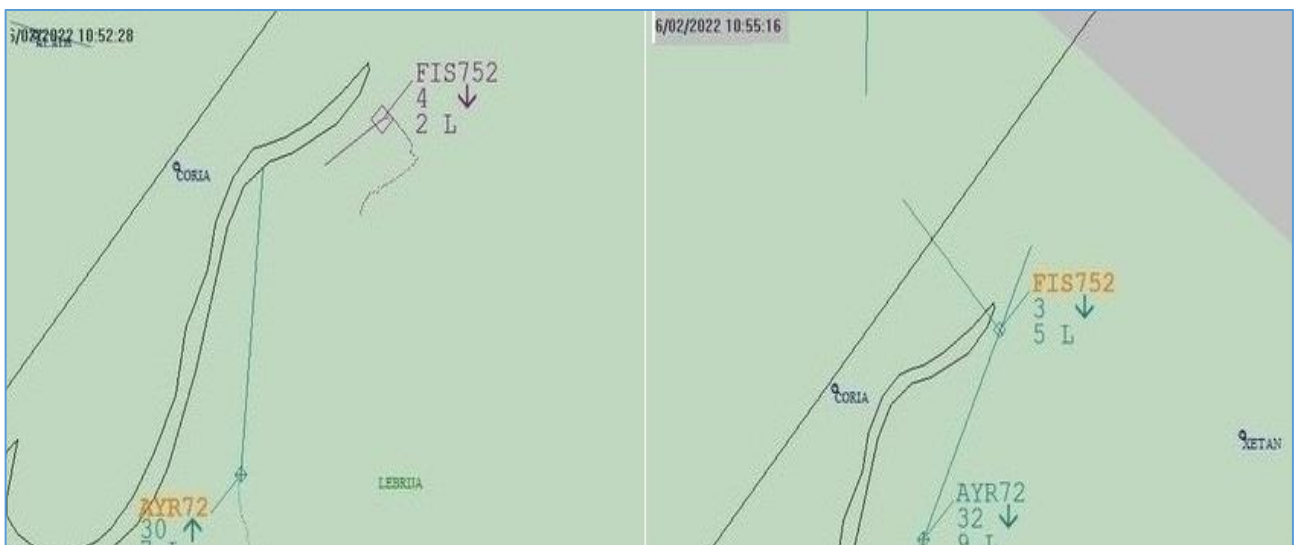
Figura 7. Third and fourth descent FIS752

The images in Figure 7 show the descents made below 400 and 300 ft, at 11:52:28 h and 11:55:16 h respectively. After ascending again, the aircraft remains in the same area, at about 3000 ft altitude.

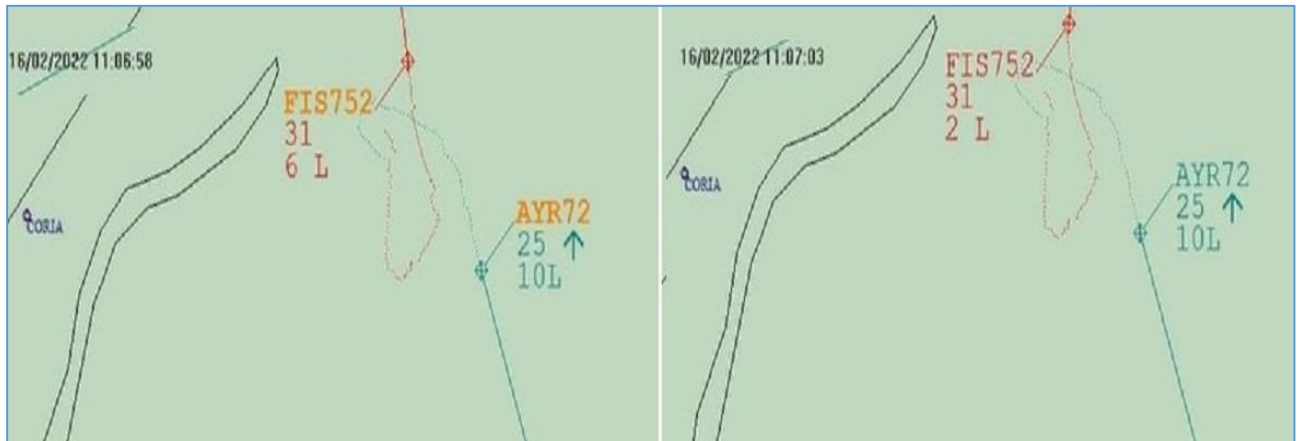
At 12:06:58 (local time), the aircraft being at 3100 ft, a ground speed of 59.38 kt is recorded, which decreases suddenly.

Figura 8. Ground speed decrease FIS752

According to the radar data provided, 3 s later the ground speed is 18.84 kt. After this the altitude information is lost and the radar trace disappears from the screen.

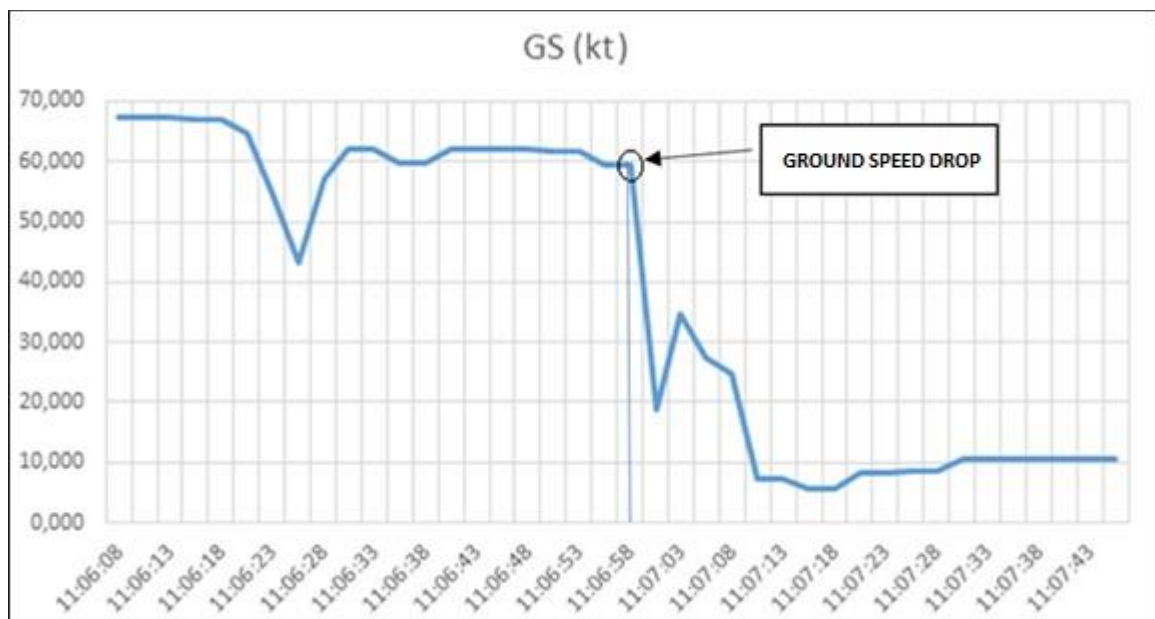
Figura 9. Ground speed variation FIS752

After the speed drop occurred at 12:06:58 h, the coordinates indicating the position of the aircraft (37° 03' 50"N 06° 01' 56"W) no longer change, indicating that it no longer moves with respect to that point. These coordinates coincide with those of the place where the remains of the aircraft were located.

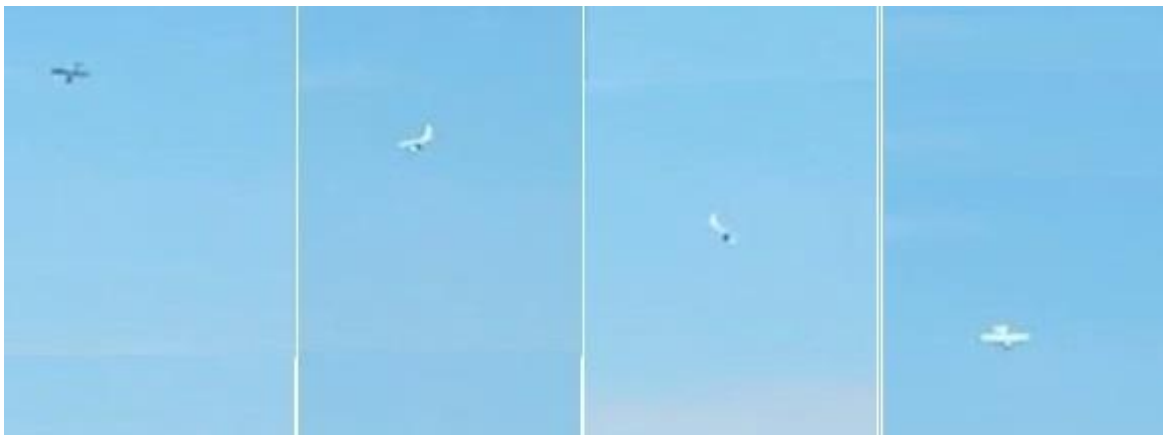
Figura 10. Video frames aircraft D-EATU

Figure 10 attaches several frames of a video recorded by one of the witnesses with his mobile phone. In these it can be seen the aircraft descending in a spin.
