TECHNICAL REPORT

A-010/2023

Accident on 17 June 2023 involving a MOONEY M 20K 231 aircraft, registration N-192JM, at Casarrubios del Monte Aerodrome (Toledo, Spain)

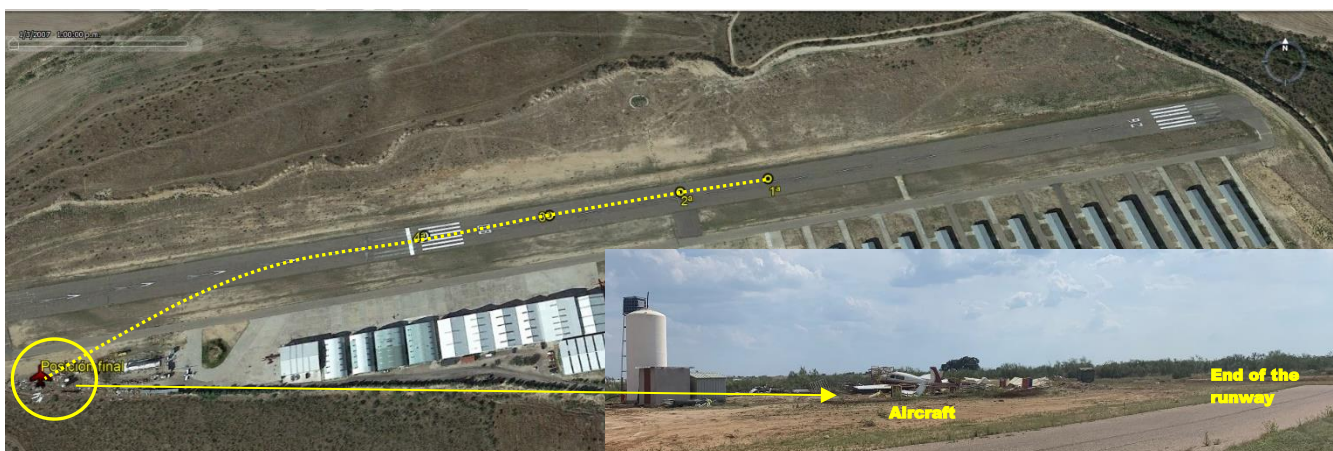
Figure 1 Trajectory of the aircraft

The footage captured by the images is consistent with the pilot's account insofar as the aircraft touched down four times on the runway before turning with its wings level throughout, but contradicts his description of where it first made contact, which was not on the threshold of runway 26, but approximately 320 m further on.

There was a distance of approximately 70 m between the first and second touchdown points, approximately 100 m between the second and third touchdown points, and approximately 90 m between the third touchdown point and the fourth on the threshold of runway 08.

The aircraft then turned left with 70 m of asphalt runway still available.

- ▶ During all the touchdowns, the aircraft hardly rolled on the ground at all, lifting off again as soon as it touched down. After the fourth touchdown, it turned left, maintaining a height approximately equivalent to the length of 1 wing section (4 m).

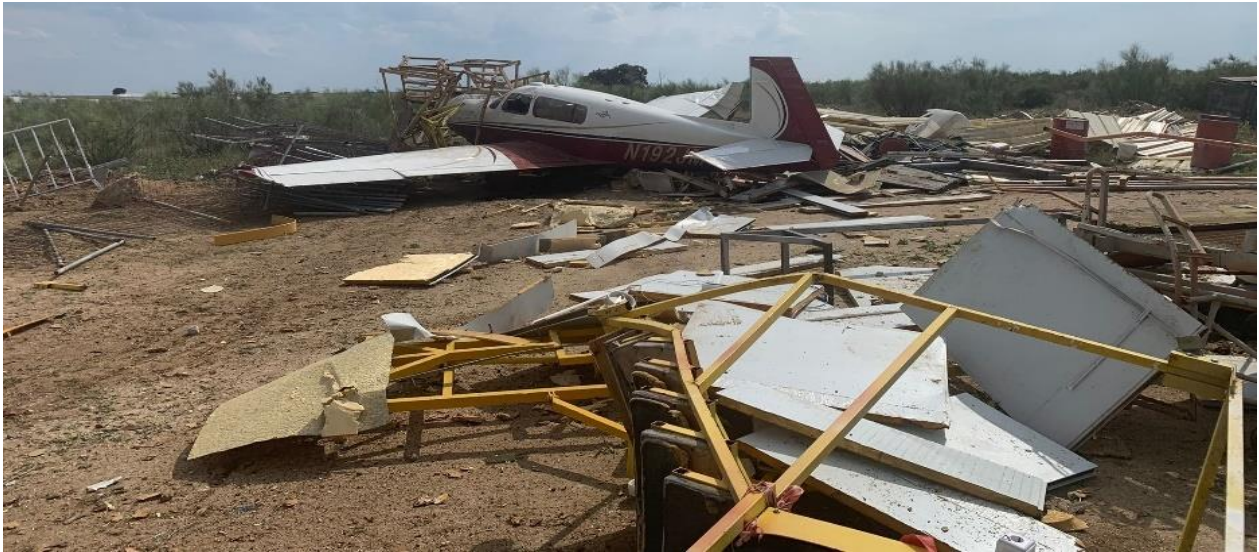
Figure 4.- Final position of the aircraft

The aircraft veered off to the left with 70 m of asphalt runway still available and crashed into a metal structure in an area where there were multiple pieces of scrap metal³ and debris, coming to rest at 40° 14' 0.31" N - 4° 1' 54.24" W, next to the aerodrome perimeter fence and 20 m from the fuel storage tank.

The area of impact, close to the fuel storage tank that aircraft must approach for refuelling, was strewn entirely with disorganised scrap metal, as if it were a rubbish dump, within the aerodrome's safety zone. These multiple scattered metal elements could easily puncture an aircraft tyre.

For this reason, we are recommending that the owners of Casarrubios del Monte Aerodrome remove all the scrap metal in the area in order to prevent fires or major damage in the event of a runway excursion, as happened in this incident.

REC. 24 /23. It is recommended that the owners of Casarrubios del Monte Aerodrome remove all the scrap metal in the area near the runway and taxiway in order to prevent fires or major damage in the event of a runway excursion, as happened in this event.

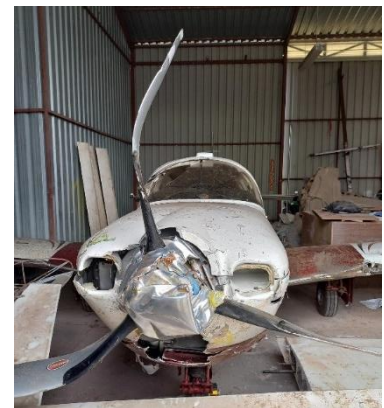
Figure 5. Damage to the

There was significant damage to the entire front of the aircraft. The cone of the propeller (which was feathered) was crushed, and the three blades had several scratches but no significant deformities. The windscreen was broken on the passenger side.

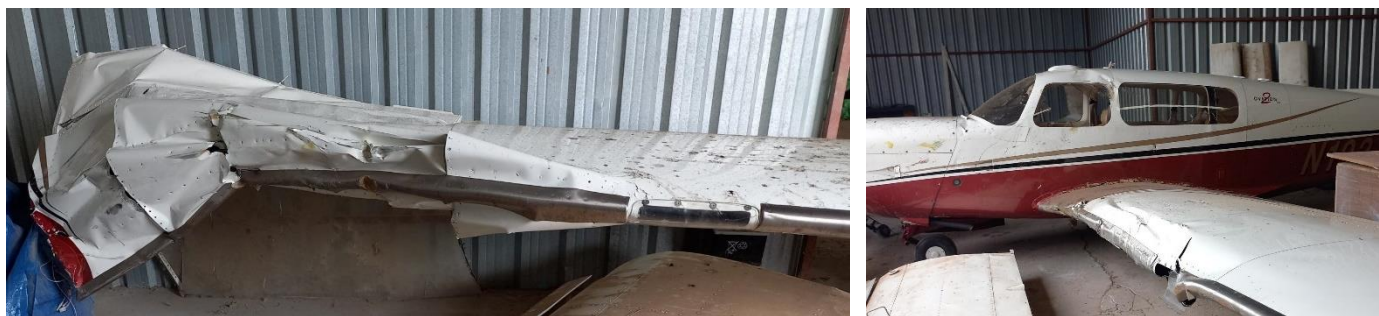
Figure 6. Damage to the wings

The right wing was also badly damaged, with a substantial impact to the middle of the leading edge that had caused severe deformation from that point to the tip area, affecting the top surface area and extending all the way to the trailing edge.

The left wing was dented on the leading edge, next to the root. No evidence of any impact was observed from the back of the cockpit to the rear, including the tail.

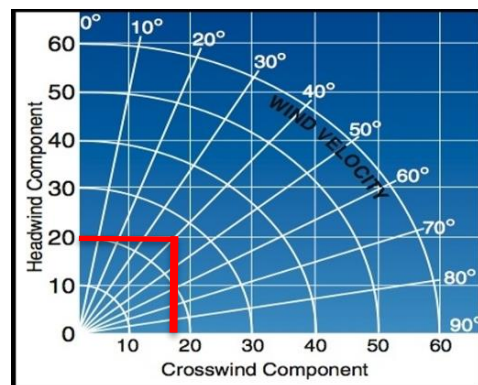
Figure 8. Crosswind component

At the most unfavourable wind speed (20 kt), we calculated the crosswind component as approximately 18 kt.
