Report A-012/2020

Accident involving a Piper
PA-60-602P aircraft, registration
EC-HRJ, on final approach to
Pamplona Airport (Navarra) on 20
February 2020

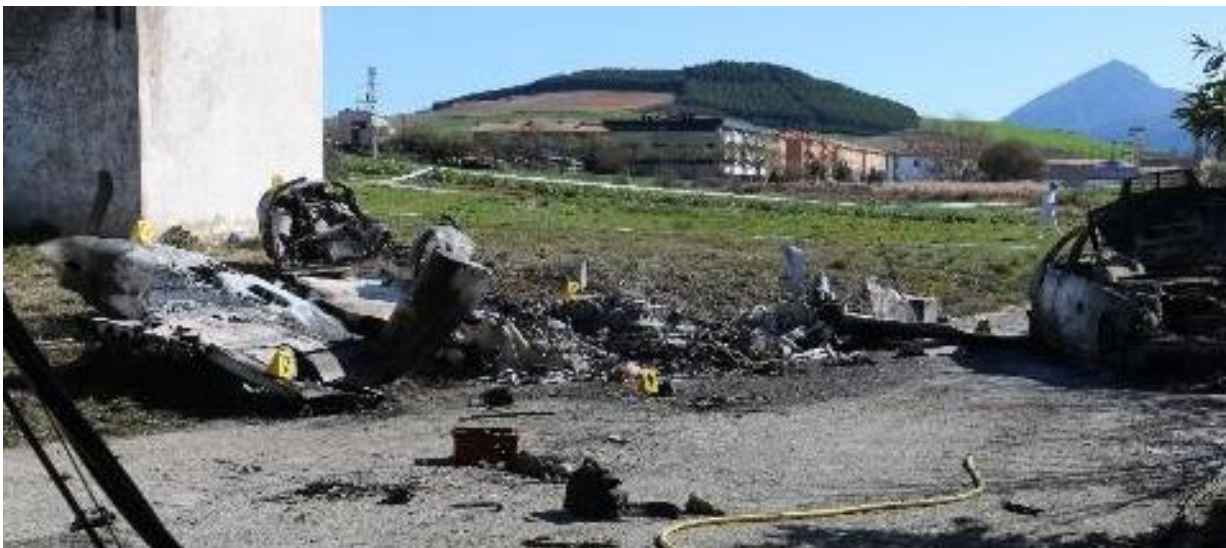
Illustration 3: damage to the accident aircraft

Most of the wreckage was completely destroyed by the impact and subsequent fire. The front landing gear was observed partially extended. The landing gear doors were open and displayed abrasion marks. The main landing gear wheels were retracted and under the fuselage. The photograph shows the aircraft wreckage at the accident site.

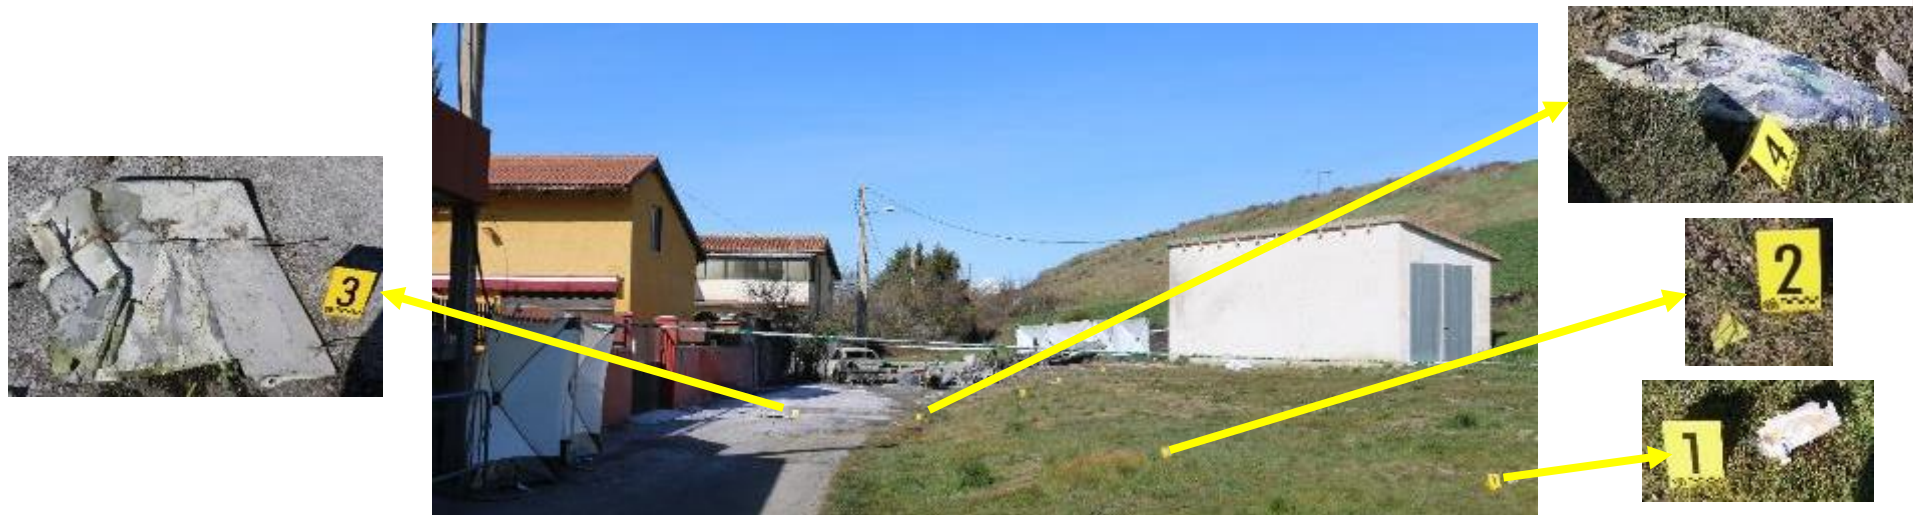
- Firstly, small pieces of material from the aircraft were found, denoted as 1 and 2 in the photograph.
- Subsequently, the tail cone's rear vertical stabiliser was observed on the right (denoted as 4 in the photograph) and, to the left, the left wingtip was found (denoted as 3 in the photograph).

Illustration 4 on the left, the left wingtip (number 3), and on the right, part of the tail cone, number 4

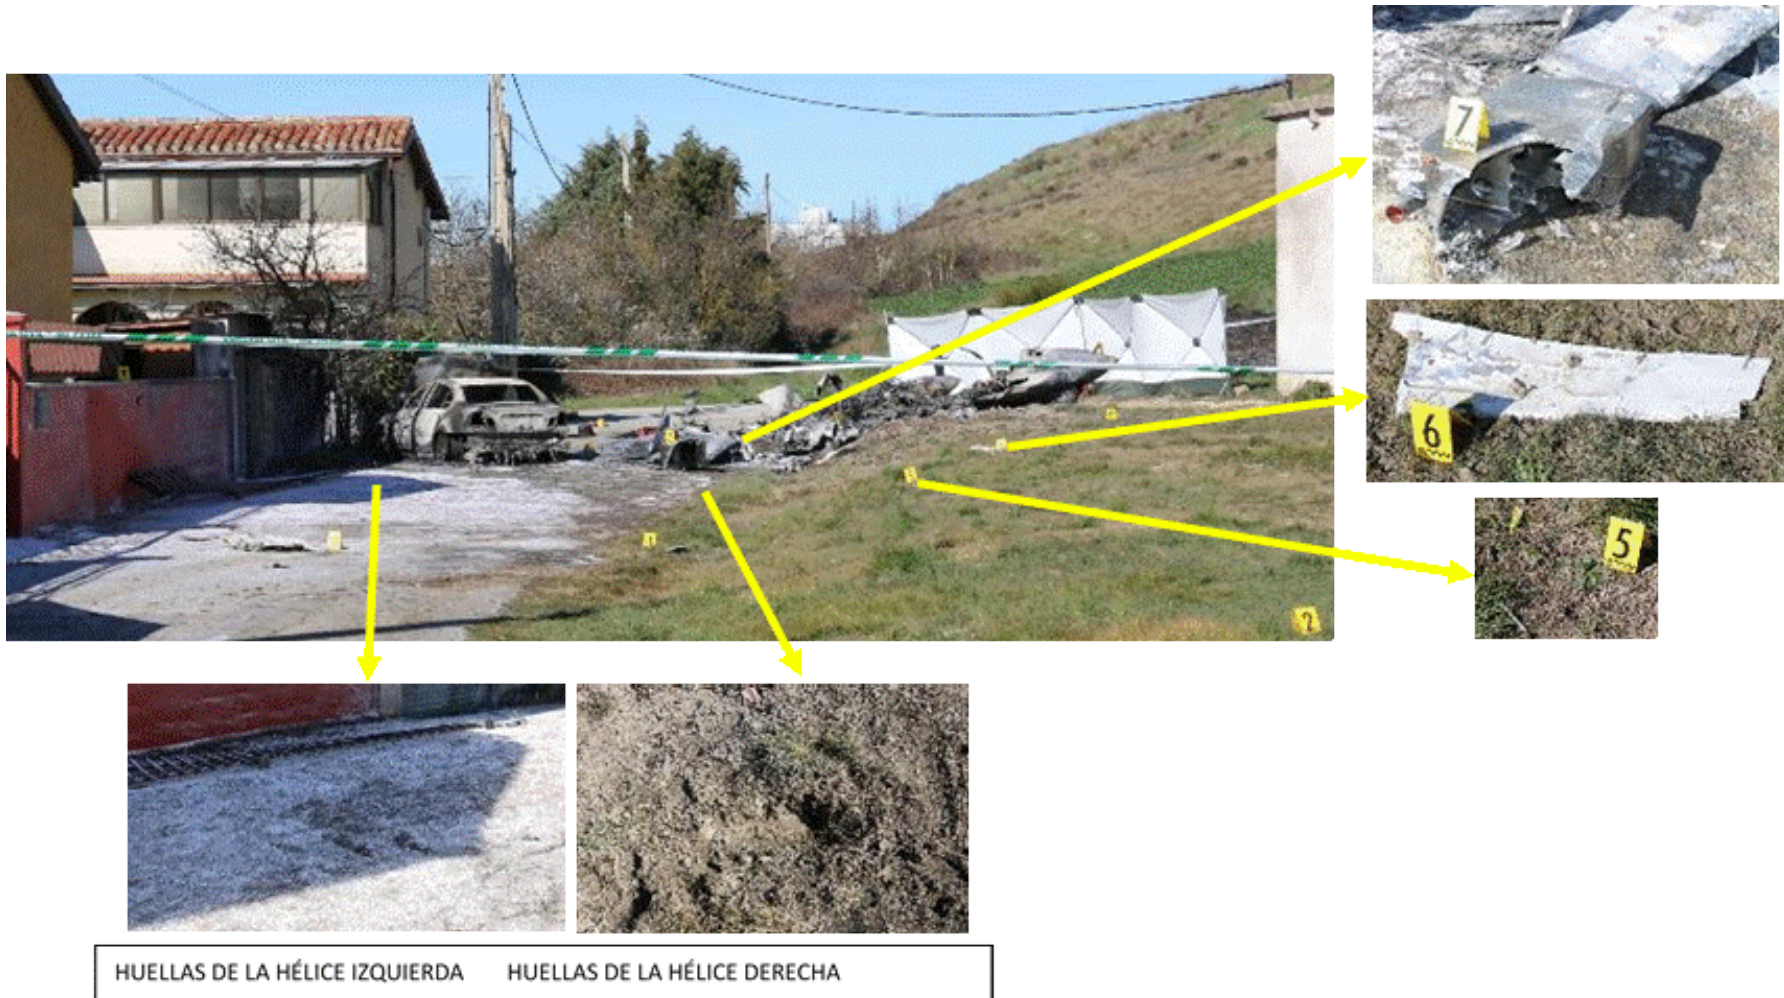
Further on, there were marks made by the left propeller on the cement road and by the right propeller on the softer ground. The elevator was found to the right (denoted as 6 in the photograph). And lastly, the main remains of the aircraft.

Illustration 5: close-up of the propeller marks and, to the right, the right elevator (number 6)

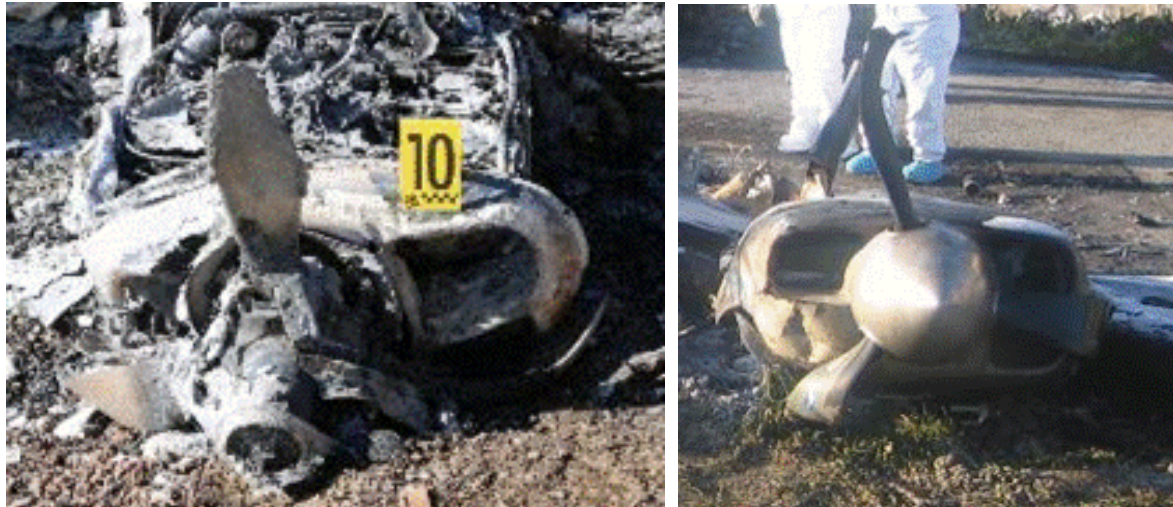
The right engine's propeller blades struck soft ground and were not feathered. The extensive rearward deformation of the left engine's propeller blades suggests it was providing power at the time of the accident.

Illustration 6: Photographs of the right engine (left) and left engine (right) propeller blades

A study of the right propeller revealed it had not been feathered. The aircraft does not have an automatic feathering system in case of engine failure.

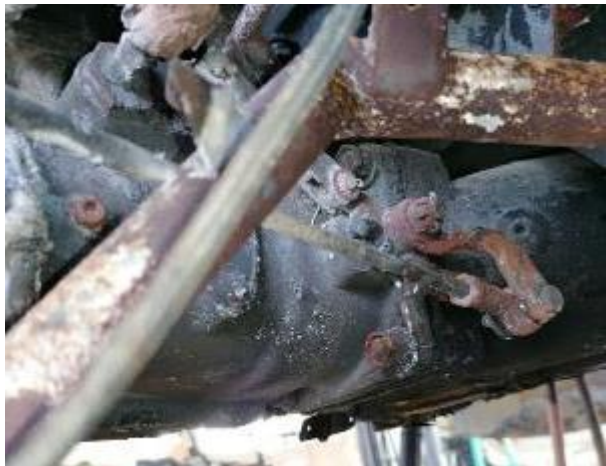
The lever was in the full-power position:

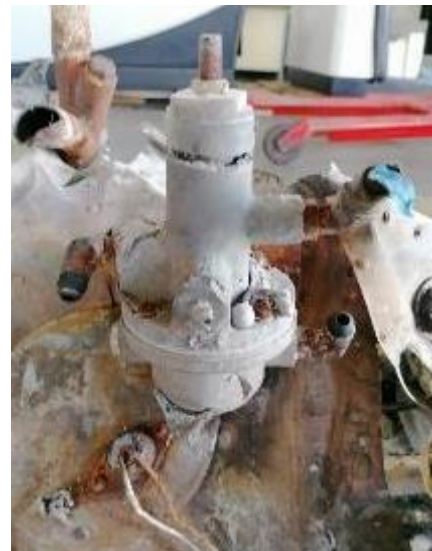
a. Automatic turbocharger system controller

The right engine's turbocharger system controller is shown in the photo to the right. (The S/N of the controller was: 005298). The controller was severed.

- In terms of the engines' turbocharger system, it was found no anomalies in its components except for the fact that the right engine's turbocharger controller was severed, presumably as a result of the impact with the ground.

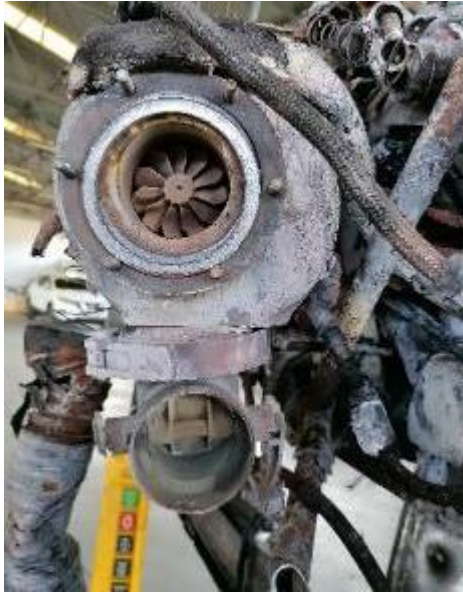
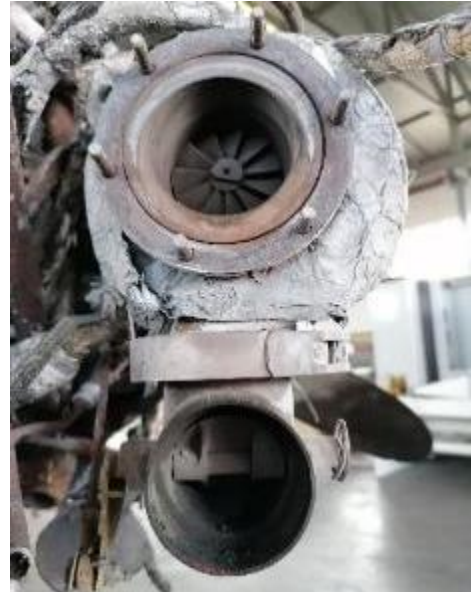
b. Wastegates of the automatic turbocharger system controller

Both the wastegates on the right engine were found fully closed.

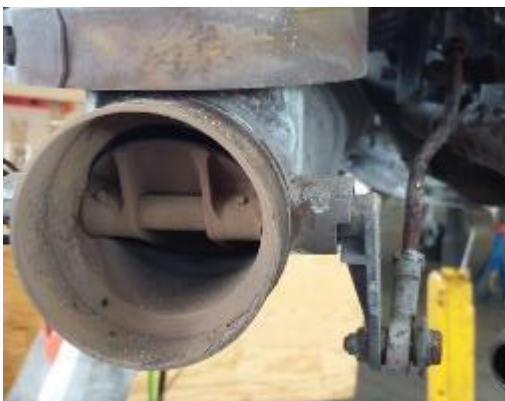
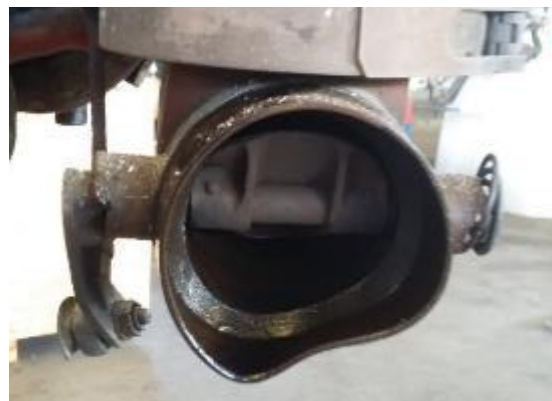
2. Left engine. Wastegates of the automatic turbocharger system controller

Both the wastegates on the left engine were found slightly open.

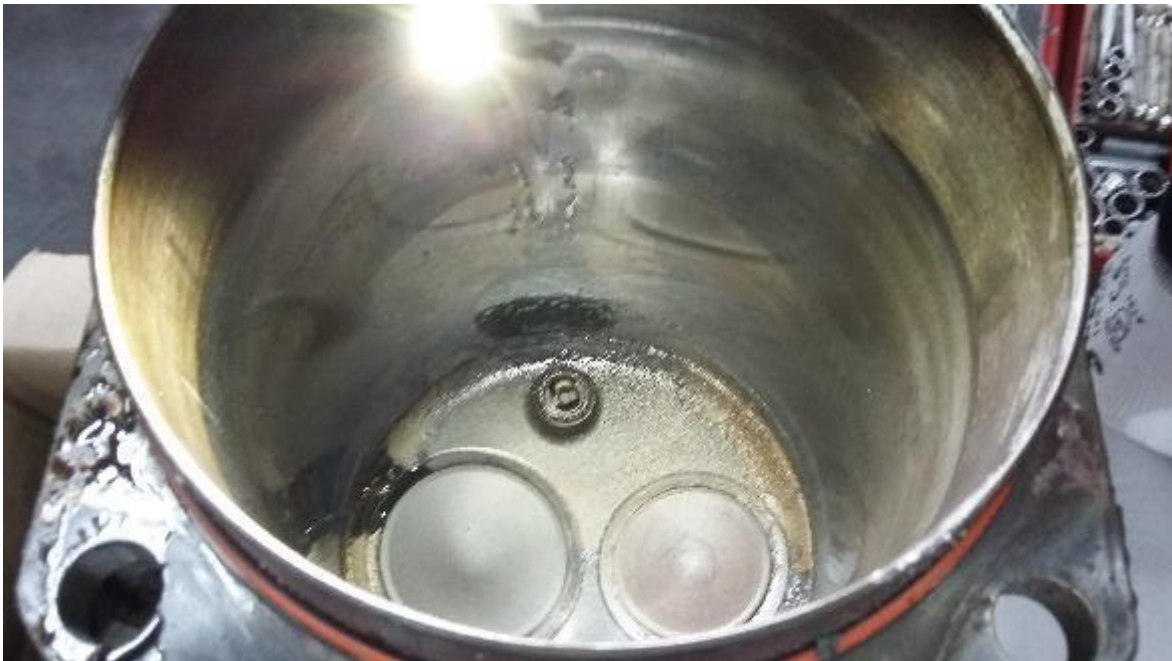
Illustration 8: interior of one of the engine cylinders

The cylinders of the right engine of the accident aircraft were disassembled to look for signs of corrosion on their walls as a result of the aircraft's extended period of inactivity before the accident. No corrosion was found on their walls. The attached photograph shows the condition of one of the right engine's cylinders.

- In terms of the right engine's general condition, there were suggestions that a lack of preservation or inadequate preservation during the aircraft's period of inactivity could have been a factor in the accident. However, its cylinders were dismantled, and no signs of corrosion were found.
