**COMISIÓN DE  
INVESTIGACIÓN  
DE ACCIDENTES  
E INCIDENTES DE  
AVIACIÓN CIVIL**

## **Report A-016/2018**

Accident involving a Mooney  
M20K aircraft, registration  
D-ETFT, in the municipality of Flix  
(Tarragona), 12 May 2018

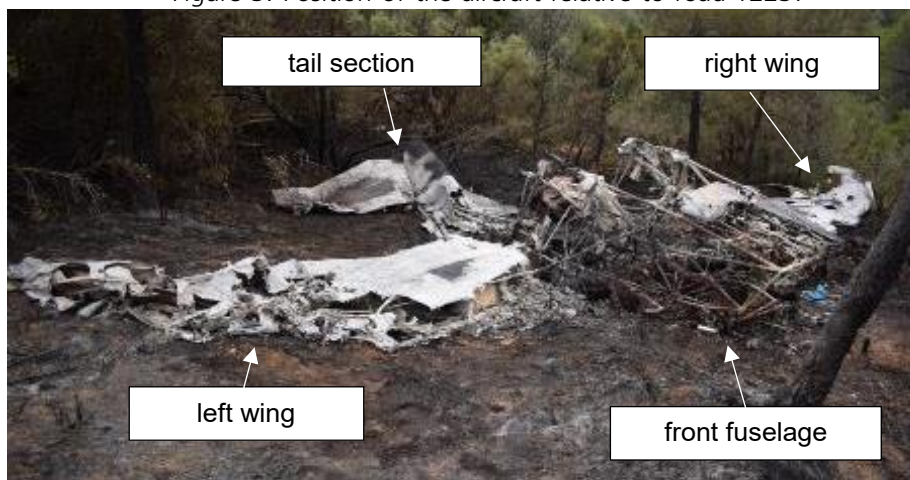
Figure 4. Aircraft upside down and burned after the accident

The aircraft was destroyed as a result of the impact and the subsequent fire. It was found upside down and the engine had completely detached from the aircraft. The ends of the left and right wings had broken off from the main aircraft body and were the only components that were not affected by the fire.

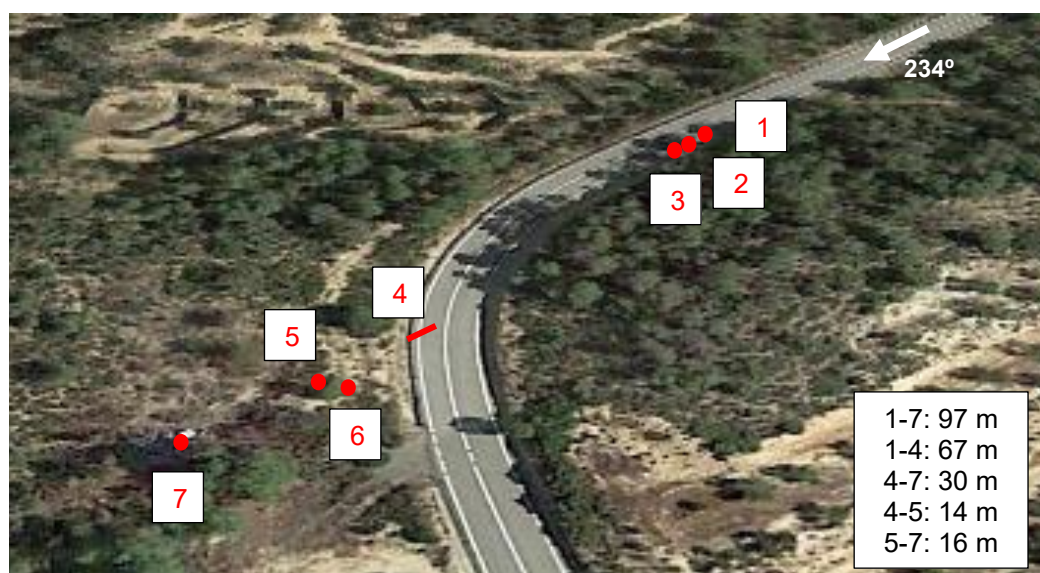
Figure 8. Location of the wreckage

The aircraft was found in a forested area on the right side<sup>11</sup> of road T2237. The road, 6 m wide (the aircraft's wingspan was 10.99 m), traveled along a section with elevation differences on either side, with the terrain going uphill on the left and downhill on the right, where the aircraft was found.

The aircraft's direction of motion was determined using the distribution of the debris and the marks found, as shown in the figure above. Marks 1-4 were oriented toward 220°, and marks 4-7 toward 240°. The distance between the most distant components of the wreckage (1-7) was 97 m.

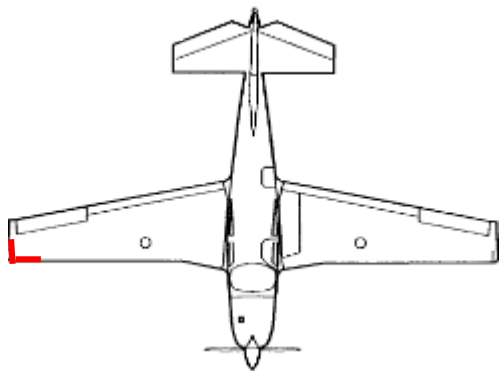
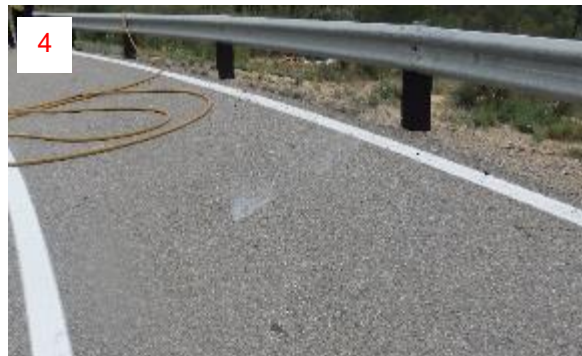
- 4 67 m away from point 1 there were friction marks on the asphalt, with small flecks of blue paint, that were oriented practically perpendicular to the length of the road. Continuing in the direction of this mark, there was similar abrasion on the guardrail. This point is at an elevation of 236 m, and the marks are believed to have been made by the right wingtip, and that the marks and deformations found in 6 were created here.

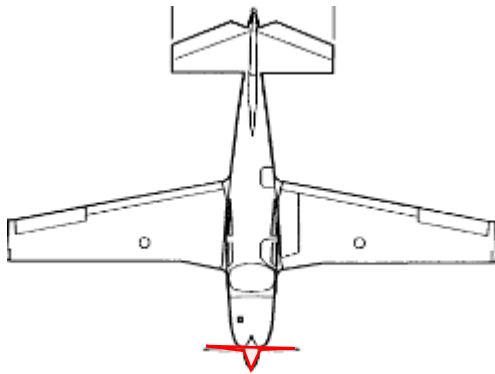
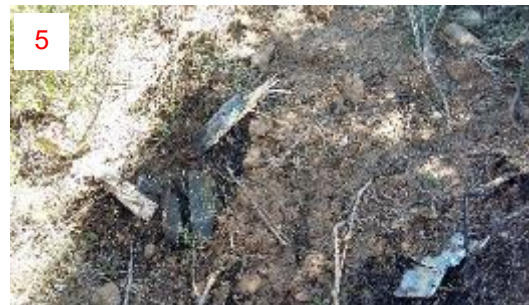
5 14 m away from mark 4, on the right slope, the debris from the propeller blades and spinner were found buried. The elevation of the ground at this point was 235 m.

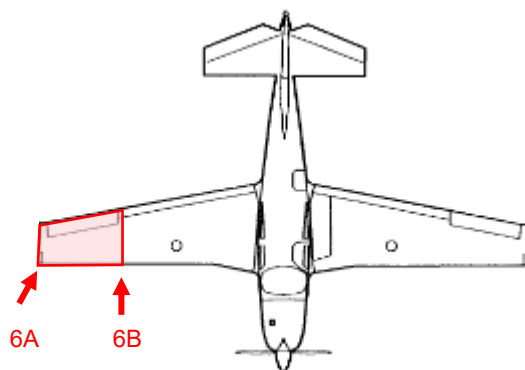
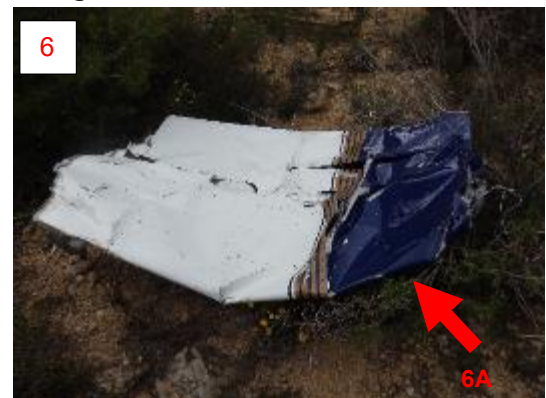
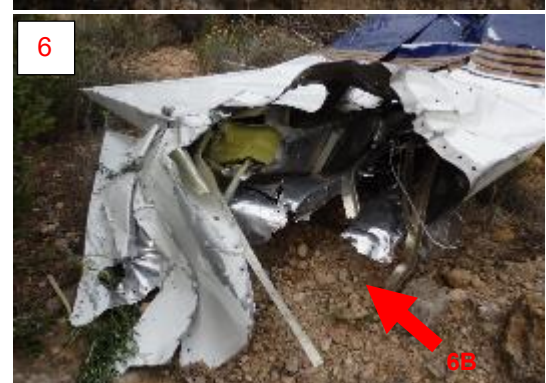
6 13 m away from 4 was a 1.8-m long section of the right wingtip, containing the aileron. It was not burned. It exhibited the following fractures and deformations:

- On the leading edge of the wingtip, there was intense deformation due to compression from the front to the back (6A).
- In the area where it joined the rest of the wing, there was a perforation on the wing that went from the leading edge to the trailing edge (6B). The material in the fracture zone was deformed and had large tears. The entire piece was deformed toward the lower surface of the wing.

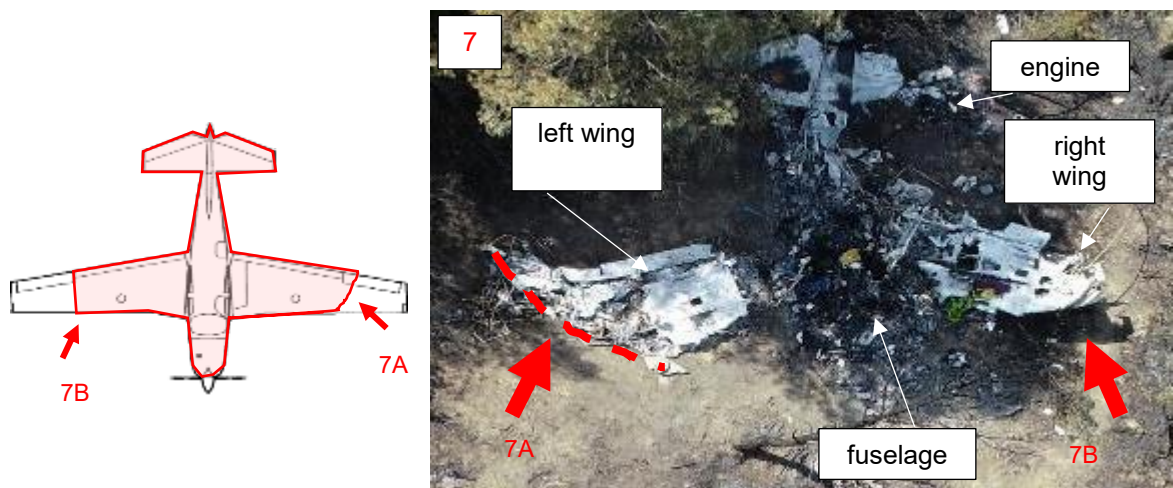
7 The aircraft was 30 m away from mark 4. It was upside down and completely burned. It was 97 m away from mark 1. The elevation of the ground at this point 231 m, 5 m below the road. The fire had been most intense in the area of the fuselage, of which there was nothing left, except for the metal structure. The fuselage pointed toward the north (344°). The extent of the destruction made it impossible to identify the position of any of the aircraft's controls.

The right wing was highly deformed and twisted near the tip (7B). The entire structure of this wing was deformed toward the lower surface and toward the back. These deformations matched those found on the wingtip that had detached, and which was found in mark 6, specifically those identified as 6B. The left wing had lost more material, and it also showed signs of compression and deformation along more than half of the wing along the leading edge. The tail assembly was attached to the fuselage and had also been exposed to the fire.

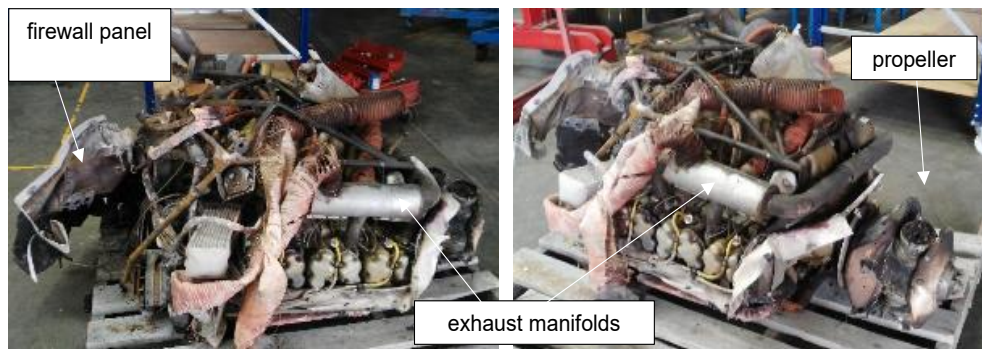
The aircraft's engine had detached and was found upside down between the right wing and the right horizontal stabilizer. It had intense burn marks along the rear and less intense at the front. The deformations and displacement of the firewall panel, which was driven into the rear of the engine, the deformation on the propeller plates and the lack of deformations at the bottom of the engine (such as on the exhaust manifolds or the turbocharger) indicated that this area had mainly been subjected to longitudinal forces acting toward the front. The engine was removed and preserved for disassembly and inspection, the results of which are presented in section 1.16.2.

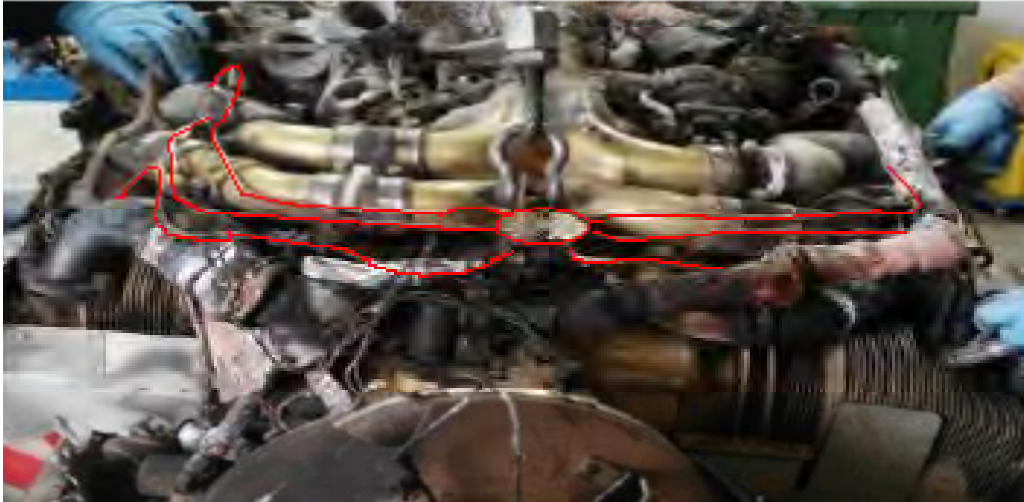
Figure 9. Fuel manifold and distribution lines

- Fuel manifold and nozzle distribution lines: removal and inspection. Upon inspecting the condition of this assembly, it was noticed that the connection between line #3 and the fuel manifold was loose, while the other lines were not. In fact, the line connecting the fuel manifold to the injector of the #3 cylinder was completely fractured at the connection between the two. The entire assembly was removed and preserved for subsequent analysis.

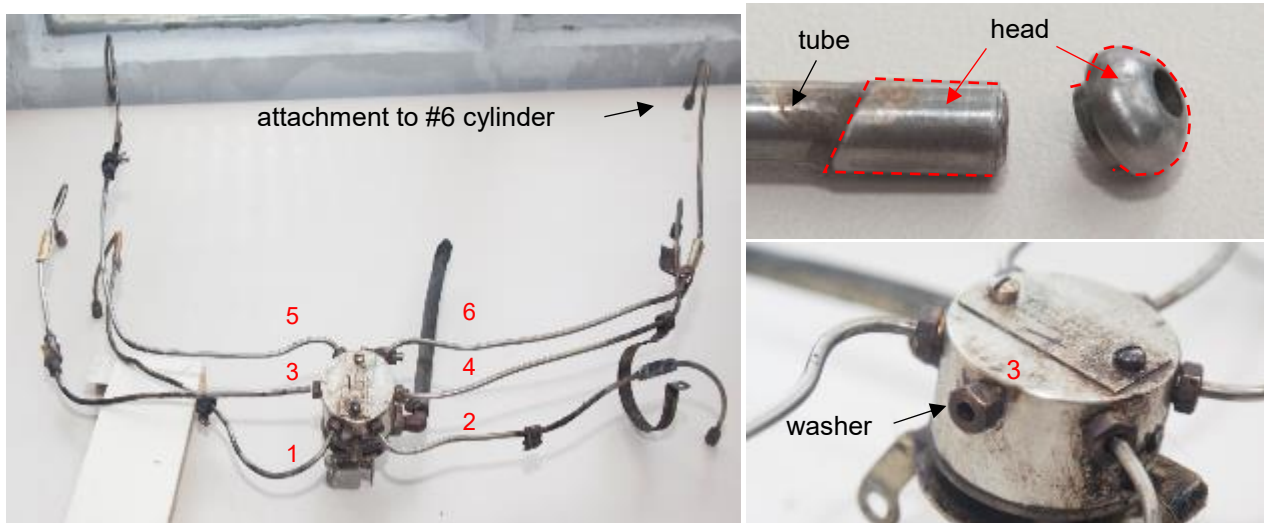
Figure 10. Fuel manifold line and nozzle distribution lines

Each end of the line, both the part that is inserted into the manifold and the part that goes into the cylinder, is terminated with an element with a larger cross section, called the head, that is welded to the line. In the case of the #3 cylinder, the attachment head to the manifold was completely fractured in the part with the changing cross section.

Chemical, fractographic and metallographic tests were done. The heads were made up of austenite crystals with fine MnS inclusions, which is an easily machinable stainless steel. The line exhibited an austenitic structure with twin graining, and the welding material had a hypoeutectic structure. The relatively high hardness of the fractured head with respect to the line is indicative of a certain degree of work hardening (possible cold drawing or forming by plastic deformation).

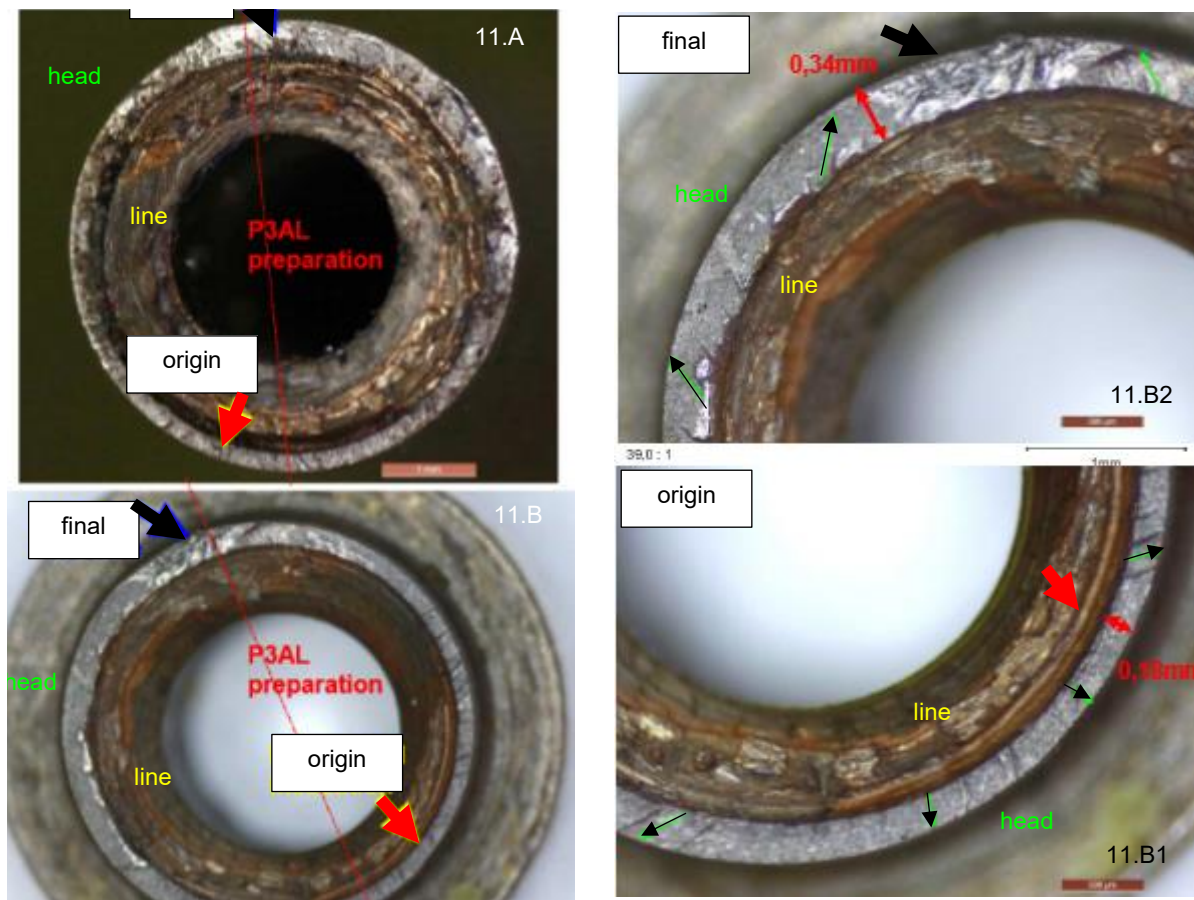
Figure 11. Fracture surfaces

The fracture occurred in a connecting piece (head) that was welded to the end of the line. The fracture surface was oriented across the length of the line and did not exhibit any apparent signs of tearing or plastic deformation. There were radial steps on much of the fracture surface that originated on the inner surface of the part, primarily in a zone where the wall thickness was 0.18 mm. At the other end, the thickness was 0.34 mm and there were signs of plastic deformation by material smashing after the fracture.

In addition to the radial steps, the scanning electron microscope images showed microsteps and transcrystalline microfaces with cleaving, which is characteristic of fatigue with a high number of cycles. All of these marks were indicative of multiple incubation points on the inner surface of the part. Most of the incubation regions exhibited tearing microdomes and other signs of plastic deformation of the material prior to the fracture. The final fracture zone showed signs of plastic deformation of the material caused after the fact.

Figure 11 shows images of the fracture surface. Figure 11.A shows part of the line, and 11.B the part where the diameter increases. Figures 11.B1 and 11.B2 provide amplified views of the fracture surface in 11.B. The images identify the start and end of the fracture, the difference in cross section and the direction of propagation of the fracture.

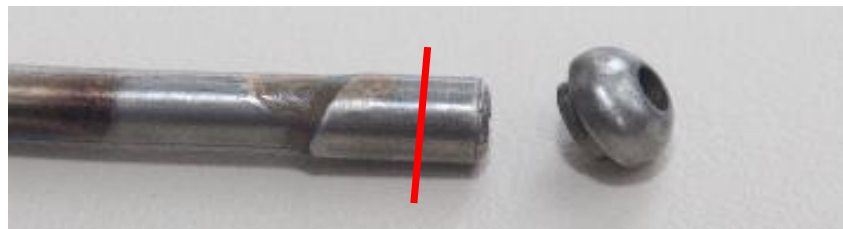
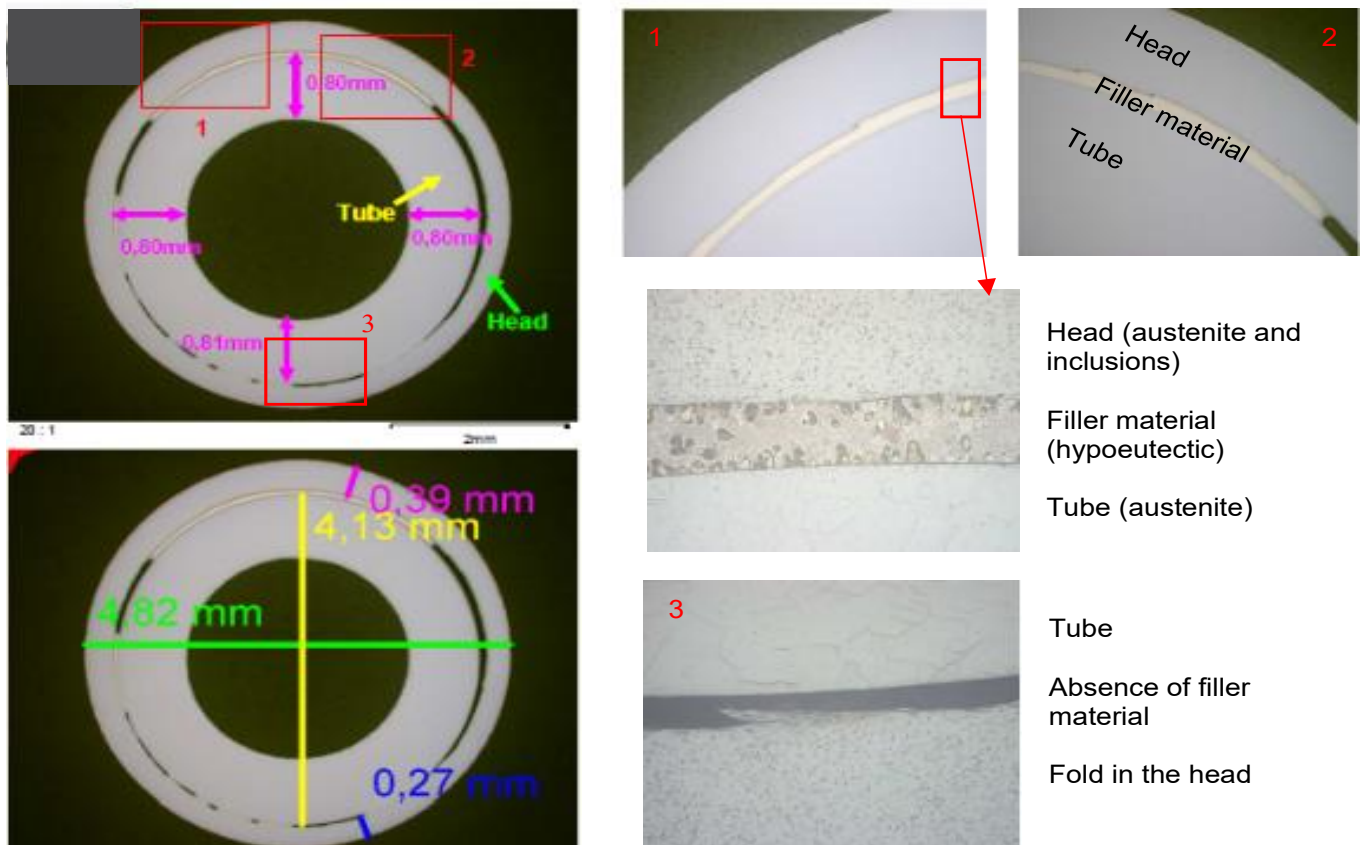
Figure 12. Cross section of the fractured end of line #3

Several regions of the inner surfaces of the heads showed signs of plastic deformation and material tearing. There were gaps caused by capillarity of the filler metal in broad regions of the tube-head weld. There were also folds on the inner surface of the heads. In some cases, the lack of filler coincided with the change in cross section of the head.

Figure 12 shows the results obtained when the following cross section was cut:

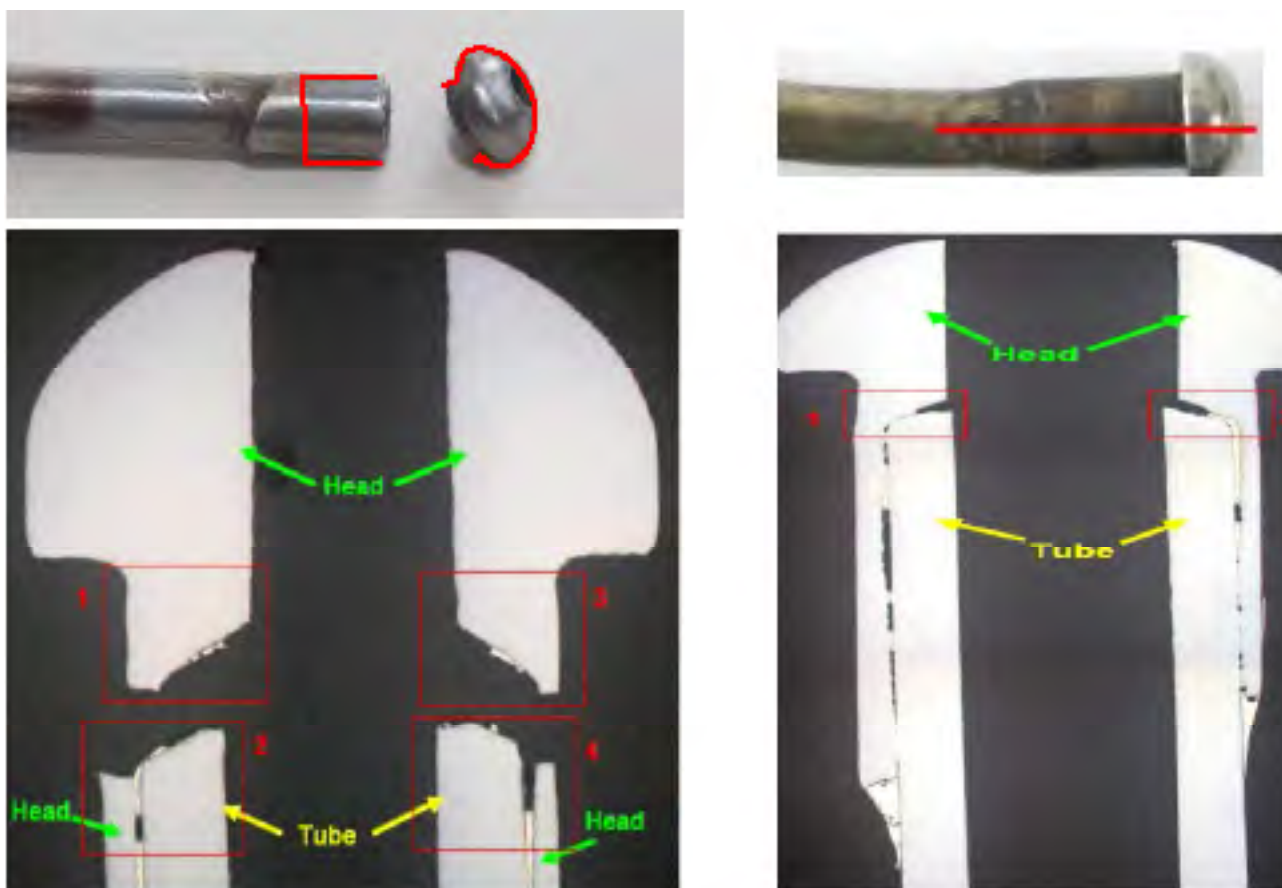
Figure 13. Longitudinal cross section of the fractured and non-fractured ends of line #3

Figure 13 shows the results of making a longitudinal cut at the fractured and non-fractured ends of line #3. These cross sections also exhibited a lack and irregularity of the filler material at the head-tube weld, as well as different dimensions.
