Report A-016/2019

Accident involving a Diamond Aircraft DA 40 D aircraft, registration G-RKAH, in the vicinity of the Huesca Airport (LEHC) on 10 April 2019.

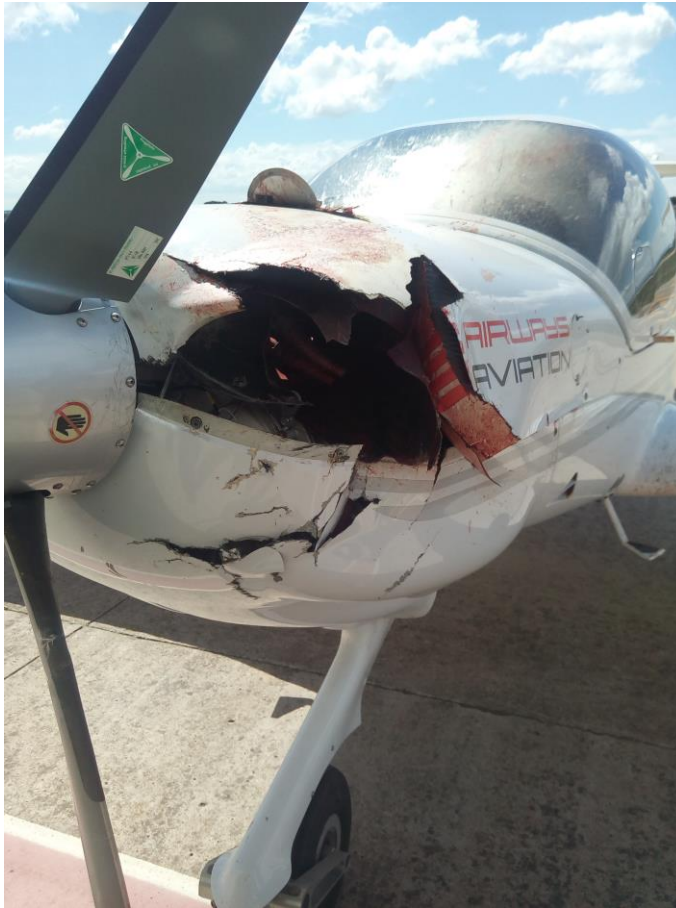
Fig. 1 Front view of the aircraft

Much of the front left part of the aircraft's nose was damaged.

Over the course of one of the maneuvers they were performing, the front left part of the aircraft impacted a vulture.

As a result of the bird strike, the aircraft sustained significant damage to its propeller, including the gearbox, the engine cover and the engine (engine mounts, radiators, accessories and connections).

The accident was caused by the head-on collision between a vulture and the aircraft.
