## Report A-016/2020

Accident involving a Piper  
PA-28R-200 aircraft, registration  
EC-HLV, at Casarrubios del  
Monte Aerodrome (Toledo)  
on 9 June 2020

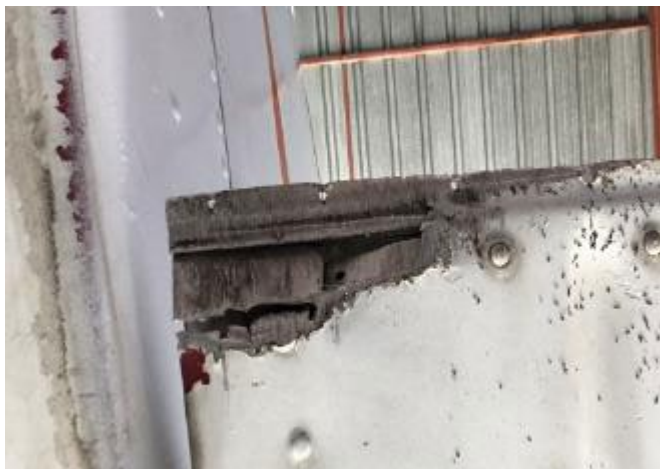
Photograph 8. Underside of the right flap

- Right wing: flap undeployed, underside damaged with missing material and scratches. The remaining surfaces, wingtip and aileron, were undamaged. The fuel tank on the right wing was three-quarters full.

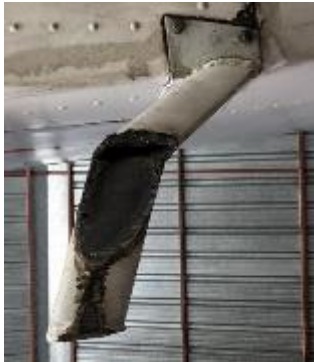
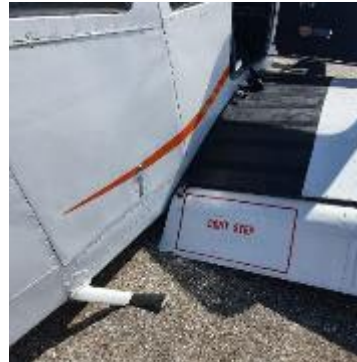
Left Photograph 9. Starboard - Right Photograph 10.  
Position of the right flap at the accident site

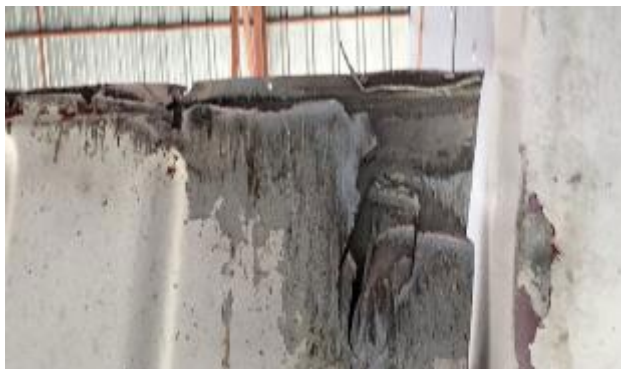
- Left wing: flap undeployed, scratches and missing material on the tip and the underside of its surface along one-third of its extension from the wing attachment point. The fuel tank on the left wing was half full.

Photograph 11. Damage to the left flap

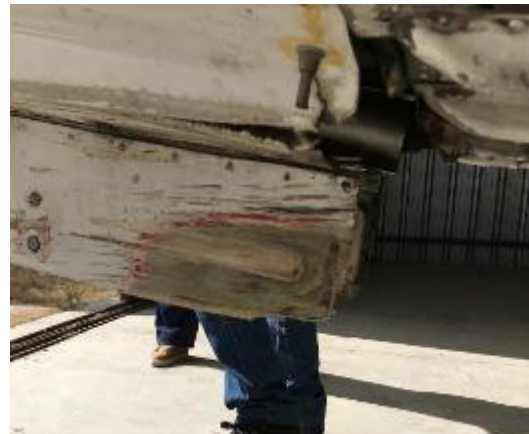
- Main landing gear: both legs and their tyres were in good condition, there were no scuff marks on the doors despite having landed gear-up, but the cockpit access step on the right side of the fuselage was severely damaged.
- Nose landing gear: The gear doors were scuffed, but no scuff marks were found on the leg or tyre.

Photograph 12. Nose landing gear door

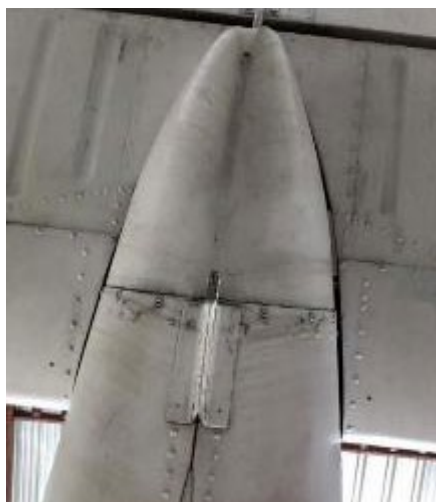
- Tail empennage: the tie-down ring under the tail displayed scuff marks to its underside.

Photograph 13. Damaged tie-down ring

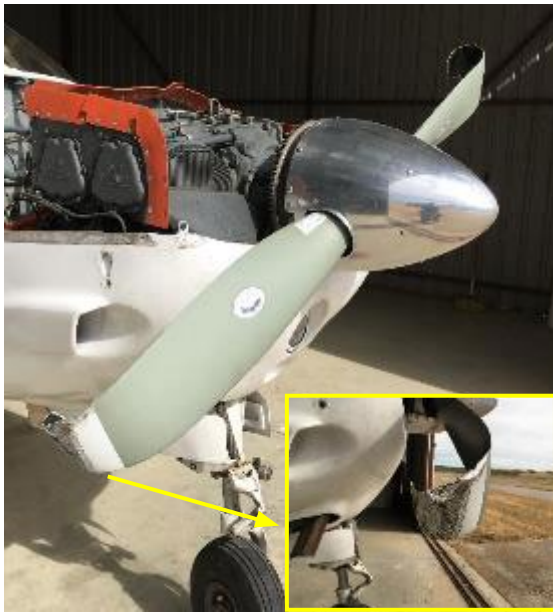
- Propeller: both blades were bent backwards.
- Cabin: The fuel selector was positioned for the right-hand fuel tank. The inspection confirmed that all the navigation, landing and anti-collision lights were working correctly, and the stall warning device was operational. The landing gear lever was in the "down" position.
- The anemometer read zero, as did the variometer.
- The altimeter was set to 1017 mbar marking an elevation of 1950 ft.

Photograph 14. Damaged propeller

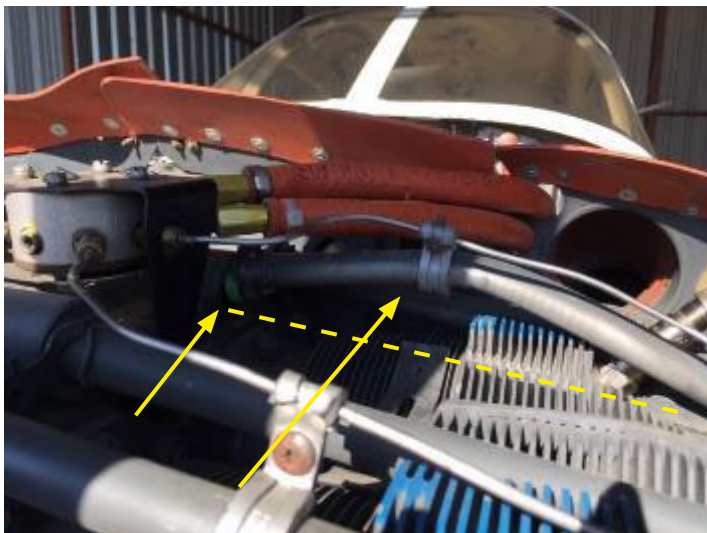
Photograph 16. Intake-valve guide tube damage

On opening the engine cowling, the guide tube for the actuator of one of the intake valves was found deformed and bent upwards, and it had almost worked its way out of its socket. However, there was no evidence of oil spillage in the area. A detailed inspection of the engine was subsequently carried out, disassembling its components to identify any internal damage.

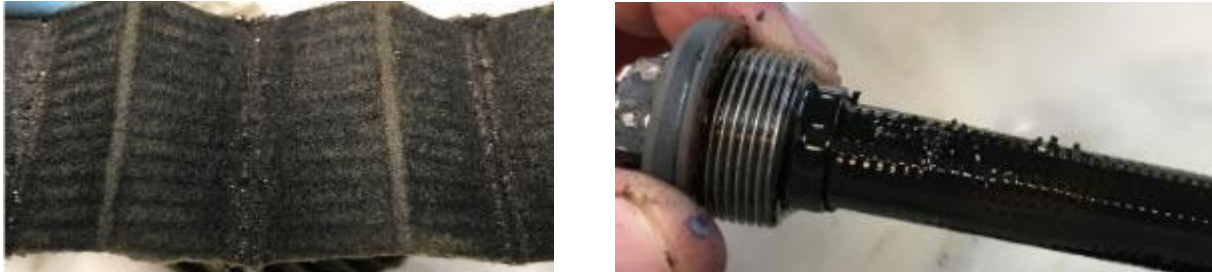
- Lubricating oil system: The oil level was above 6 US quarts. It was drained for subsequent analysis. It was almost black in colour, which is unusual after nine hours of operation. The oil filters were disassembled, revealing a large quantity of metallic and non-metallic particles inside.

Photograph 17. Presence of particles in the interior of the oil filters

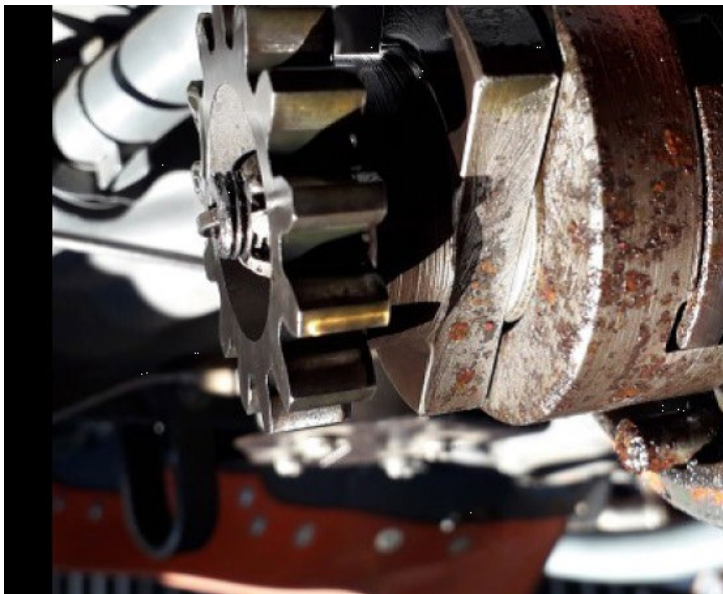
Photograph 18. Presence of corrosion in the left magneto

Both magnetos were disassembled. On closer inspection, it was revealed that the left magneto was unable to rotate freely due to the presence of severe corrosion around the flange, "impulse coupling", and the shaft-bearing, making it difficult to move by hand.

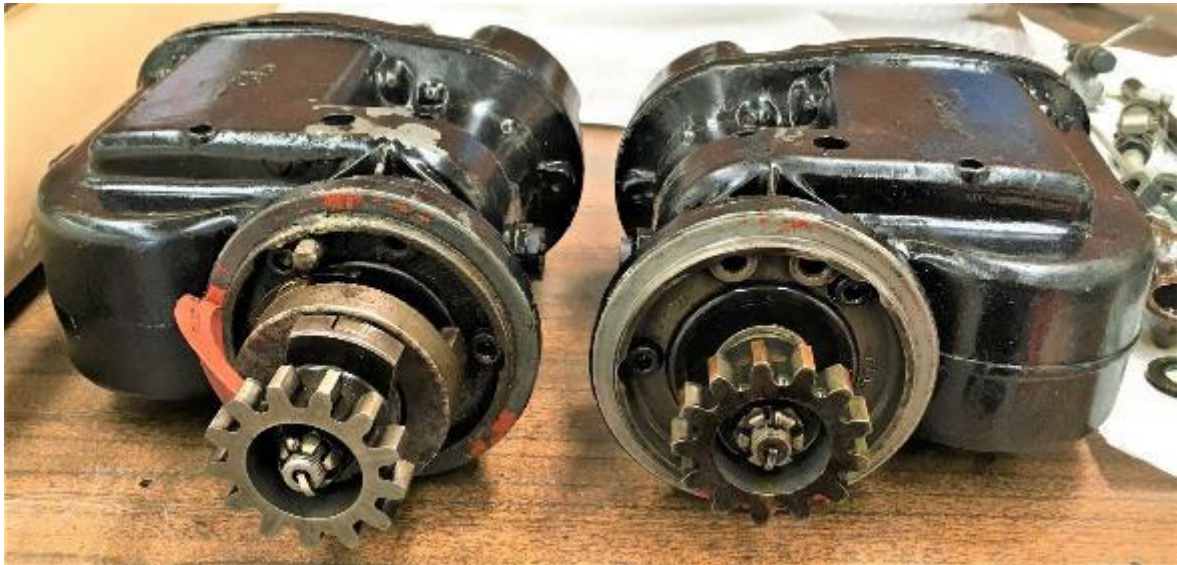
On checking the opening of the magneto contacts (“contact points”) they were found to be 0.006” on the left and 0.016” on the right. The AMM specifies 0.016”.

Photograph 19. Left and right magnetos

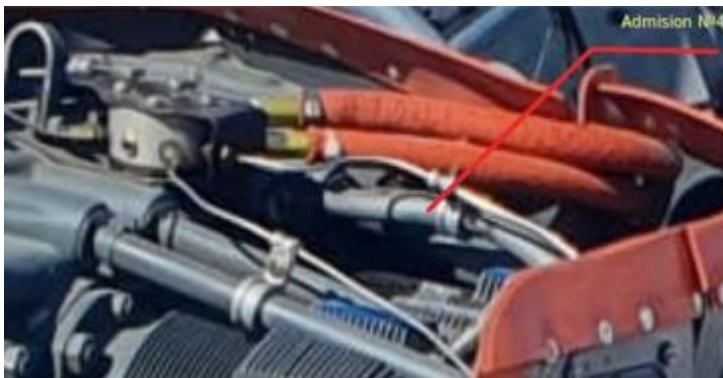
Photograph 20. Cylinder no. 4 intake valve guide

- In cylinder no. 4, the inspection found that the protective tube and pushrod of the intake valve were bent upwards about 10 cm above their normal position in the central area of the tube, and it had disconnected from its socket on the side of the oil sump, releasing the oil seal. Therefore, the decision was taken to remove cylinder 4.

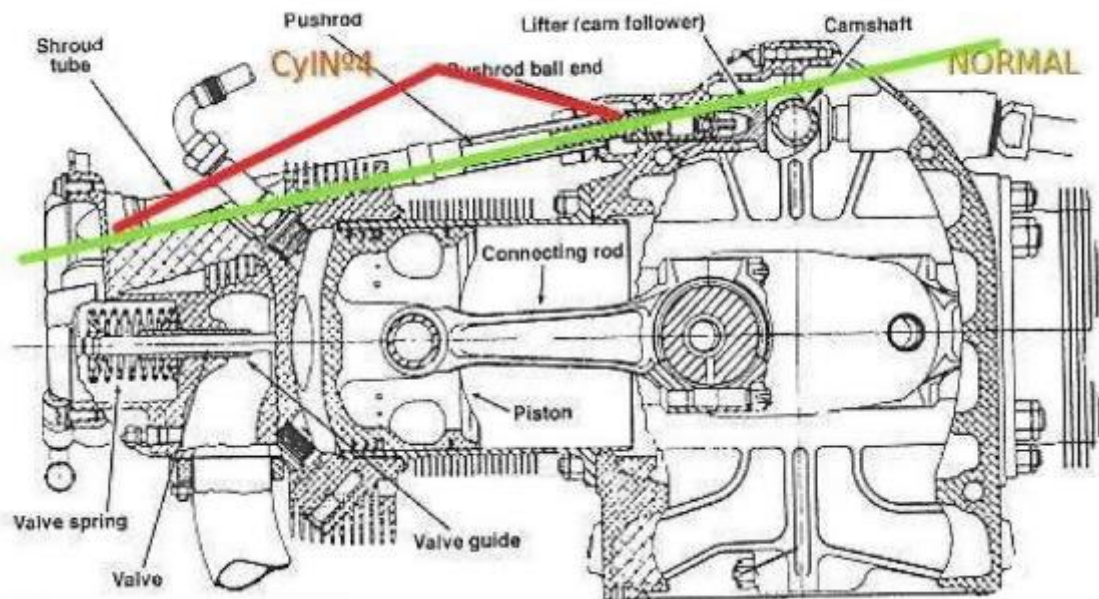
Figure 4. Diagram showing the deformation of the intake valve guide with respect to its normal position

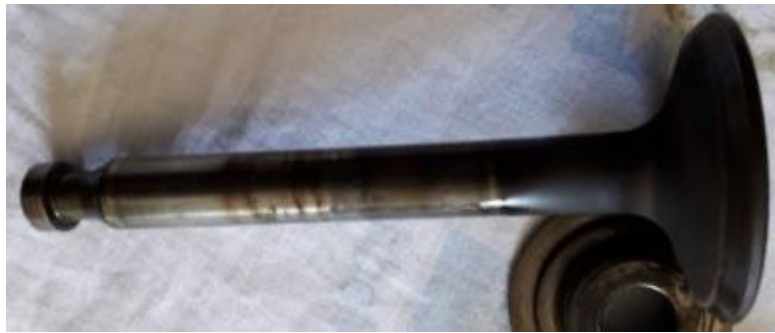
The exhaust valve had adequate movement and came out of its guide without difficulty, although there was evidence of surface corrosion and deposits on the rod and guide.

Photograph 24. Cylinder no. 4 exhaust valve

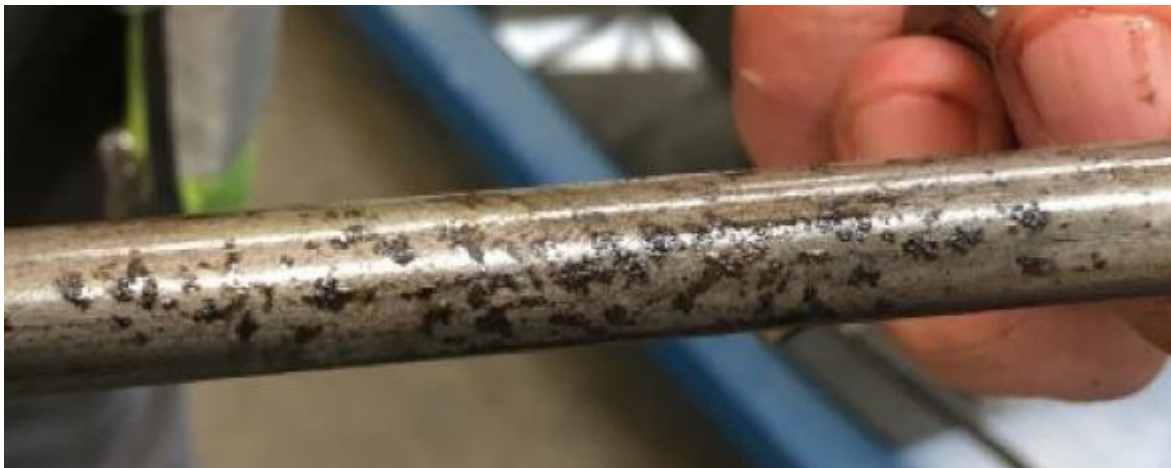
Photograph 25. Presence of oxidation in the valve rod

- In cylinders no 1, 2 and 3, the valves were moving correctly and the rods were straight, but there was evidence of deposits and superficial oxidation.

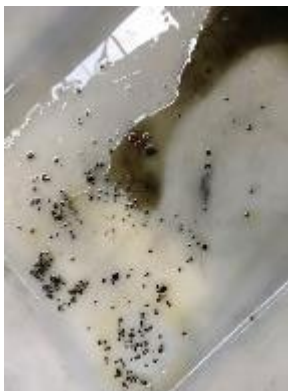
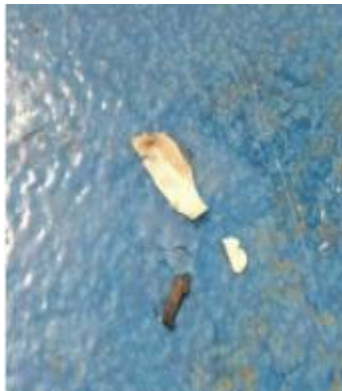
Photograph 26. Particles in the oil in the sump

- On disassembling the oil sump and accessory case, the oil was found to be predominantly black in colour, and contained a large number of particles of different materials. A large quantity of sludge had also accumulated in the bottom and corners of the sump.
- The holes through which the oil passes from the accessory case to the semi-sump had traces of silicone

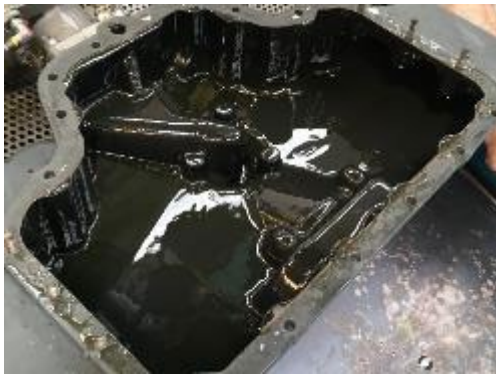
Photograph 27. Oil in the oil sump

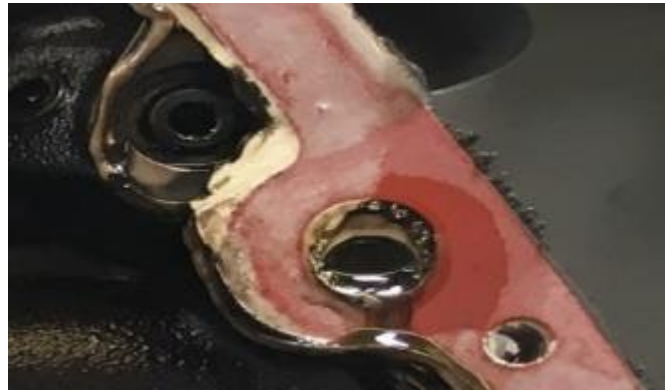
Photograph 28. Holes in the accessory case

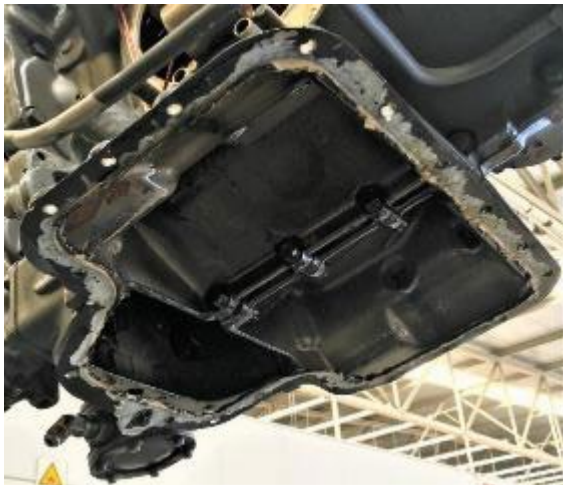
due to difficulties in using it correctly; extreme care must be taken with both its placement and subsequent cleaning. In fact, the engine manufacturer advises against it and suggests the use of alternative sealants.

Photograph 29. Sealant on the surfaces of the sump

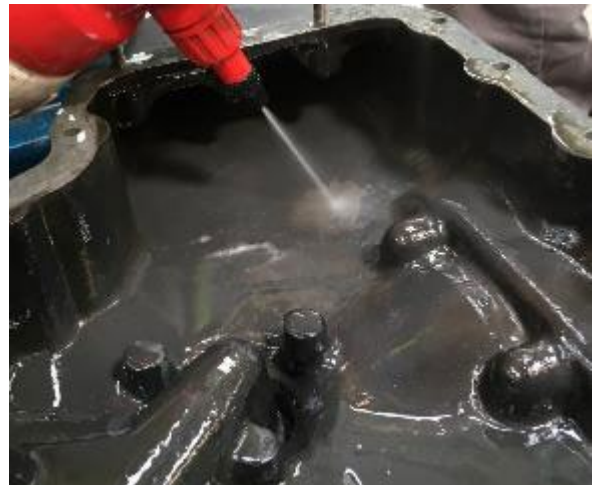
Photograph 30. Sludge and dirt in the sump

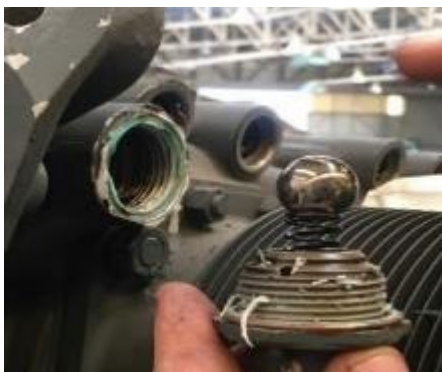
Photograph 31. Oil valve

- The seal and various sealants on the oil pressure regulating valve had deteriorated.
- The oil pump, which was in good condition, was also removed.
- The hydraulic tappets were removed with no significant observations.

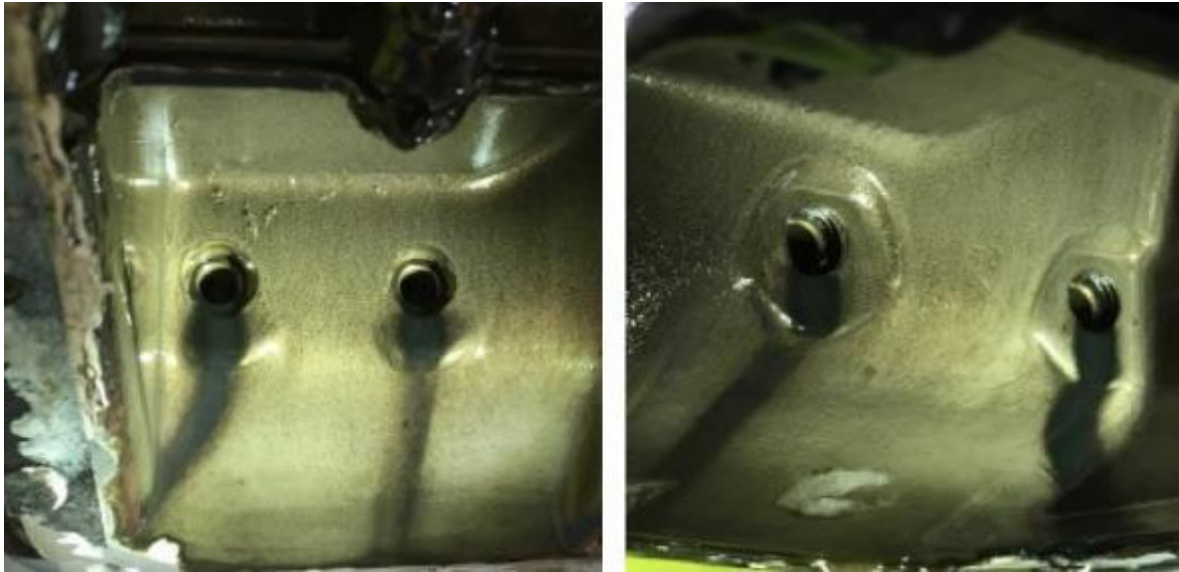
The oil returning from the cylinders to the sump had a charred appearance.

Photograph 32. Oil returning to the sump

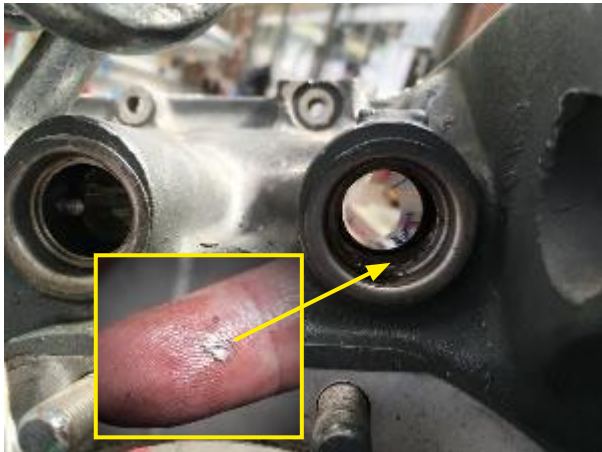
Photograph 33. Piece of silicone found in cam follower housing of cylinder 4

- Chunks of white silicone came out of the lubricating oil conduits in the cam follower housings of cylinder no. 4, as did other contaminating particles that were blocking the holes and dislodged when air was blown through them.
- Excess white silicone used as a sealant was observed in the joints of the semi-sumps.

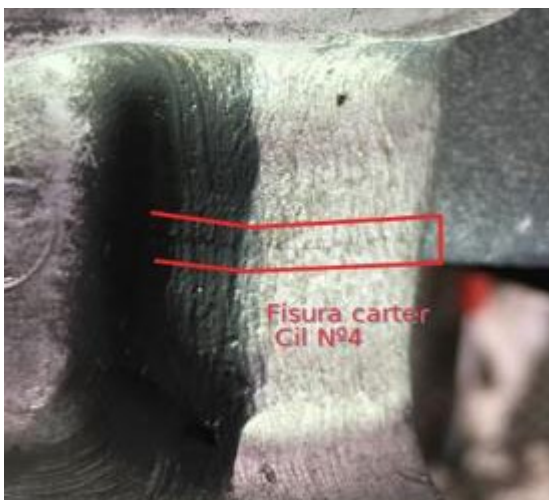
Photograph 35. Crack in cylinder no.4's oil sump

- A crack was also found in the oil sump

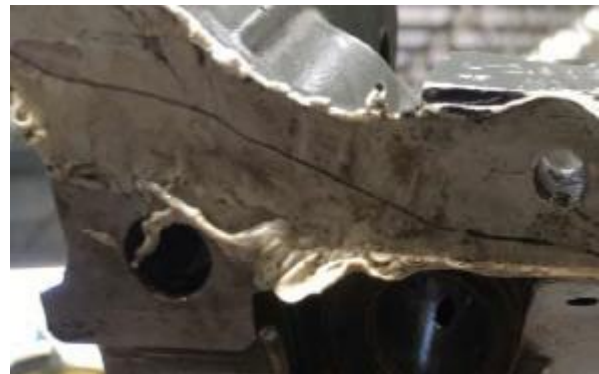
Photograph 34. Silicone in the joint of the semi-sump

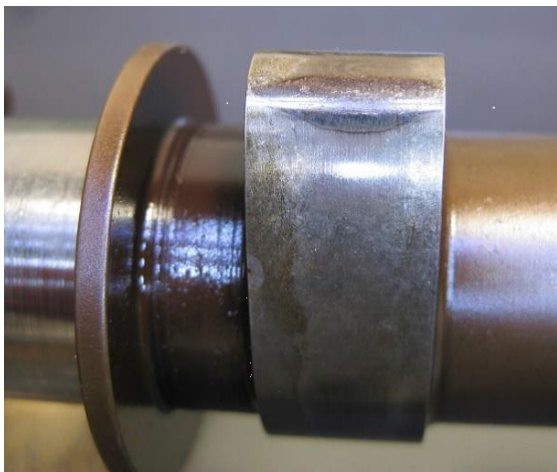
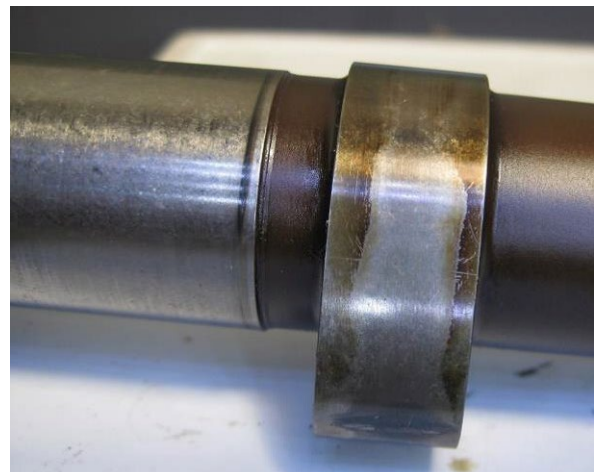
Photograph 36. Cam wear and tear

- The camshaft showed wear on the camshaft tips, rendering it unfit for service.
- Of the eight distribution pushrods and their eight tubes, three of the tubes had a different p/n to the number specified in the engine manufacturer's IPC for that model.
- The owner requested a pre-engine repair report from an EASA Part 145 approved facility. Following an NDT inspection, the report confirmed that the fuel pump piston p/n: 61544 was not in an acceptable condition.

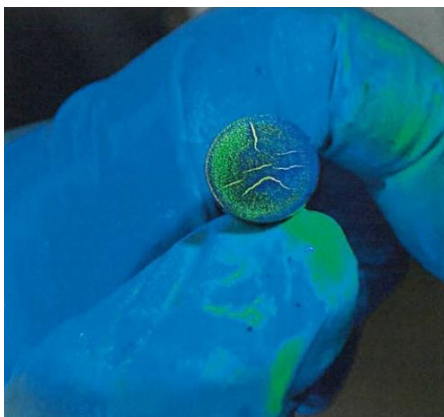
Photograph 37. Defects found on the piston with p/n 61544 following NDT

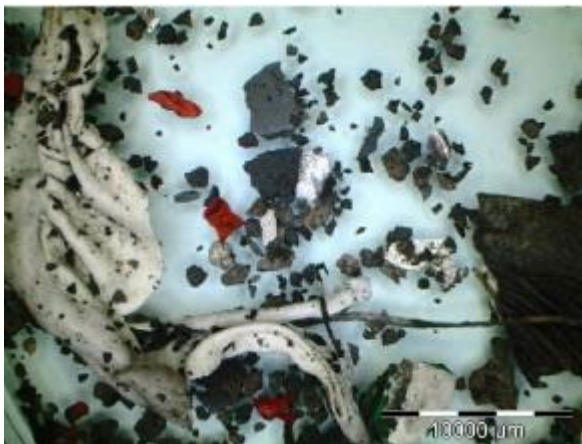
Photograph 38. Particle sample

large, white, soft and flexible particles and others with a polymeric/organic appearance in different colours: grey-brown, black, dark grey, white, orange and green. The sample also included some type of fibre or yarn, a black-stained felt paper, and large, shiny, metallic-looking particles.

was C, with titanium particles, probably from some type of colourant, also present in some cases). The black particles, some of which were porous, were particles of burned organic material, while the white elastic particles were identified as some type of silicone.

The most abundant particles were grey-brown in colour and composed mainly of lead, bromine and aluminium, in that order. Three types of shiny metallic particles were identified: the most abundant large particles were unalloyed iron particles. Large particles of aluminium and smaller copper particles were also found.
