Technical report

A-017/2021

Accident on 18 May 2021 involving a SPEED
2002 aircraft, registration EC-XIE, in
Torremocha de Jiloca (Teruel, Spain)

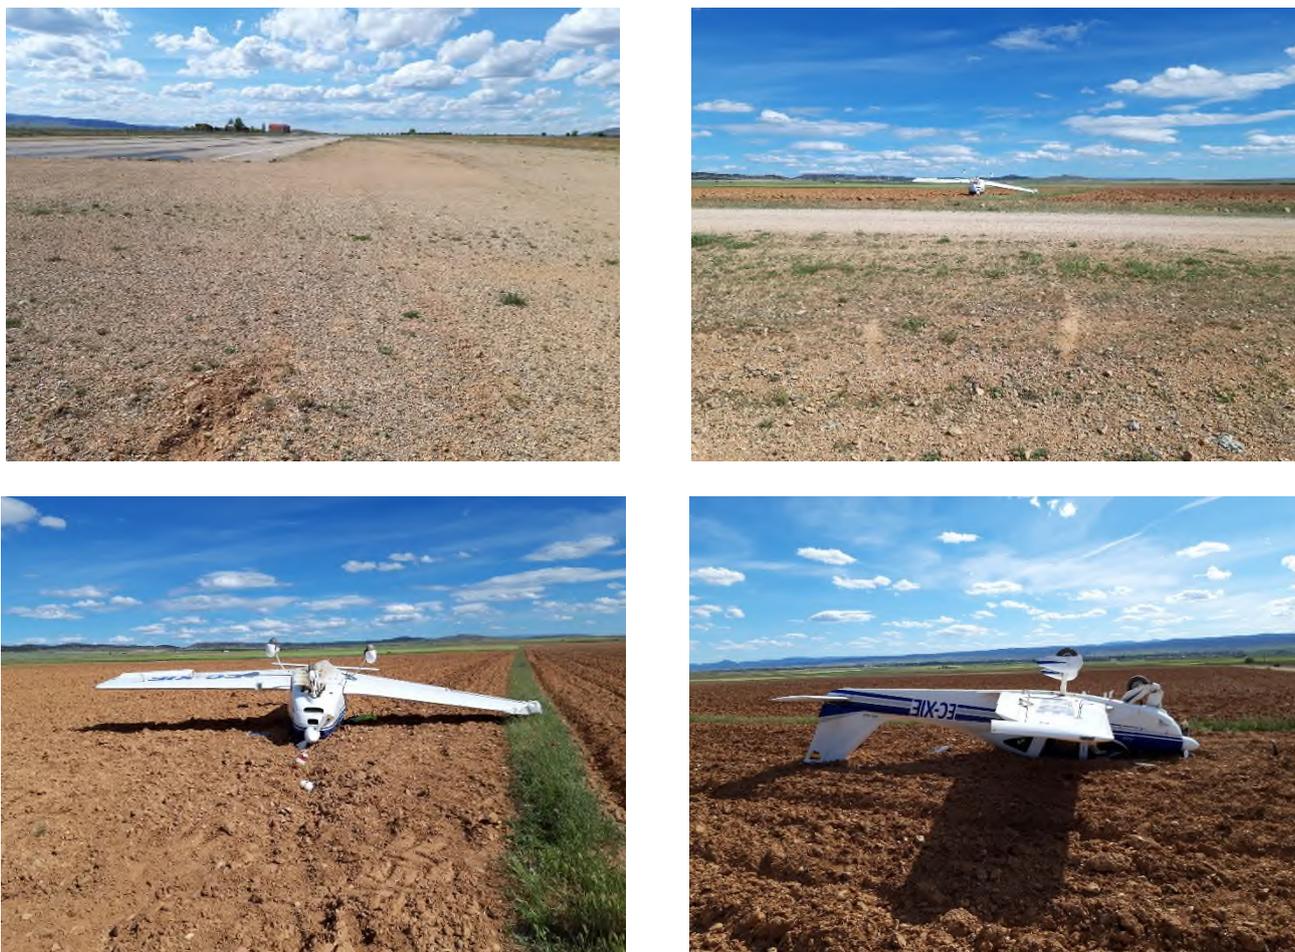
FIG. 6 TRACKS AND FINAL POSITION OF THE AIRCRAFT

The aircraft's approximate distance from the end of the runway was 50 m in a direction parallel to the runway centreline. The distance from the aircraft to the extension of the runway centreline was 21 m.

About 30 m from the end of the runway, a slight slope rises to a dirt road about 7 m wide. On the other side of the road, another slight slope bridges the upward gradient to the farmed field.

Given that there were no signs of wheel wear or marks on the runway, there was no evidence of heavy braking.

During the inspection carried out by the Civil Guard on the day of the accident, two tracks were observed on the unpaved ground to the left of the runway and about 28 m before its end, which is where the aircraft likely veered off the asphalt.

They observed tracks in the terrain on the slope between the road and the field.

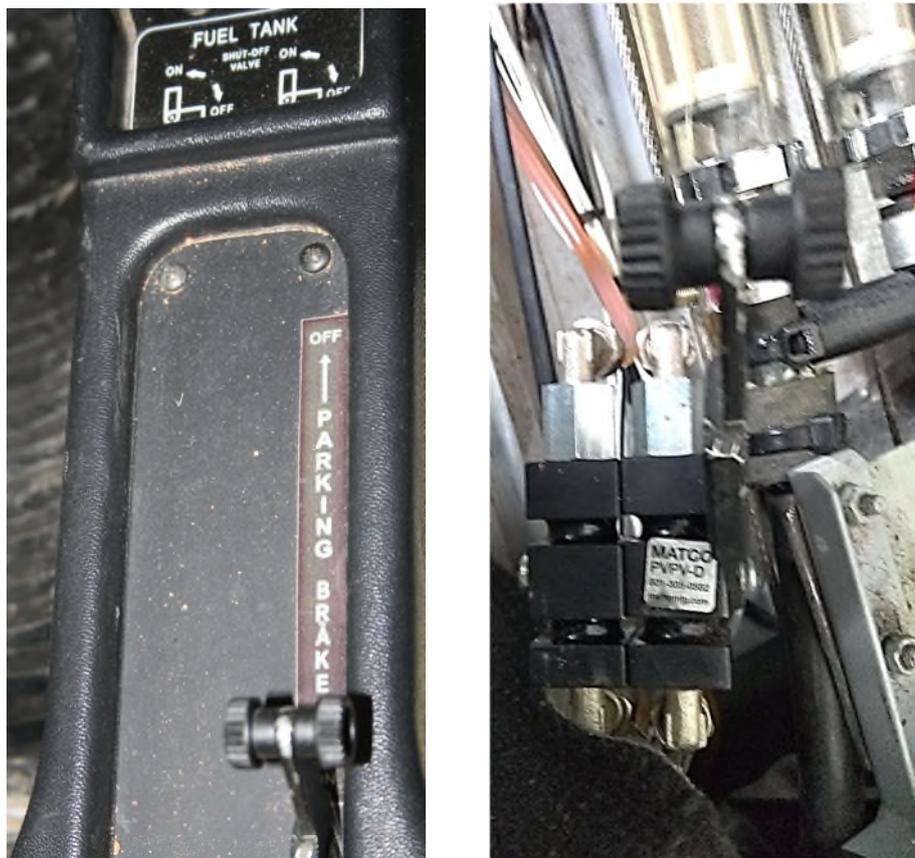
FIG. 7 PARKING BRAKE VALVE

The fact that the brakes failed on both sides of the landing gear pointed towards the involvement of the brake valve, which is common to both sides. As a result, it was disassembled, and its interior was inspected. The seal assemblies were in good condition and no leaks were found.

The following pictures show the valve installed in the EC-XIE aircraft. The photograph on the left shows that the lever has to be pushed forward to put the valve in the OFF position. To put it in the ON position, the lever has to be pulled back.

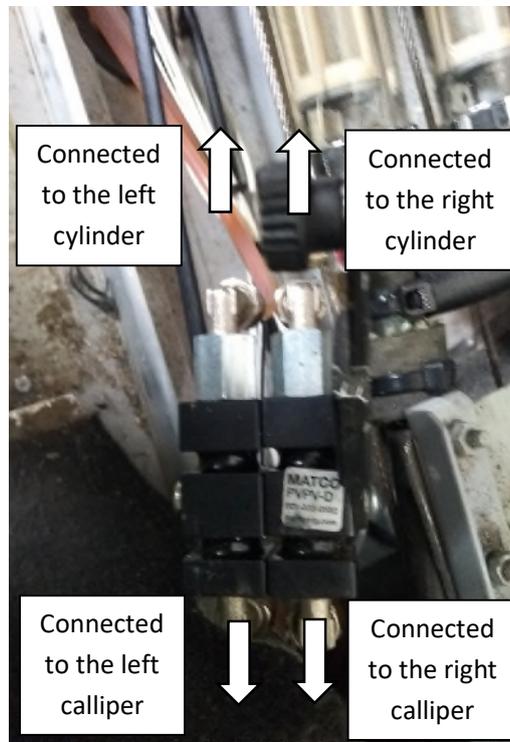
FIG. 8 OVERVIEW OF THE PARKING BRAKE VALVE INSTALLATION

In this photograph, you can see that the adapters with item number 6 in the manufacturer's exploded view (fitting, adapter) are attached to the lines coming from the cylinders.

Having reviewed the manufacturer's information on installing the parking brake valve (sections 1.6.6 and 5.1) and the information gathered from the inspection of the brake system on the EC-XIE aircraft (section 1.16.1), the investigation has found that the valve was installed in the opposite direction to that indicated by the manufacturer in figure 11.

The incorrect installation of the parking brake valve is considered a latent failure which became apparent when the possible inadvertent activation of the parking brake lever in flight and an excessive landing speed combined to precipitate the accident.

The investigation has revealed that the accident was caused by the faulty installation of the parking brake valve, which prevented the pressure exerted on the pedals from reaching the brakes.

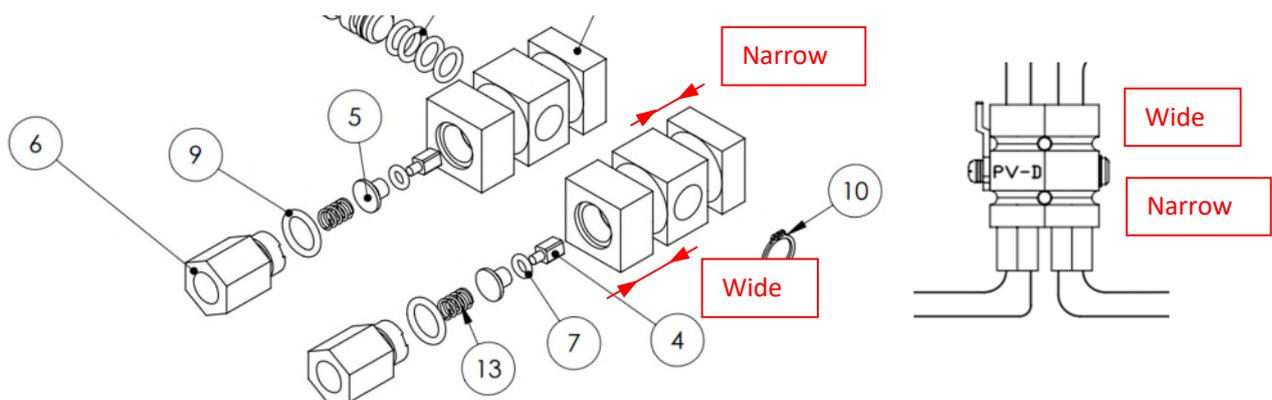
FIG. 9 EXPLODED VIEW AND INSTALLATION OF THE VALVE

In the manufacturer's exploded view of the parking brake valve, which can be found in the appendix, the hexagonal adapters with item number 6 in the manufacturer's exploded view (fitting, adapter) are connected to the wide part of the valve body; however, in the installation diagram provided by the manufacturer (figure 11), they are connected to the narrow part. This is shown in the diagrams below:

As detailed in 1.18.5, the investigation detected a contradiction between the exploded view of the parking brake valve and the installation diagram provided by the manufacturer (figures 10 and 11 in the appendix). This conflicting information could lead to confusion during the installation process; therefore, a safety recommendation is issued in this respect.

REC 33/22. It is recommended that MATCO mfg, as the manufacturer of the parking brake valve, correct any contradictory installation instructions to prevent confusion during installation.

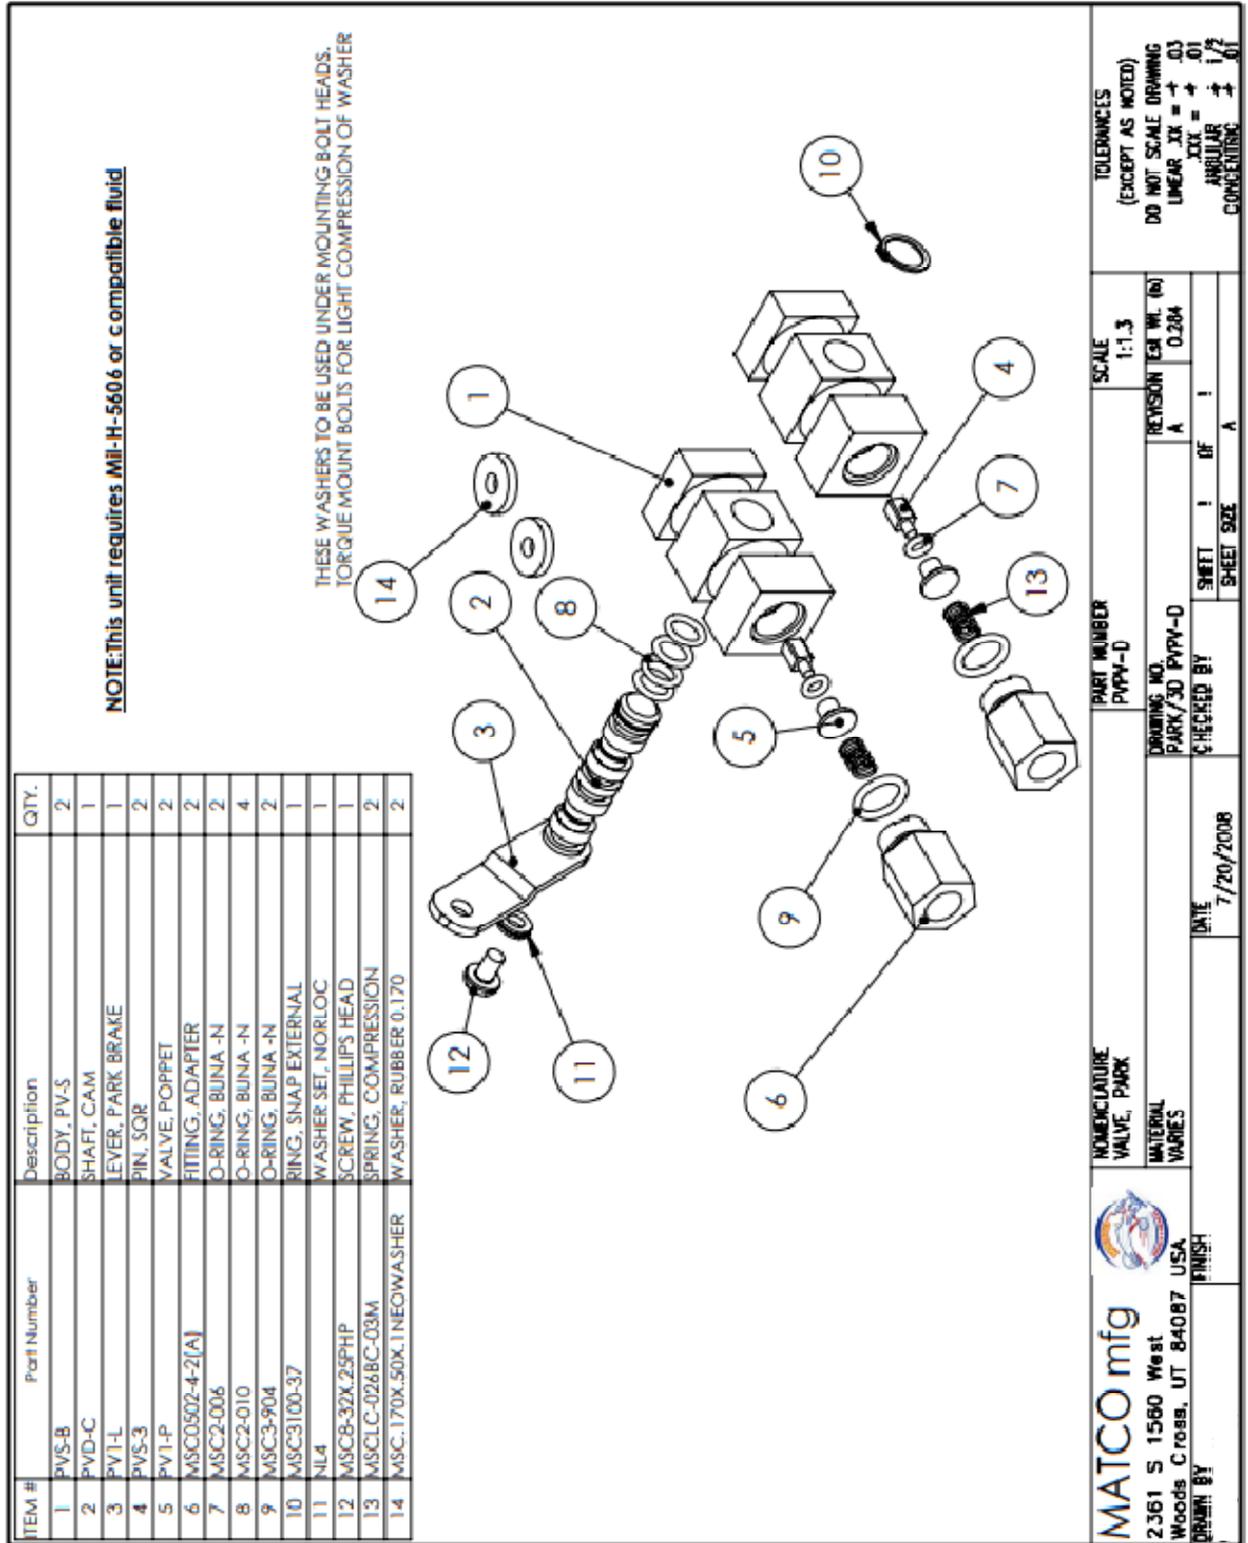
FIG. 10 EXPLODED VIEW OF THE VALVE MATCO PVPV-D

It should be noted that, in the installation guide provided by the manufacturer, which can be seen in figure 11 in the appendix, the adapters with item number 6 in the exploded view (fitting, adapter) in figure 10, are attached to the fluid lines leading to the brake callipers on each wheel.

REC 32/22. It is recommended that MATCO mfg, as the manufacturer of the parking brake valve, add a permanent marking to the body of the valve to help prevent confusion during installation.
