**COMISIÓN DE
INVESTIGACIÓN
DE ACCIDENTES
E INCIDENTES DE
AVIACIÓN CIVIL**

Report A-022/2018

Accident involving an Air Tractor
AT-802 aircraft, registration
EC-GVN, operated by Martínez
Ridao Aviación S.L, in the
Mediterranean Sea near the
municipality of Pollença
(Mallorca-Spain) on 12 June 2018

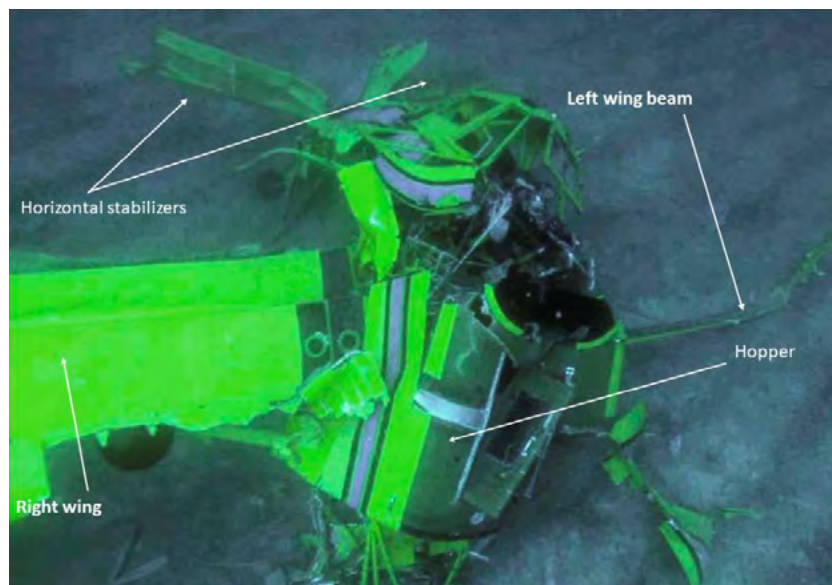
Figure 2: Front view of the aircraft

The aircraft was heavily deformed, and as the above figures show, its tubular structure broke, dividing the aircraft into two sections, see Figure 3. The front section included the hopper, wing and engine. The rear section consisted of the cockpit and the rest of the airframe up to the tail.

The left wing only contained the main spar, and the right wing had lost various parts (flaps, leading edge, etc.). The pedals were visible in the cockpit, which was sheared at the control panel. The left side of the cockpit was crushed. The underside of the tailcone showed a significant impact. The horizontal stabilizers were bent upward, the bracing had detached and the right elevator had detached from its actuating shaft.

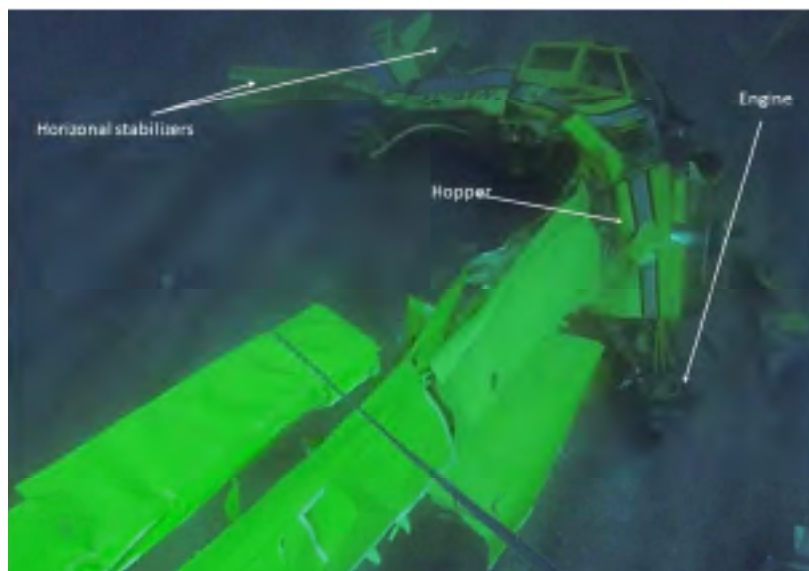
Figure 3: View of aircraft from front right quarter

Other damage found, such as the detachment of the front of the airframe, behind the hopper, is explained by the distribution of loads along the hopper itself. The damage in the tail section, with the horizontal stabilizer bent upward and the right elevator dislodging from its shaft, is all the result of the impact with the water.

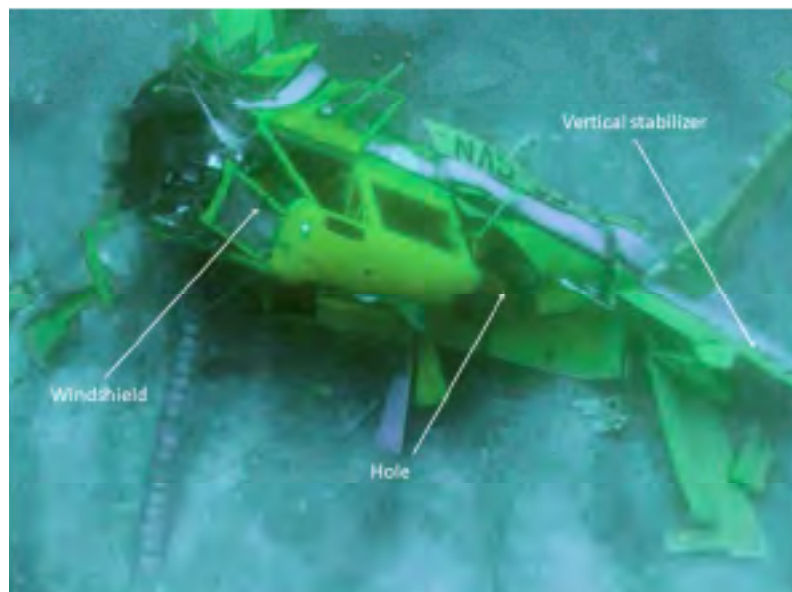
Figure 4: Overhead view of the aircraft

Located around the main wreckage were the propeller, with two of the five blades whole and attached to the pitch mechanism, part of the flap surfaces and the elevator, as well as various fragments of the wing and fuselage skin.

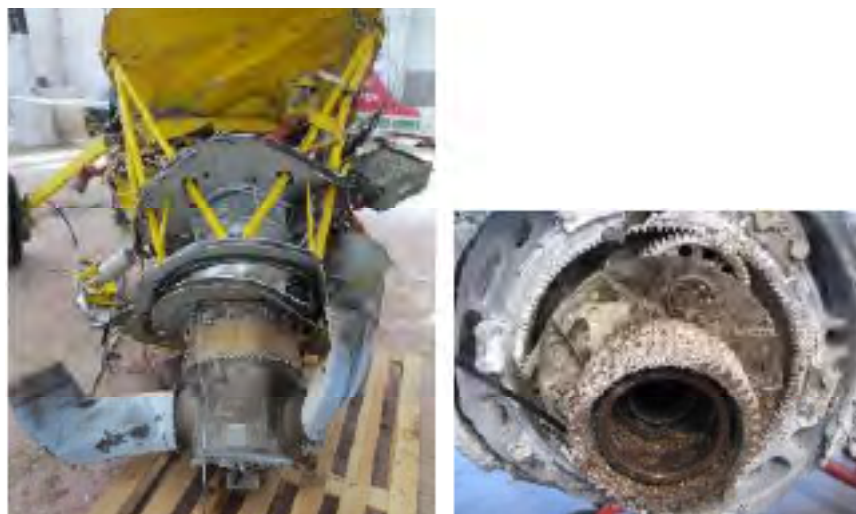
Figure 5: Overview of the engine and propeller gearbox

The wreckage was lifted from the seabed on 17 June. Fractures surfaces had undergone moderate corrosion, although the paint protected the remaining surfaces from rusting. Figure 5 shows the damage to the front of the aircraft, where the engine is located. There was an impact mark on the bottom left that directly affected the exhaust gas nozzle on that side, the engine mount and the partition that separates the engine from the hopper. The propeller detached, along with the second stage of the gearbox. At least two of the five propeller blades were distinguishable and had not detached.

The external inspection of the engine showed that the first stage of the propeller gearbox and the accessory group exhibited the effects of salt water corrosion.

The fracture in the gearbox revealed that the bottom of the exhaust duct was bent inward all the way to the gas generator and inside the engine. The cover that spans the combustion section did not exhibit any significant damage.

The absence of significant damage at the gas generator intake and the gas exhaust suggest that the engine was not operating at high power. The bent blade at the compressor inlet also indicates that the engine was turning when it went into the water. In short, it was concluded that the engine was running, albeit at low power, when the aircraft impacted the water.

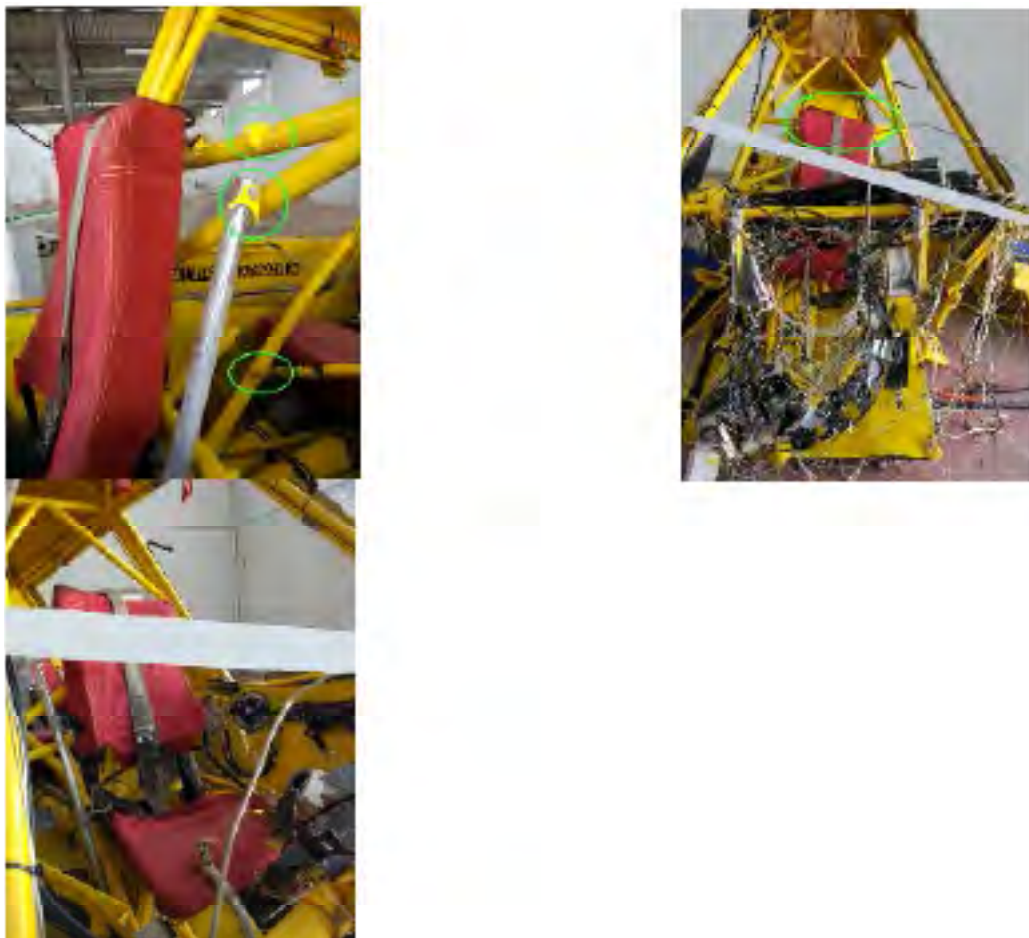
Figure 6: Cockpit of the aircraft

Inside the cockpit, the tubular structure that attaches the seat to the frame was in its position, but some joints had yielded (green circles in Figure 6). The seat had sunk to the left and the seatback was leaning forward. The retention system had kept the pilot in his seat, and the harness was fastened when the pilot's body was retrieved.

Figure 6 shows various views of the cockpit, seat and safety harness.

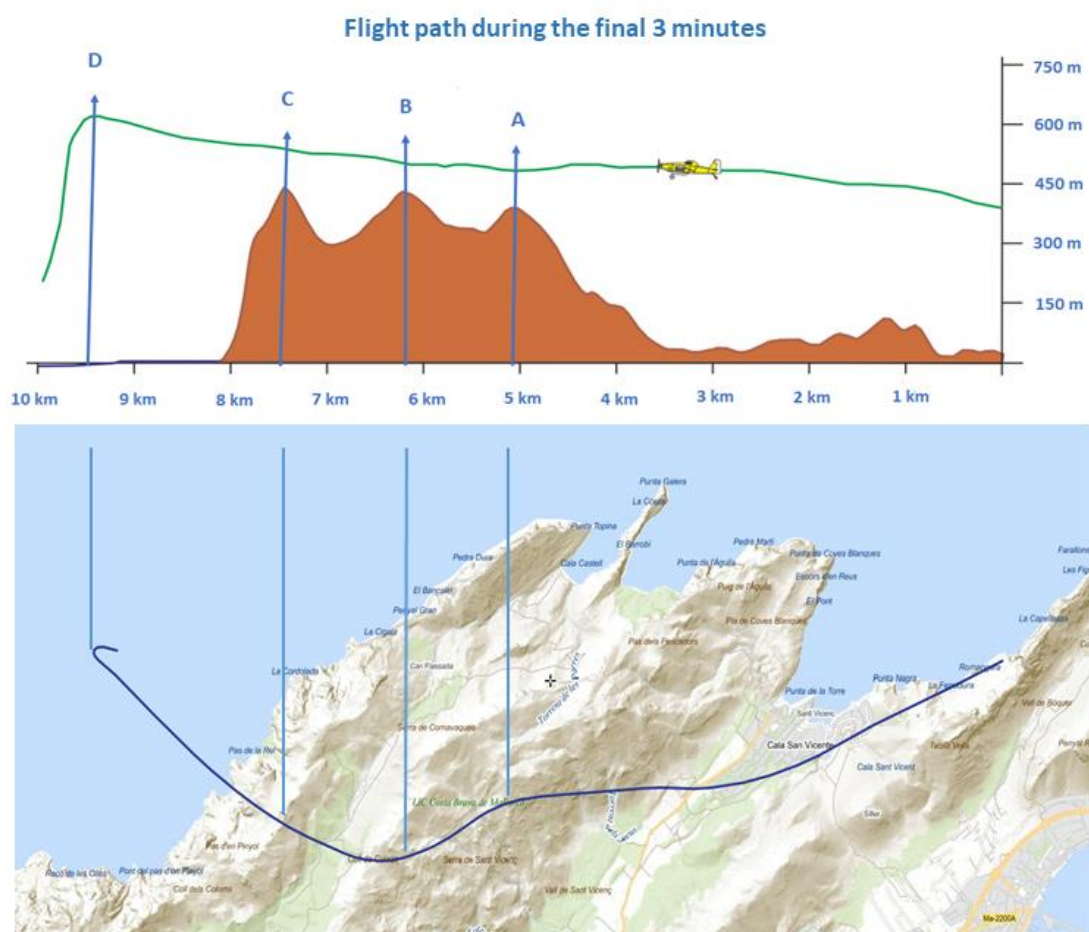
Figure 9 : Profile and plan views of the aircraft's flight path during the final 3 minutes

This last part of the flight, as shown in Figure 9, lasted about 3 minutes. The aircraft climbed gradually and constantly, to an altitude of 530 m above ground level before going over the coastline. It then continued its gradual climb over the sea on a heading of 307°, at which point the aircraft began to descend while turning to its right. The known GPS data were used to make the table below, where each row corresponds to the readings provided each second by the GPS unit:

As for how the final segment evolved, initially there was a gradual descent while maintaining the same course. This was followed by a sharp, coordinated turn to the right that caused the aircraft to descend 386 m (1266 ft) in 12 seconds, at which time the GPS readings stopped, 226 m (741 ft) above the water. As analyzed in Section 2.4, this action is consistent with the execution of an aggressive maneuver in which the control stick is pushed forward in coordination with a steep roll to the right. The final maneuver levels the wings while lowering the descent rate.

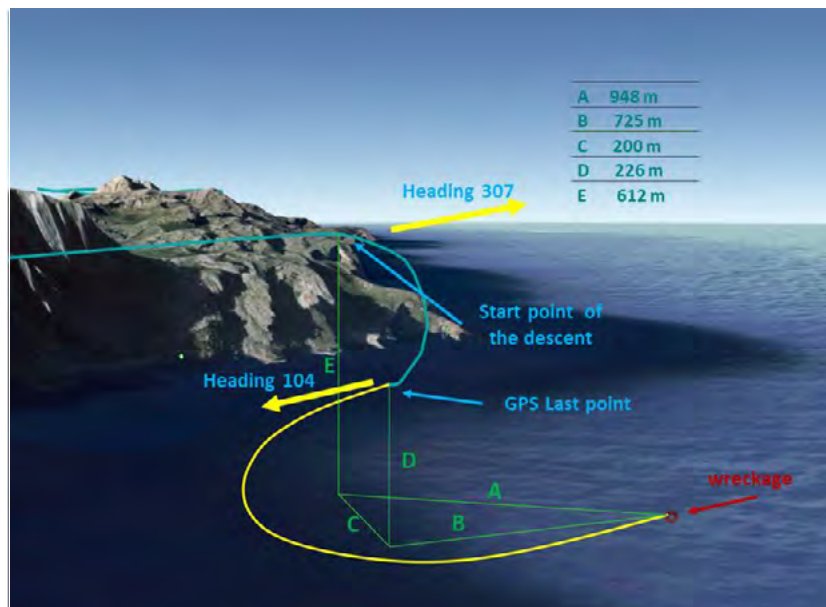
Figure 15: Flight path over the water

Similarly, Figure 15 shows an approximation of the final flight path, again using the data in the table. The flight path obtained from the GPS is shown in blue, and in yellow one possible flight path it might have taken until impacting the water, assuming currents did not move the wreckage as it sank.

Finally, Figure 15 shows one of the possible flight paths, in yellow, that would link the last GPS reading with the position where the wreckage was found. This part of the flight path is achieved after making a left turn, resulting in a more or less circular flight path that cannot be accurately determined.

The setting for this final segment of the flight is as described in Figure 15. It started after the aircraft had leveled off and was descending with a Y value of approximately -33.4°. Based on the condition of the wreckage, it seems that the aircraft impacted the water with a slight left roll angle and the engine at a power below that needed to resume climbing.
