# Technical report

## A-023/2021

Accident on 02 June 2021, involving a SCHLEICHER ASK 21 aircraft, registration EC-JEQ, in the municipality of Sabiñánigo (Huesca).

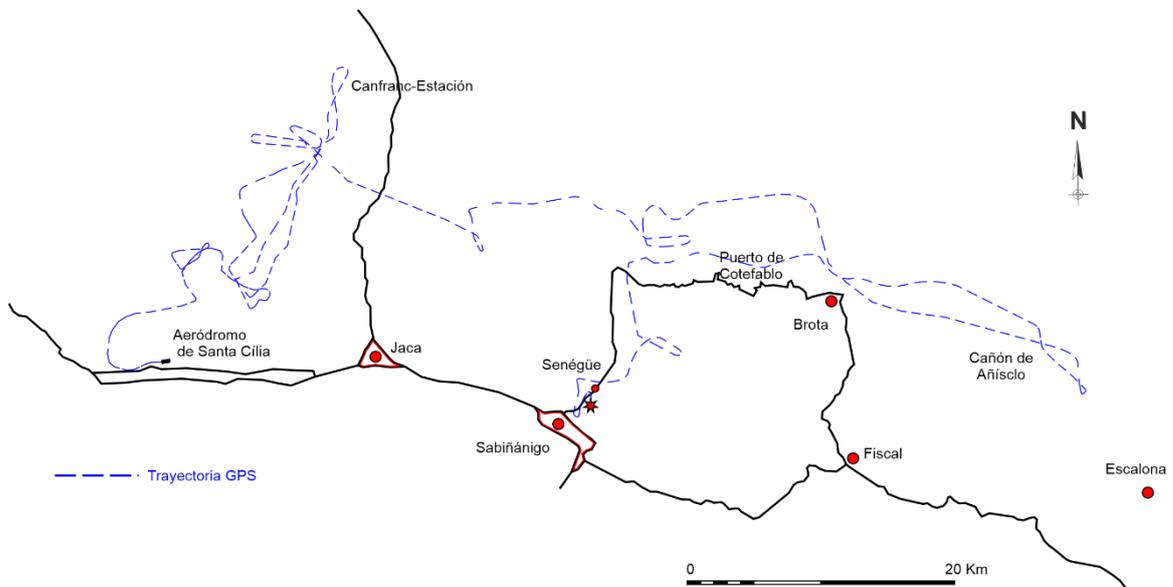
**Fig. no. 2 - GPS Trajectory**

The recorded data shows that the aircraft took off at 13:03 h from Sta. Cilia Aerodrome, located at 679 m of altitude, and released at 13:06 h at 923 m of altitude. From this point on, it made continuous manoeuvres to gain altitude, first on a northerly and then easterly course. The furthest point reached was the Añisclo canyon, located some 68 km east of the starting point. During the return leg, about 9 km beyond the Cotefablo pass, the aircraft turned south to land in an agricultural field south of the town of Senegüe in the Sabiñánigo area.

The aircraft gained 1,815 m of altitude during the flight, reaching the highest point at 15:55 h. The landing took place at 17:09 h at 793 m of altitude. The flight duration was 4 h and 5 min.

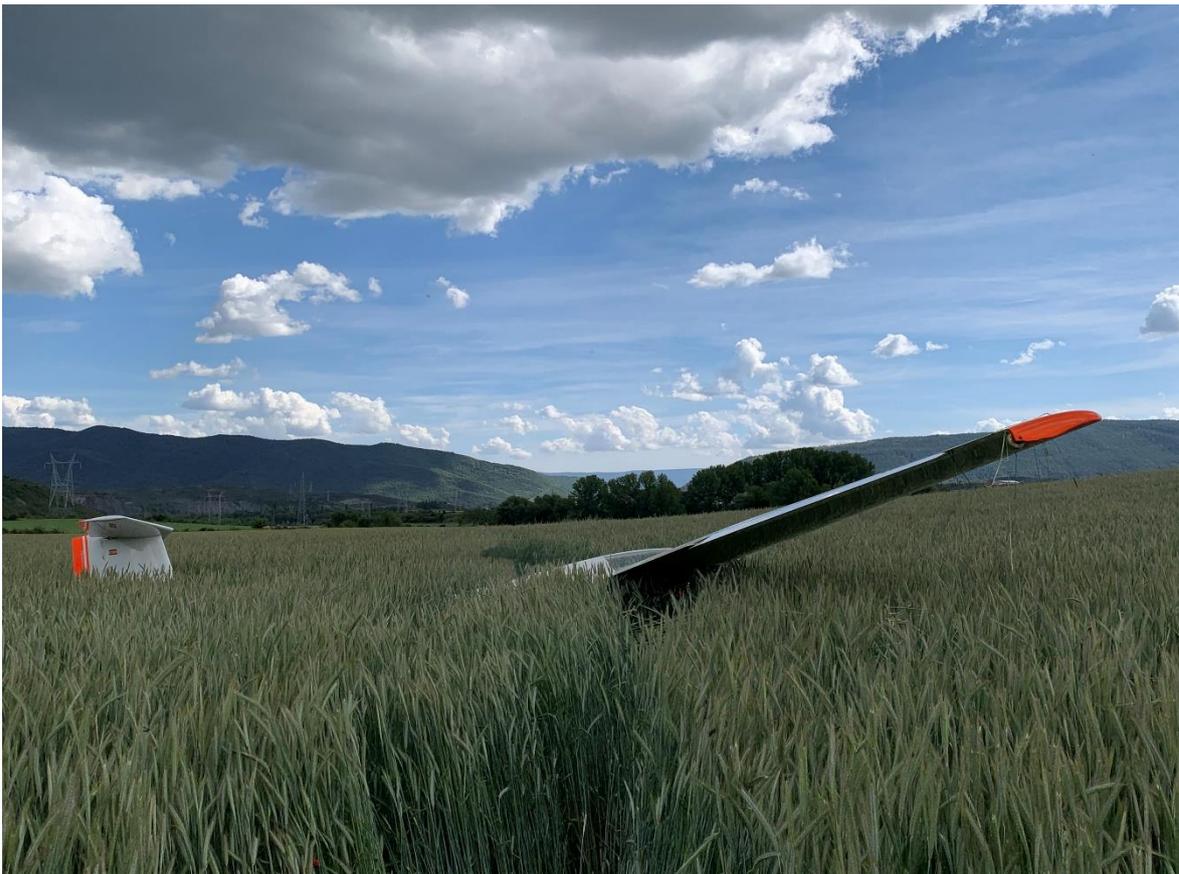
*Fig. no. 1 - Aircraft in its final position*

The aircraft landed in a field planted with a cereal crop; on hitting the crop, it made a sharp right turn and came to a sudden stop.

The aircraft did not sustain any damage.

The first part of the aircraft to hit the grain was the underside of its right wing, which produced a sharp turn to the right.

The cause of the accident was the performance of an emergency off-field landing in a field planted with a tall cereal crop.
