# Technical report

## A-024/2021

Accident on 14 June 2021 involving a Flight Design CTLS-LSA aircraft, registration D-EPAB, at Herrera de Pisuergra Aerodrome (Palencia, Spain)

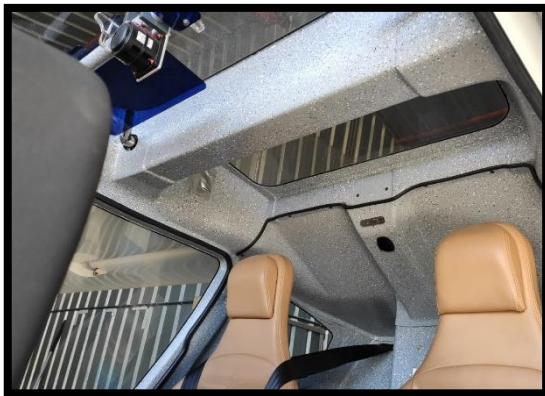
Figure 1 – Cabin (1)

Lastly, a central beam crosses the cabin from one side to the other.

Although the pilot was wearing his safety harness when the aircraft flipped over, he hit his head against the beam in the upper part of the cockpit (see figures 1 and 2). The pilot unbuckled his safety harness, secured the aircraft and exited through one of the side windows (which had smashed when the aircraft overturned, as had the windscreen). He sustained minor injuries from the blow to his head.

As shown in Figures 1 and 2, a structural beam runs across the roof of the aircraft's cockpit from one side to the other. Although this beam prevented the cockpit from suffering any structural deformities during the accident, the pilot hit his head on it when the aircraft overturned, even though he was wearing his safety harness.

In his interview, the pilot explained that when he configures the cockpit seat to suit his height, the resulting position causes the top of his headset to hit the beam, or, if he is not wearing a headset, his head almost touches the beam.

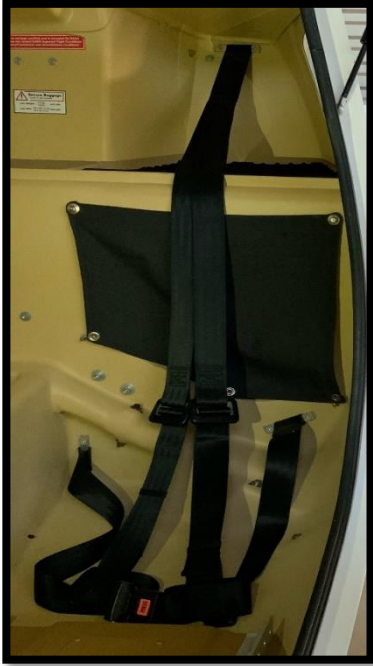
*Figure 3 - Safety harness on the accident aircraft*

According to the information provided by the pilot, the accident aircraft was equipped with the original safety harnesses at the time of the accident. The harnesses, which are anchored to the aircraft in three places, restrain the occupant with shoulder and waist straps, as shown in the following photograph:

The harnesses in the aircraft are the original factory fitted safety harnesses. The pilot indicated that they come loose easily in flight.

It is possible the pilot may have been focusing on other aspects (such as the presence of a storm and the runway conditions) and forgot the "before landing" checklist item that specifies tightening the safety harness (see 1.6.4.1). If the safety harness was not sufficiently tightened when the aircraft flipped over, the slack would have allowed the pilot's body to shift and his head to hit the beam.

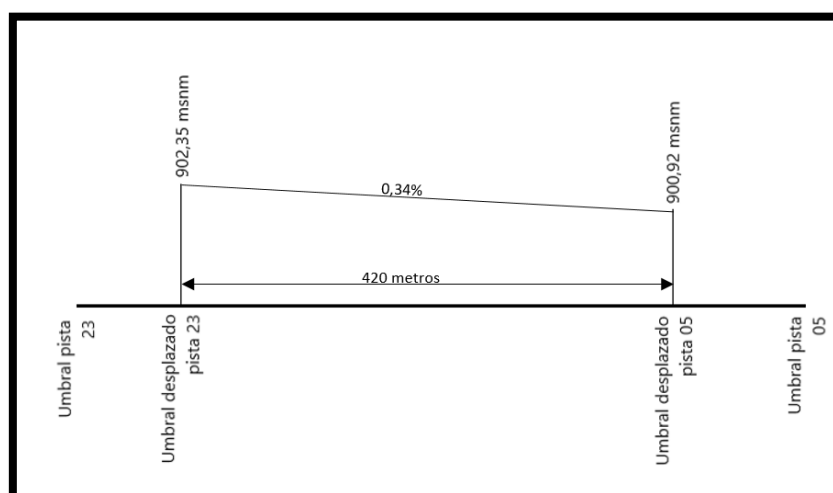
Figure 5 - Longitudinal sketch of runway 05/23 at Herrera de Pisuergra Aerodrome.

The previous table shows that runway 23 has a slight negative slope:

Based on the foregoing, it is believed that two factors prevented the pilot from being able to brake the aircraft sufficiently within the confines of the runway: firstly, the fact that it approached at a slightly higher speed than recommended in the POH (5 kt) for flaps at 15°, and secondly, the fact that the grass runway was wet (even waterlogged in some places) and had a slight negative slope.

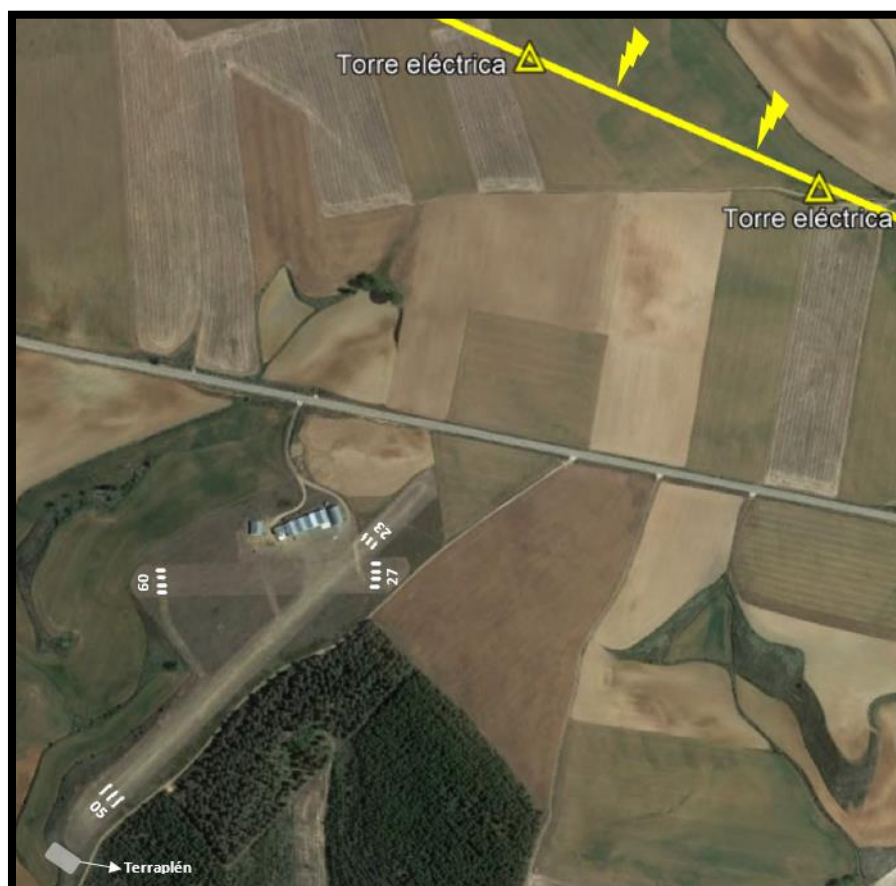
Figure 6 - Satellite image of Herrera de Pisuergra Aerodrome.

Next to the extremity of runway 05, a slight embankment slopes down to farmland.

The existence of a high-voltage power line located approximately 650 metres from the head of runway 23 should also be noted.

**REC 13/22:** In order to increase the visibility of the existing power line under the approach obstacle limitation surface for runway 23 and the take-off climb obstacle limitation surface for runway 05, it is recommended that the manager of Herrera de Pisuega Aerodrome liaise with the owner of the power line to mark the cables with spherical markers, beacons or similar.

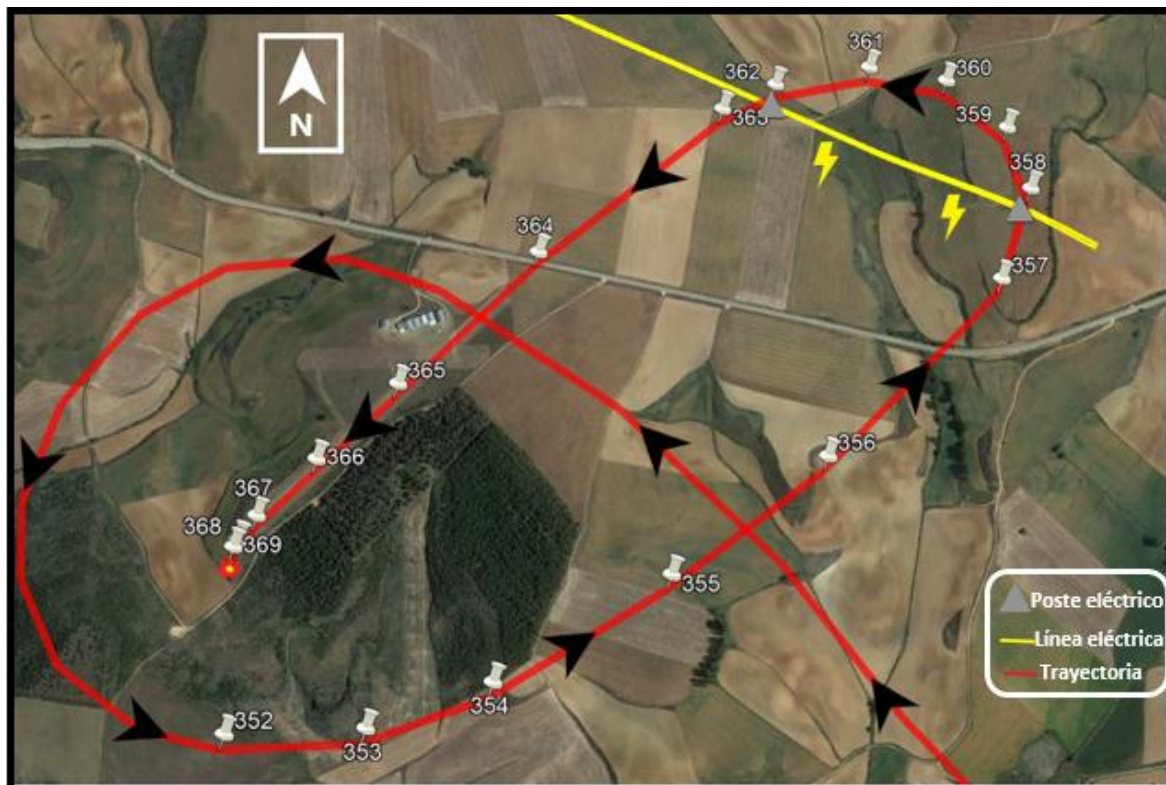
Figure 7 – Path followed by the aircraft (1).

As can be seen from the GPS trace, the pilot approached the aerodrome area from the southeast. He passed over the airfield, turned to join the aerodrome circuit for runway 23 on the crosswind leg, and then proceeded to the downwind leg.

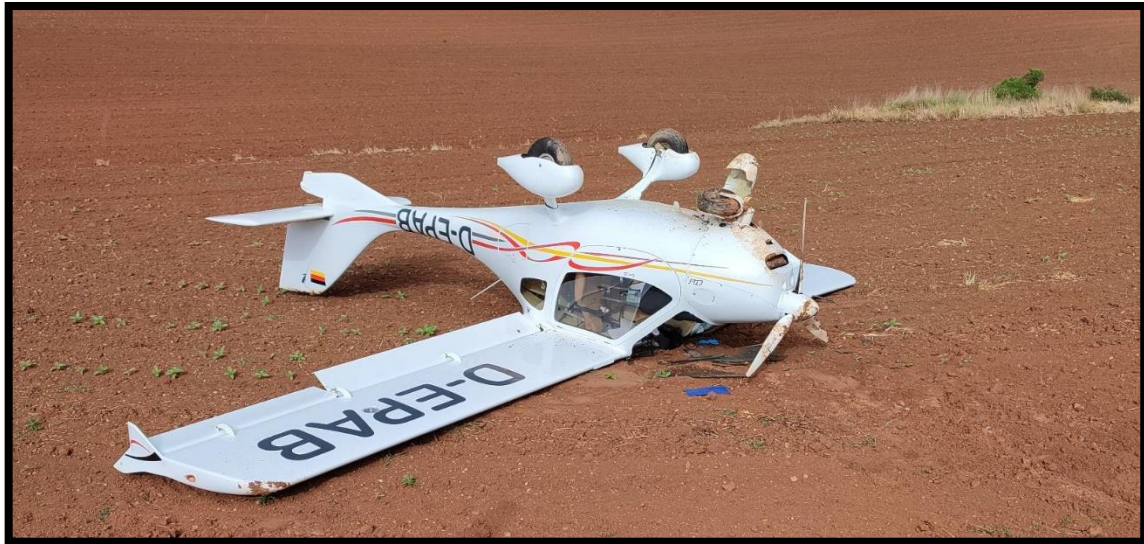
The aircraft touched down about 90 metres from the threshold on runway 23 and taxied approximately 360 metres along the runway until it crossed the threshold of runway 05. It then continued for a further 80 metres to the end of the runway.

After overshooting the end of the runway, the aircraft rolled into a field and flipped over.

*Figure 8 - Aircraft after the accident (1).*

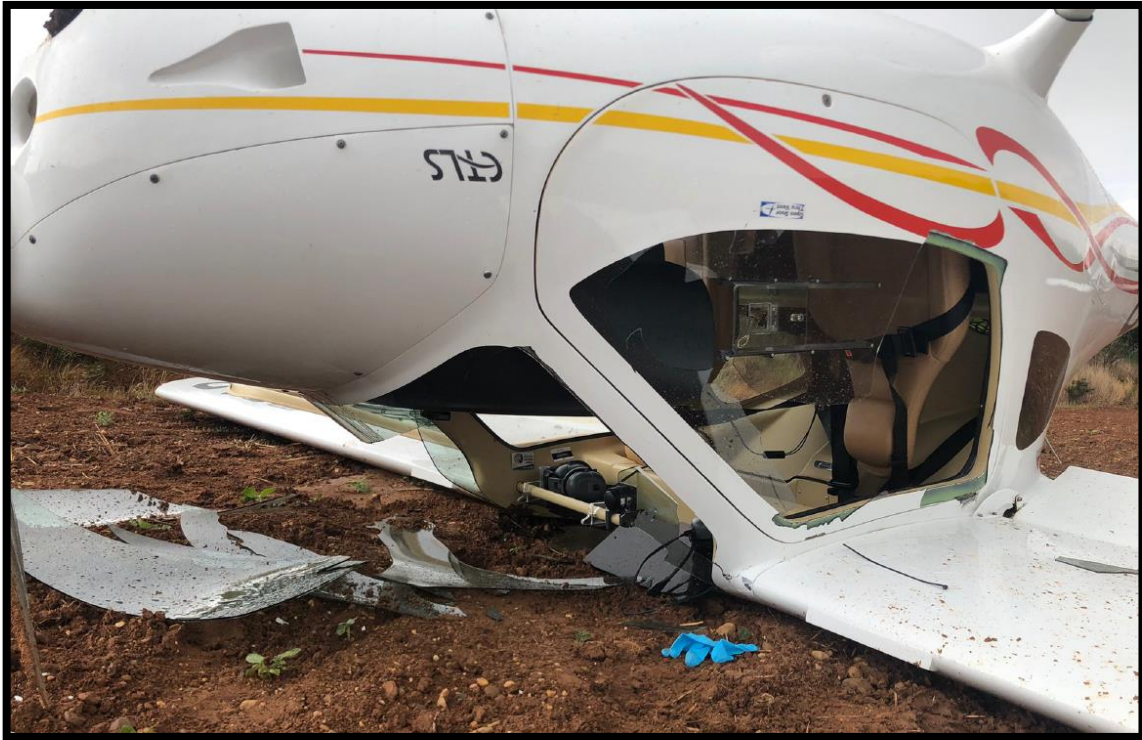
The cockpit maintained its structural integrity, and the harnesses and restraint systems performed their function, preventing serious injury to the pilot.

Figure 9 - Aircraft after the accident (2).

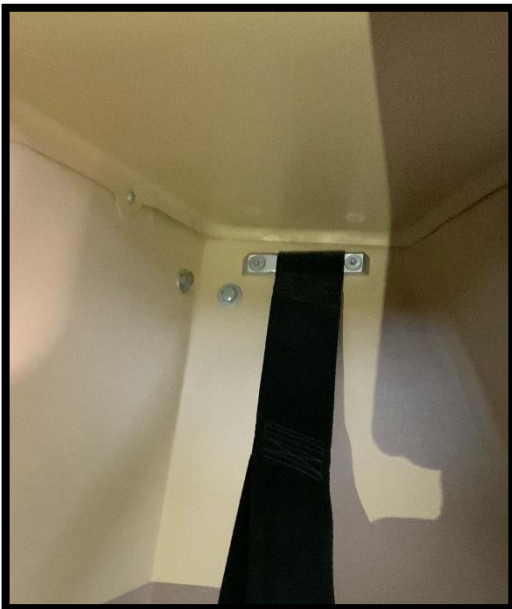
The photographs received from the pilot show that all three harnesses anchorages were intact.

Figure 10 - Aircraft after the accident (3)

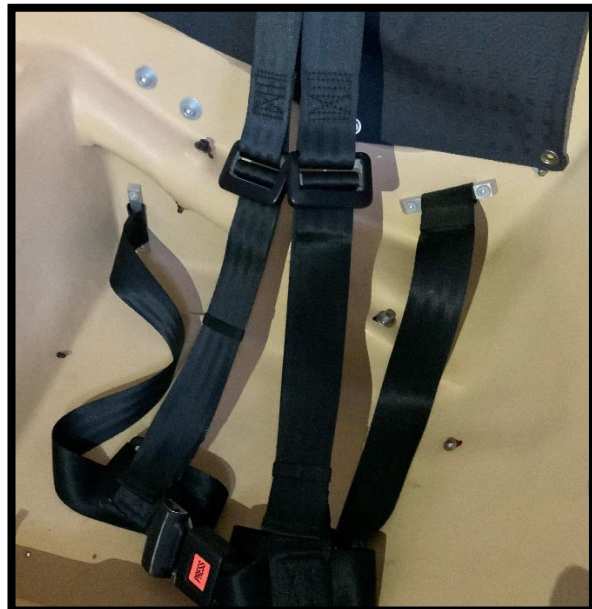
Figure 11 - Aircraft after the accident (4)

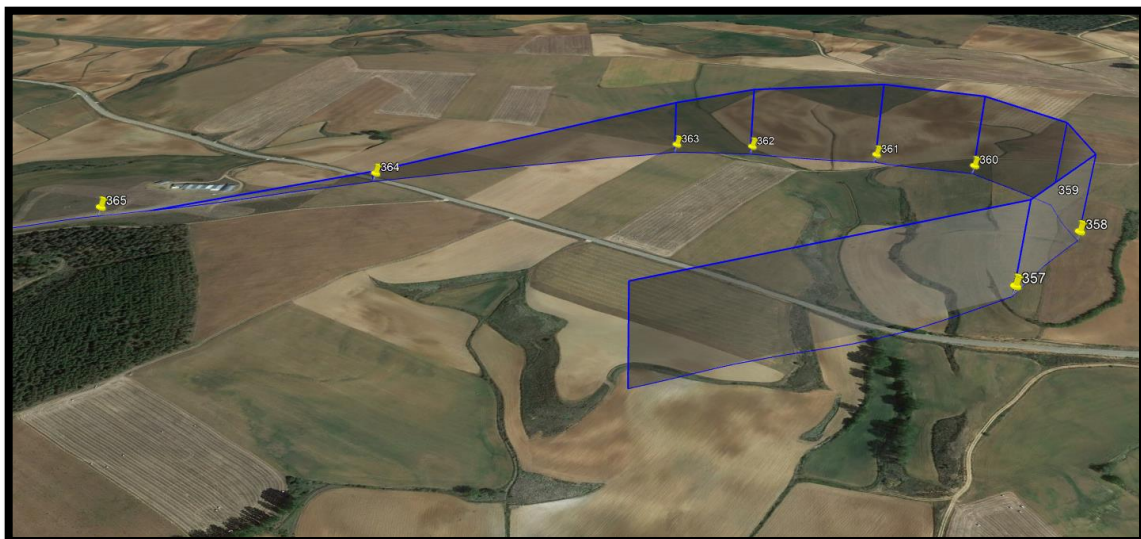
Figure 12 - Path followed by the aircraft (2).

The image below illustrates the final approach phase and the initiation of the landing manoeuvre, showing the points indicated in the table above:

- The flight was not affected by any type of limiting meteorological phenomena.
- The runway was contaminated (water).
- The landing was performed at a slightly higher speed (5 kt) than that recommended in the POH for the selected aircraft configuration.
