Technical report

A-027/2019

Accident on 12 June 2019, involving AgustaWestland AW139
aircraft operated by Babcock Spain, registration EC-NEH, at the
municipality of Albarracín (Teruel, Spain)

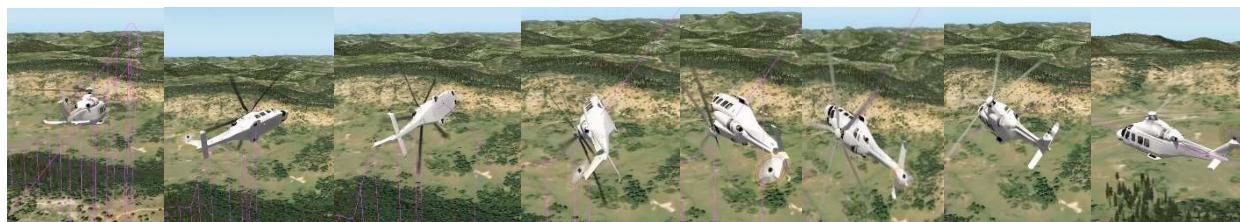
- The roll angle⁶ was increasing to the left until, at 3 seconds (13:30:53), it reached a maximum value of -140°.
- The yaw angle⁷ underwent variations in both directions with maximum opposite rates of variation of +70°/s and -31°/s.
- The pitch angle⁸ ranged from -12° to +22°.
- Within six seconds after the start of the event, the failure of the electronic controllers of the two engines (EEC) was recorded, which changed the mode of operation from automatic (AUTO) to manual (MAN).

Figure 2. Event reconstruction: 13:30:50 to 13:31:01 (FDR data)

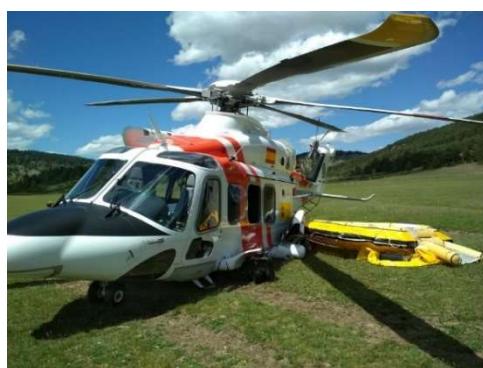
Figure 3. Status of the EC-NEH aircraft after emergency landing

The helicopter was found resting on the left side of the lower fuselage, the right main landing gear and the nose landing gear. The entire area of the left structure and raft housing above it has been displaced upwards. As a result of this displacement, the raft was ejected, landing next to where the helicopter was stopped and where the left skid had collapsed. The searchlight support had fractures and was supported on the ground. In the left area of the main rotor fairing, vertical traces

of oil from the dumper were identified, indicating that they had occurred during contact with the ground, not while in flight. The rest of the structure was not damaged. The rotors were intact and had no impact marks.

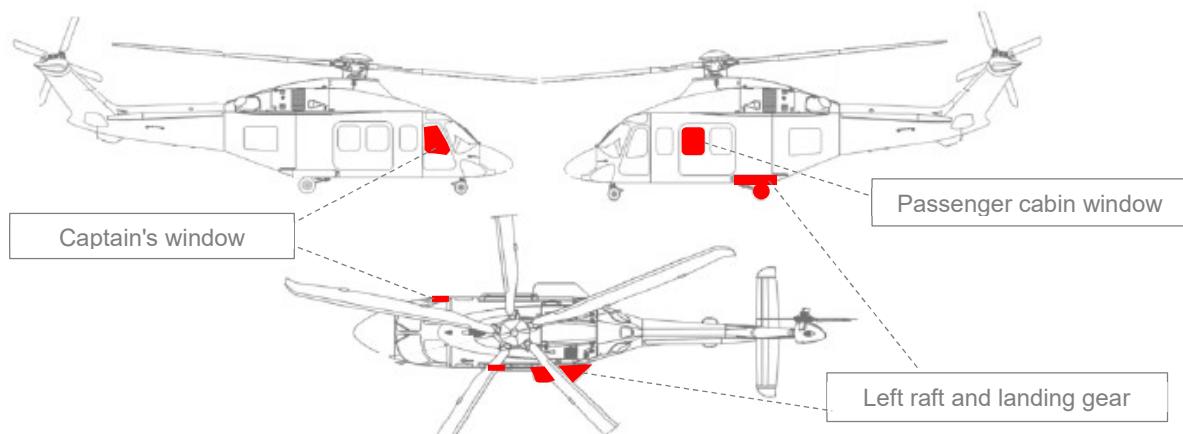
The aircraft had damage to the left main landing gear, which had collapsed. The left raft was found deployed next to the helicopter. Two of the helicopter's eight windows, one on each side, had come off. The left-side window (of the passenger cabin) was located inside the helicopter with the curvature reversed. The right-side window (cockpit), on the captain's side, was not found.

Figure 4. Damage to EC-NEH aircraft

Damage to the helicopter undercarriage, lower fuselage, main rotor and left raft occurred during touchdown and ground taxiing, and did not contribute to the accident, occurring only moments prior to the stopping of the helicopter.

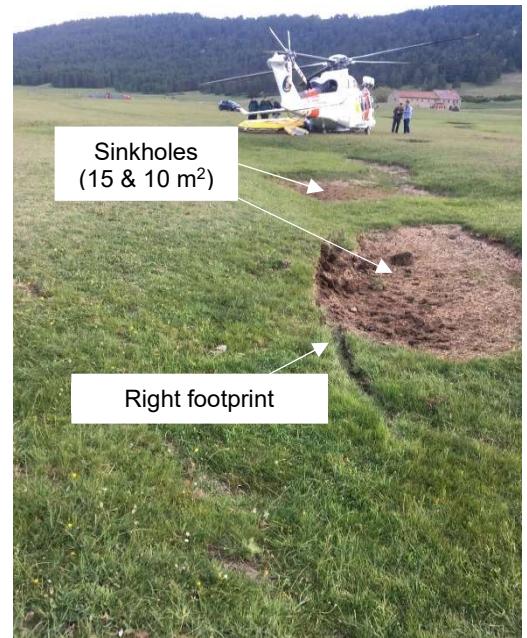
Figure 8 shows the terrain covered by the helicopter over the last 27 metres, with two sinkholes which were crossed by the right main landing gear (see point 1.12).

Figure 8. Sinkholes and right footprint

- In the last 27 metres:
 - The footprint of the left landing gear continued another 27 m to the helicopter.
 - The footprint of the right landing gear was found to be divided into three sections, since it crossed two large sinkholes of earth of 15 and 10 m² (see figure 8).

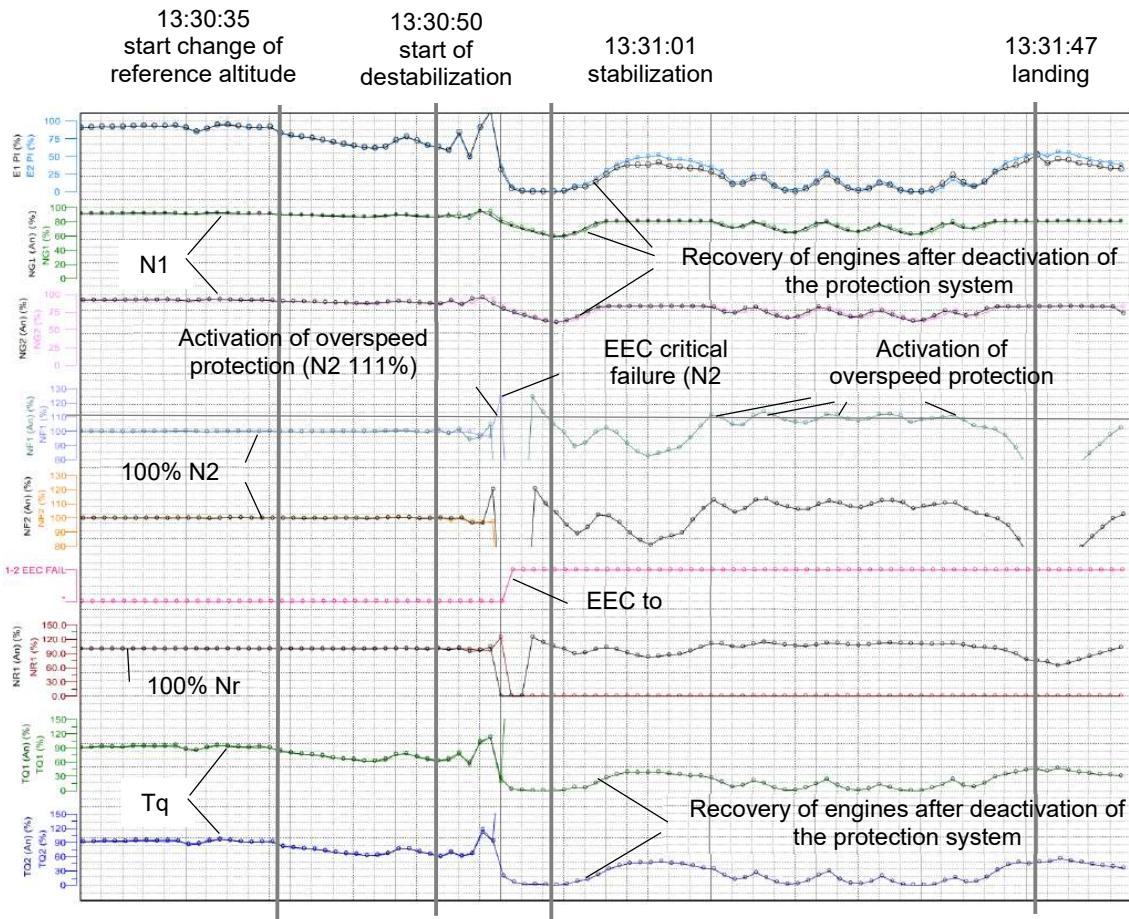
Figure 11. Engine parameters from the event until landing

At 13:30:56, the roll angle and pitch angle continued to decrease (-37° roll and +6° nose-up) and the speed recorded was 57 kt IAS. From this moment, the descent began to reduce (-5,500 fpm). The pilot kept the collective fully down. The engines and main rotor maintained the tendency to accelerate initiated in the previous second, despite the reduction in fuel, with the power turbine exceeding 127% N2 (with N1 above 70%), producing the critical failure of the two EEC and recording the complete failure of the EEC in the FDR. For its part, the main rotor exceeded 115% NR, activating the ROTOR HIGH warning (activated when the NR is greater than 104%).

These parameters (activation of the engine overspeed protection system, EEC failure, the position of the collective, torques, turbine revolutions) coincide with the data extracted from the DCUs (part 1.11.1) and therefore, it is considered that the time reference of 13:30:56 is valid as the reference time for the EEC passage from AUTO to MANUAL. This change in the EEC from AUTO to MANUAL occurred when the fuel was already being limited to the minimum by the protection system, which explains the reduction of N1 in both engines to the minimum. Since this fuel restriction was active until 13:31:00, the pilot pulling on the collective at 13:30:58 to increase power had no effect on the engines, but the N1 continued to be reduced due to the operation of the engine protection systems. Once this system was deactivated, the N1 increased to the value it had been when the EEC made the transition from AUTO to MANUAL, which was also being reduced as a result of the protection system.

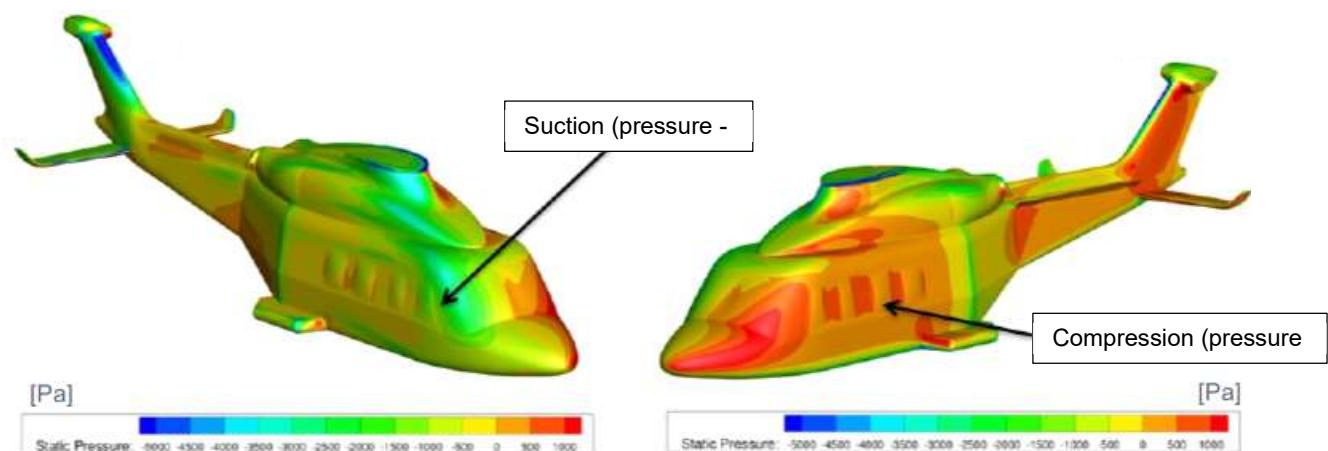
The study results confirmed that the windows subjected to the greatest pressures were precisely those affected during the event:

- The right side of the helicopter was subjected to suction, with the pilot's window coming under the most pressure.
- The left side of the helicopter was subjected to overpressure, with the central window of the passenger cabin receiving the most pressure.

Figure 13. Pressure diagram for case study (0° pitch angle, 30° roll angle)

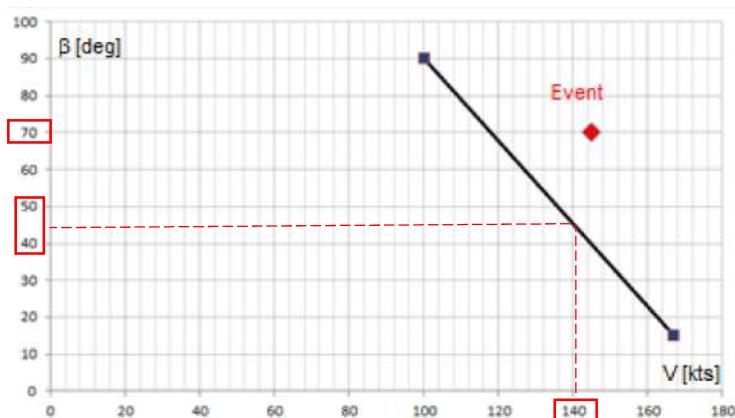
The AW139 certification requirements (CS 29.351) establish a slippery flight envelope defined by two points: for 167 kt (V_{NE}) a slip of 15°; for a speed of 100 kt (0.6 V_{NE}) a slip of 90°. Thus, for a speed of around 140 kt, the speed during the event, a maximum skip of 45° is possible. This value was exceeded by far during the event, in which the helicopter reached angles of 60°-70°.

Figure 14. Event with regard to the slip certification envelope
