Report A-028/2020

Accident on 23 July 2019,
involving a PC-28 CRUISER
operated by FLYBAI, S.L.,
registration EC-NAO, at
Valladolid Airport
(Villanubla-Valladolid, Spain)

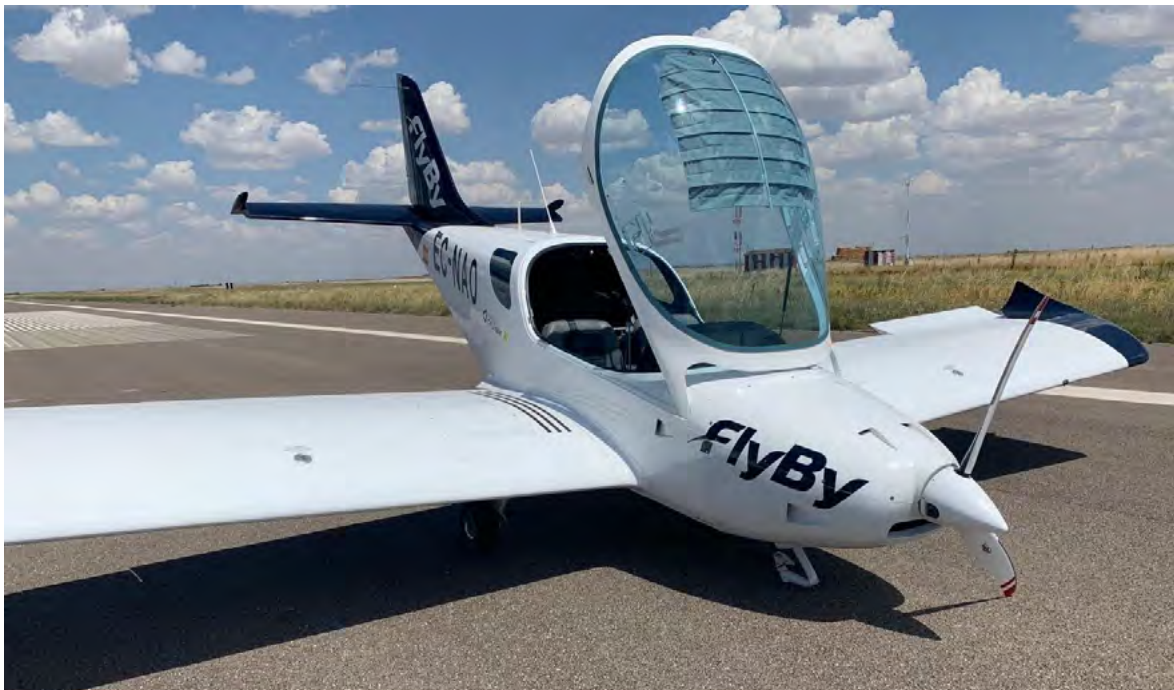
Photograph 1. Aircraft at the accident site

According to his version of events, he entered ground effect expecting to float for a sufficient distance before making contact with the runway. Instead, the aircraft's main landing gear hit the runway, bouncing and falling several times until the nose gear hit the runway and collapsed and the wheel fork detached from the gear leg.

The aircraft slid along on the deformed nose leg until it came to a complete stop just before the PAPI signals.

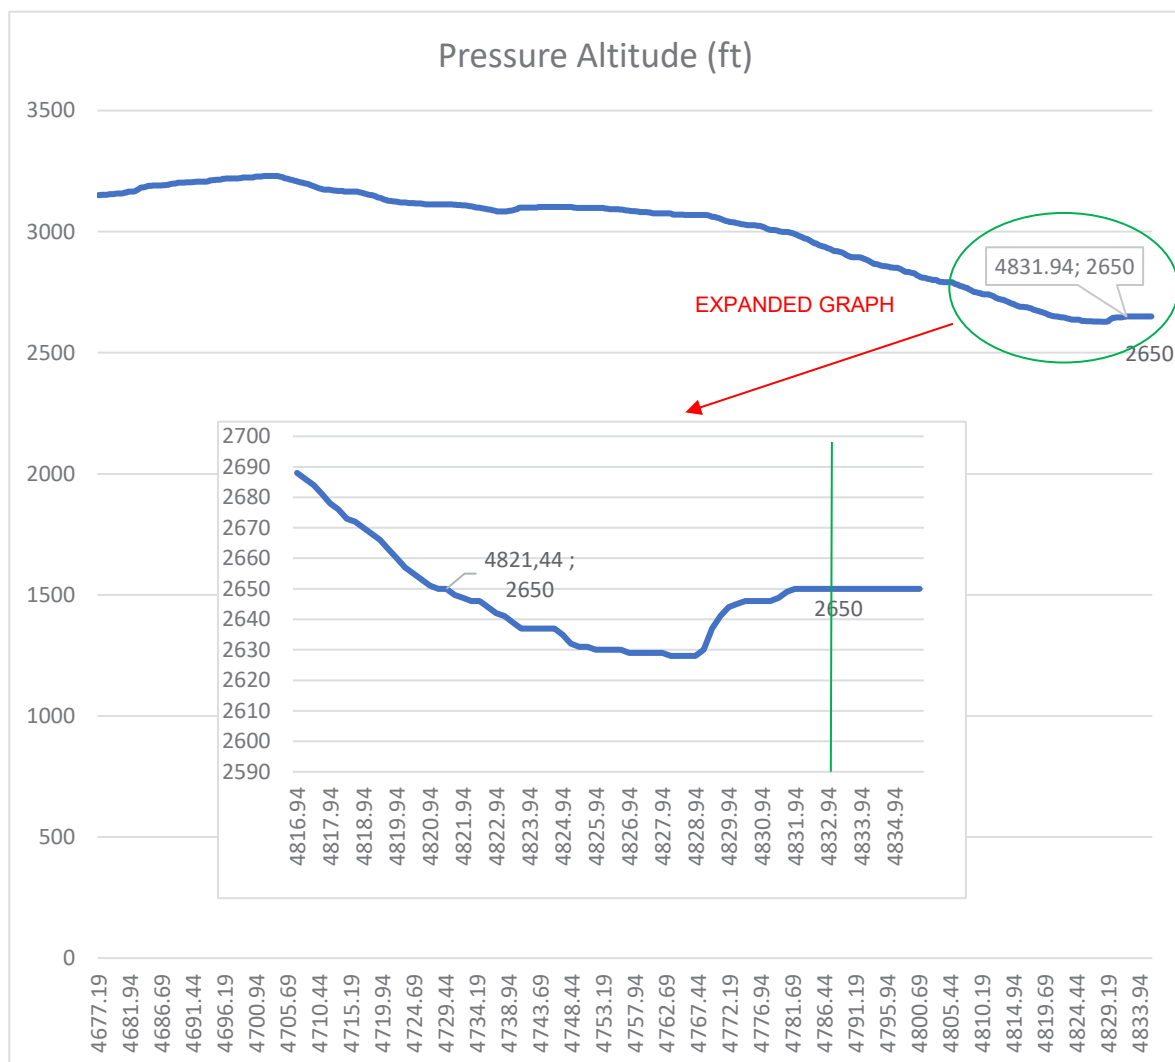
Graph 1. Altitude data during touchdown and expanded detail

- The vertical acceleration had its maximum and minimum values of 3.1 g and 0.2 g at 13:31:28 and 13:31:31 UTC. For reference, the maximum positive load factor limit with flaps extended for this type of aircraft is 2 g, and the maximum negative limit is 0 g. From 13:31:28 UTC (4825.44) to 13:31:32 UTC (4829.38), the "GEES" alert was registered, which is displayed when the "g" meter is in the yellow range of the indicator (i.e. it's between the values of -0.5 and 3 g).

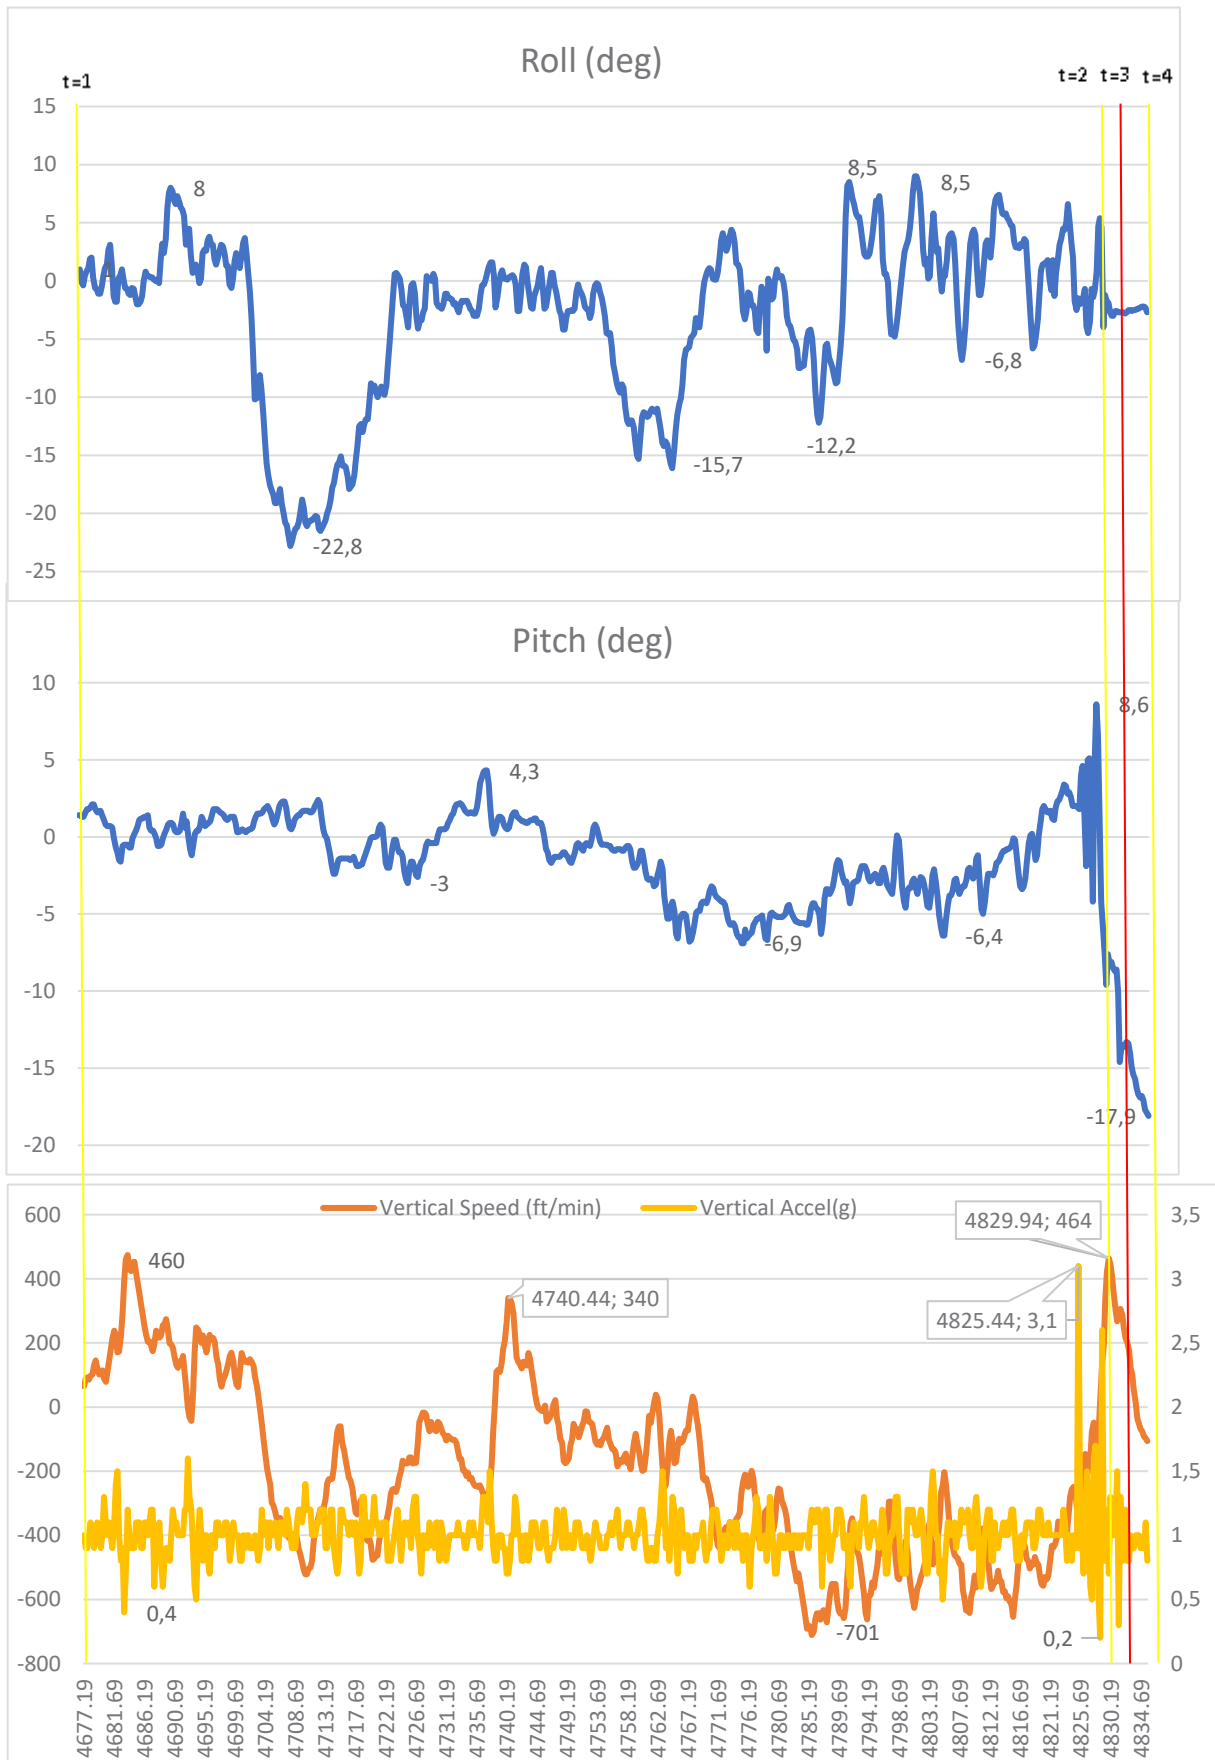
Graph 2. Flight data during touchdown

- The indicated speed had its maximum and minimum values of 90.20 kt and 0 kt at 13:29:07 and 13:31:38 UTC, respectively. Consequently, the aircraft came to a stop at 13:31:38. This aircraft has a maximum flaps-extended speed of 75 KIAS and a maximum flaps-extended approach speed of 60 KIAS. Up to 13:30:42 UTC (4779.38), the FLAPS OVERSPEED alert was registered, with minimum speeds of 75.5 KIAS.

- The engine rpm had its maximum value of 4981 rpm at 13:29:06 and a minimum value of 0 rpm from 13:31:33 UTC to the end of the analysis at 13:31:38 UTC.
- The aircraft landed on runway 23 at LEVD. Before landing, a wind direction of 333° and speed of 10 kt was recorded, representing a transversal component of 9.7 kt and a longitudinal component of -2.2 kt. According to the POH, the aircraft can operate safely in a maximum transversal wind speed of 12 KIAS and a longitudinal wind speed of 22 KIAS.

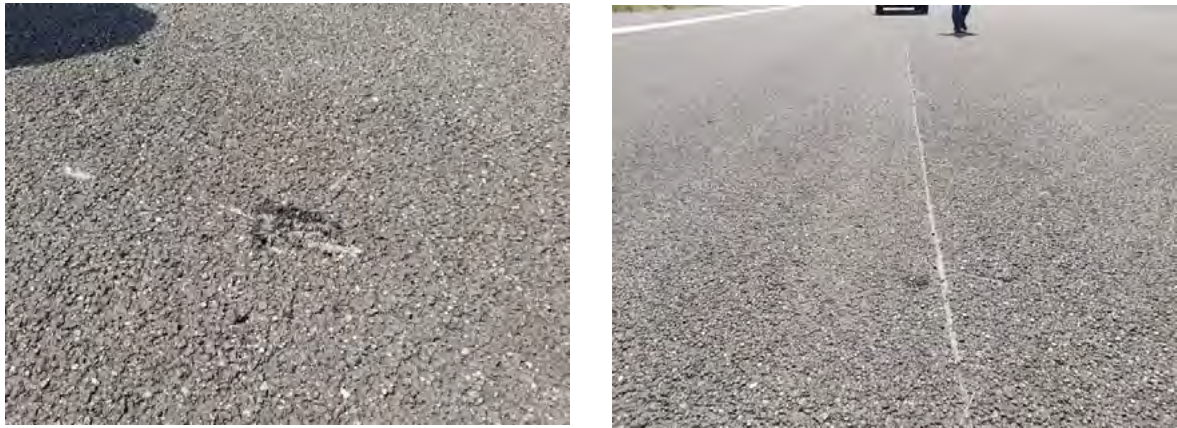
The aircraft left a rounded mark on LEVD runway 23. It measured roughly 20 cm in diameter. There was another continuous linear mark more than 20 m long leading to the point where the aircraft finally stopped.

Photograph 4. Marks on the runway

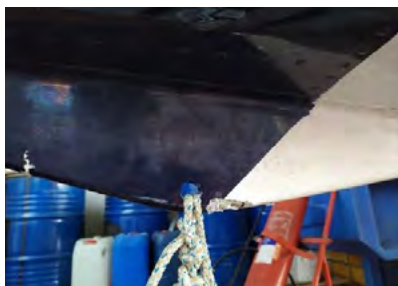
Photograph 6. Damage to the tail anchor point

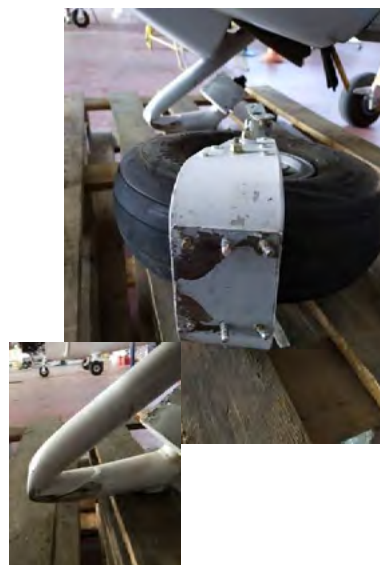
Photograph 7. Damage to the nose landing gear
Photograph 8. Detail of the left photo: damage to the side of the nose leg

The damage to the propeller, nose gear and underside of the fuselage is consistent with the aircraft's nose impacting the runway after the wheel fork detached and the leg buckled in the direction of travel.

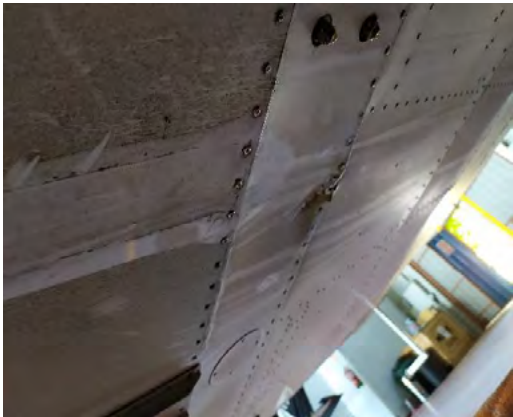
Photograph 9. Damage to underside of fuselage

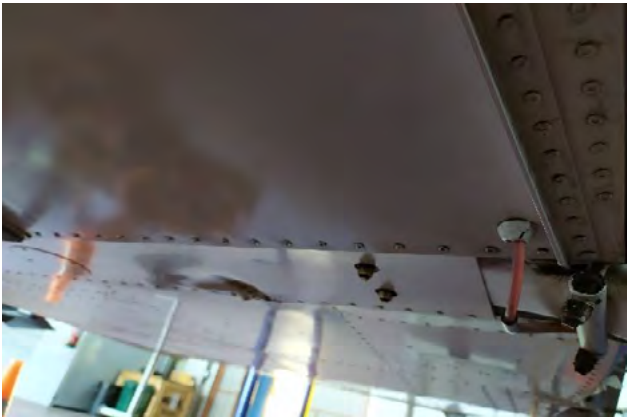
Photograph 10. Damage to main landing gear

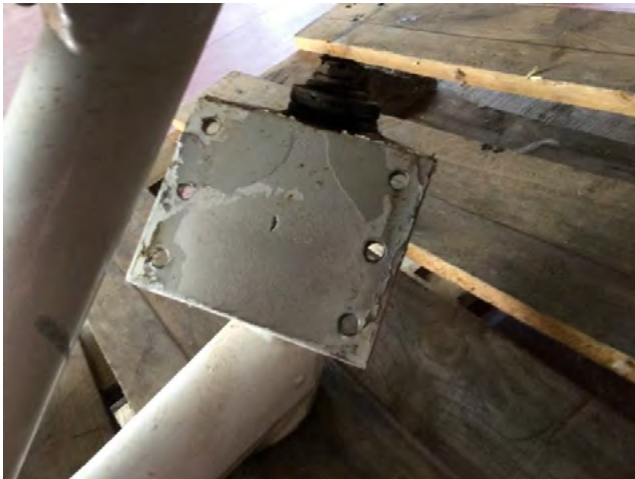
Photograph 11. Connecting plate for the nose gear wheel fork

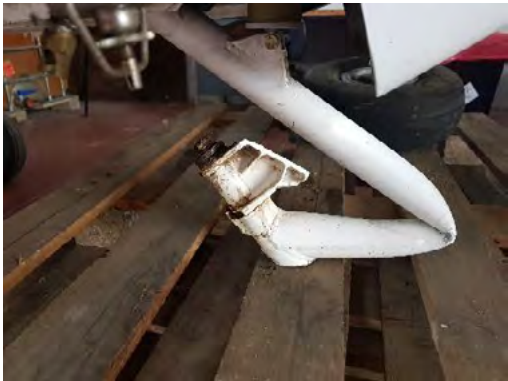
Photograph 12. Buckled nose gear leg

The wheel fork's mounting bolts and the nose leg were bent in the direction of the nose's impact with the runway, but there were no signs of any flaws or damages to suggest they were in a questionable condition prior to the event. The nuts and washers came off as a result of the impact.

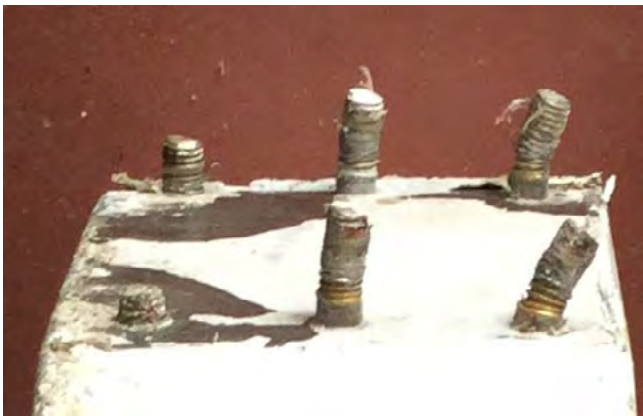
Photograph 13. Bolts that fix the fork to the nose gear leg after the accident

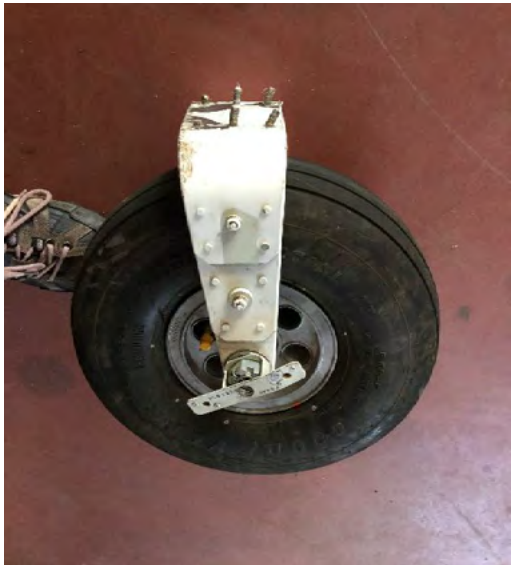
Photograph 14. Nose landing gear wheel and fork

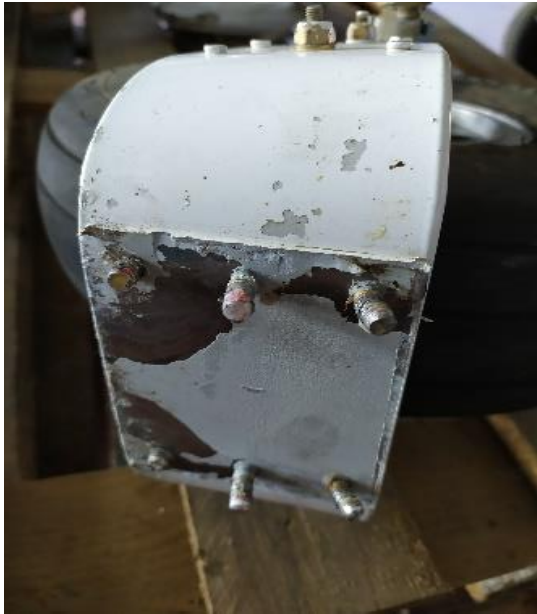
Photograph 15. Area where the fork attaches to the nose gear leg

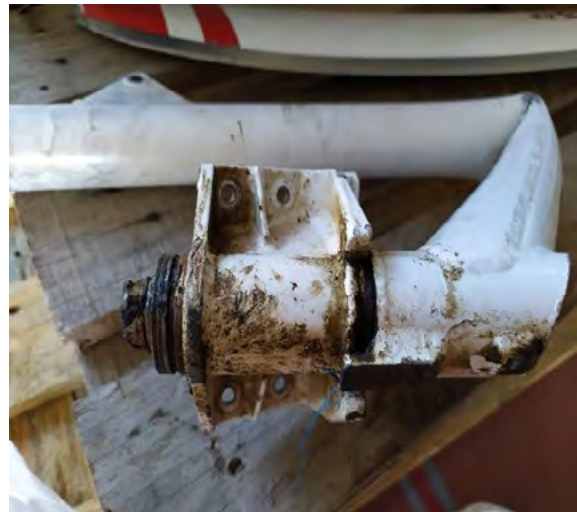
Photograph 16. Lower part of the nose gear leg that dragged along the runway
