CIAIAC

Report A-033/2020

Accident involving a VANS RV-9A
aircraft, registration EC-XLF,
on 22 August 2020 at Tiétar
Aerodrome, La Iglesuela (Toledo)

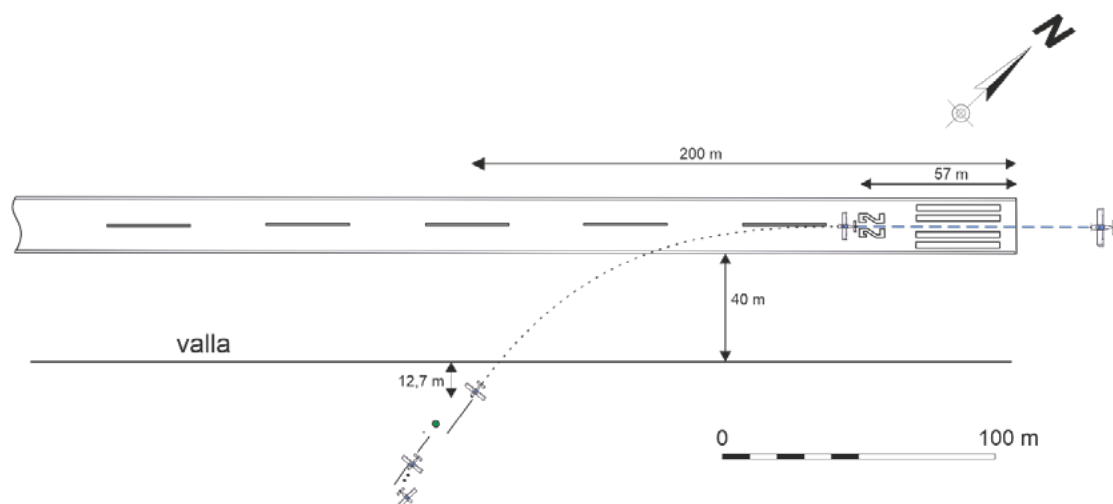
Fig. no. 1 - Diagram of the aircraft's trajectory

During the landing, on making contact with the runway just after the runway designation numbers, the aircraft bounced back into the air.

According to the pilot, when they bounced back into the air, he applied power in an attempt to fly the aircraft and land further along the runway. However, the aircraft veered to the left, and despite his attempts to correct the direction by applying pressure with his right foot, he was unsuccessful. As a result, the aircraft continued to veer to the left, deviating approximately 45° from its original path.

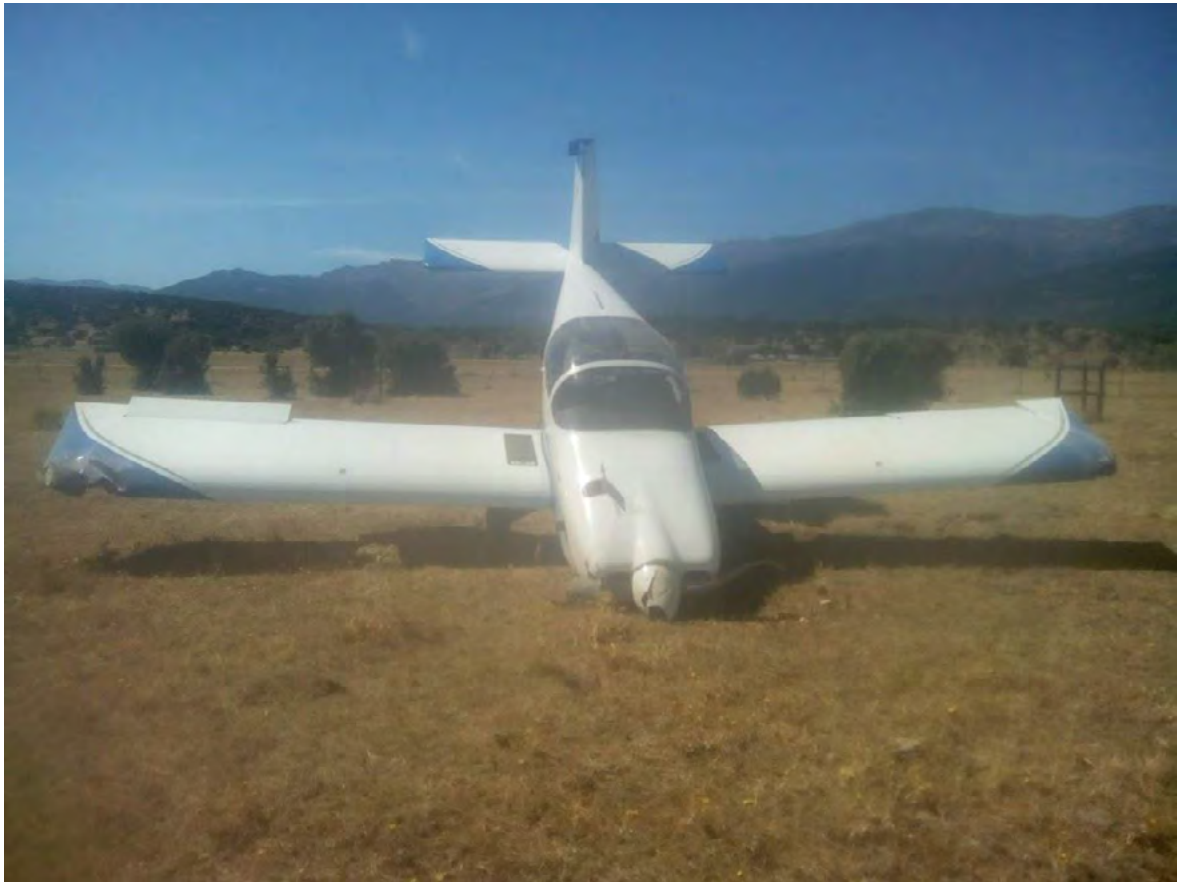
Fig. no. 2 - Aircraft in its final position

The aircraft then made it over the aerodrome's perimeter fence, making contact with the ground on an adjacent property with its left main gear wheel first, followed by its nose wheel and then the right main gear wheel. It finally came to a halt after a pronounced yaw to the left.

The pilot was unharmed and the passenger suffered minor injuries. The aircraft sustained damage to its fuselage, wings, landing gear, propeller and engine.

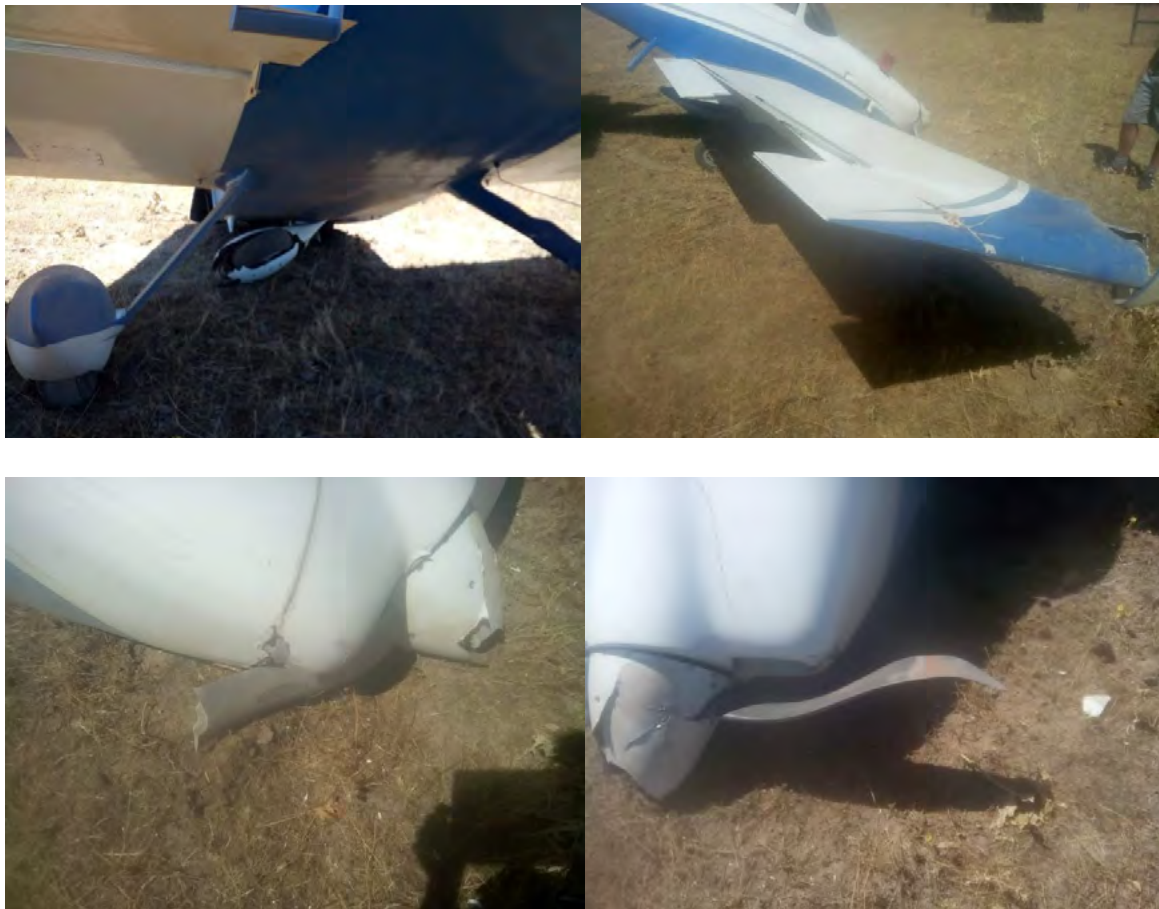
Fig. no. 3 - Detail of the damage to the aircraft

The aircraft's propeller hub and blades were damaged and it also sustained significant damage to its nose cone, landing gear and wingtips.

Subsequently, the 1.3 m-long transverse track marks are indicative of the propeller blades impacting the ground as the aircraft lost speed and its nose lowered as a result.

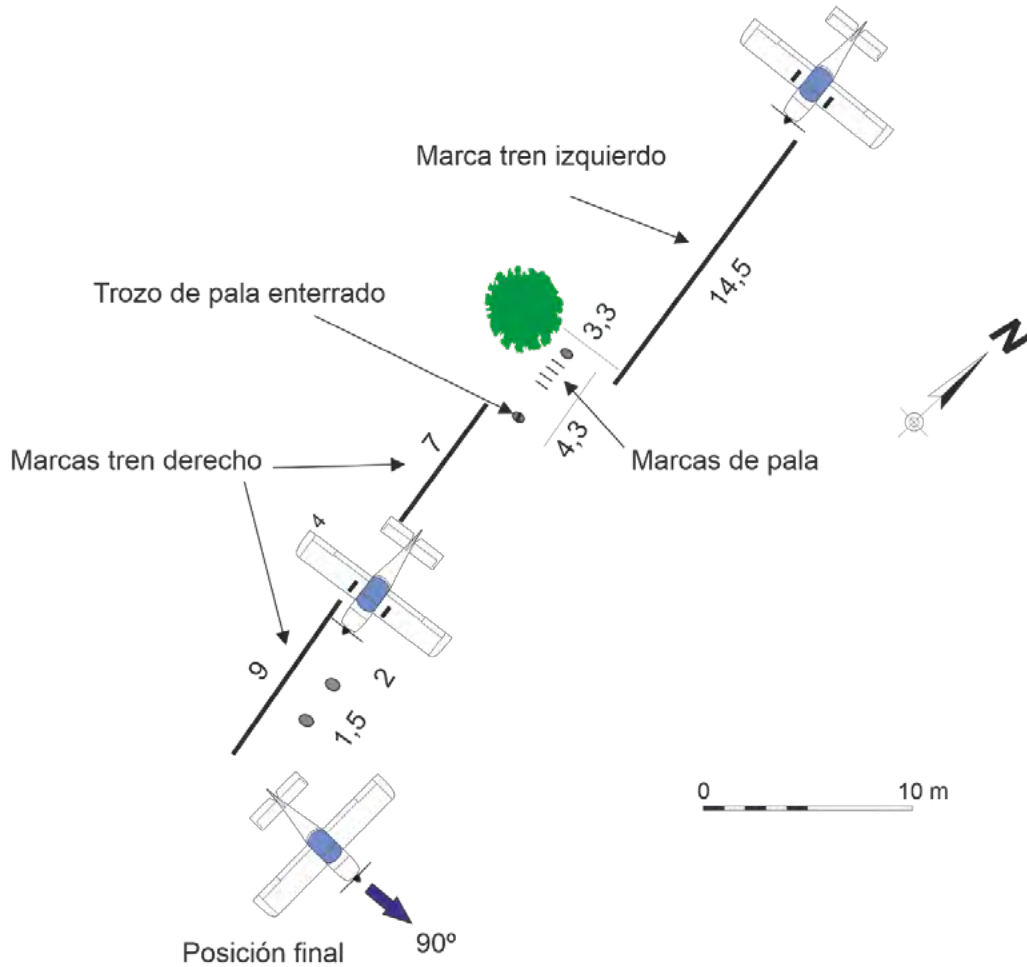
Fig. no. 4 - Diagram of the track marks and final position of the aircraft

After touching down on the runway, the aircraft rebounded into the air, following a curved trajectory to the left. After passing the aerodrome perimeter fence, it travelled for 12.7 m before returning to the ground, making initial contact with its left main landing gear wheel.

At the end and to the right (according to the direction of travel) of a 14.5 m-long track mark, four 4.3 m-long transverse marks with two small holes at either end were observed. The tip of one of the propeller blades was found in the last of the holes.

Further on and to the right, according to the direction of travel, there was another 7 m-long track mark which then disappeared for 4 m and reappeared for another 9 m. Parallel to and 2 m away from this last track mark were two small holes set 1.5 m apart.

Finally, turned about 90° to the left according to the direction of travel, the aircraft was found resting on its nose and landing gear with its tail pointing upwards.

The longitudinal 14.5 m-long track that begins 12.7 m from the fence suggests the aircraft made contact with the ground at that point and then rolled on its left main gear wheel, which would be consistent with the slight left-hand roll attitude the aircraft adopted after the bounce.

Further on and to the right, according to the direction of the previous track marks, there were two aligned longitudinal tracks measuring 7 m and 9 m, with an intermediate section of 4 m bearing no track marks. These would have been made by the right main gear wheel rolling over the ground with a 4 m-long bounce in the middle.

All of the above indicates a clearly unstable second landing and roll out, with the aircraft initially making contact with the left wheel only, then with the right wheel only, and with contact being lost completely at some intermediate points.
