# Technical report

## A-035/2022

Accident on 20 July 2022, involving a  
Eurocopter AS-350-B3 aircraft,  
registration EC-LBU, operated by Pegasus  
Aviación, in the municipality of Tortuero,  
Guadalajara (Spain)

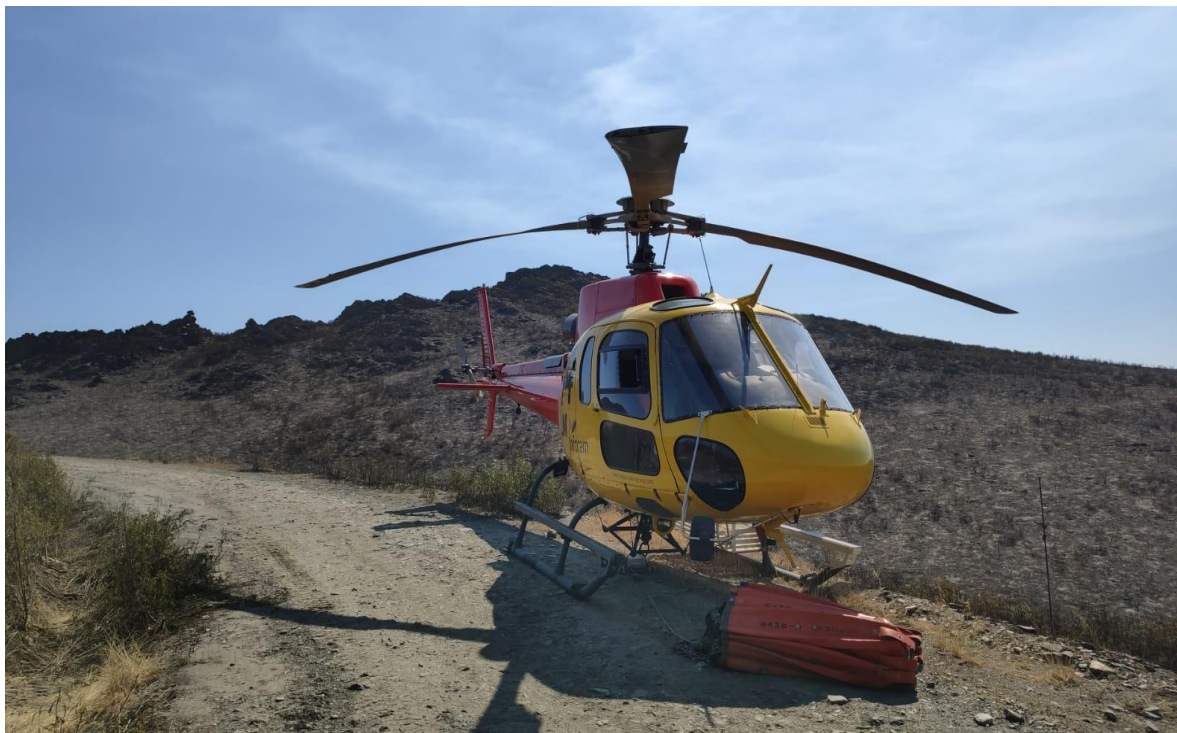
Photograph 1: Aircraft EC-LBU at the incident site

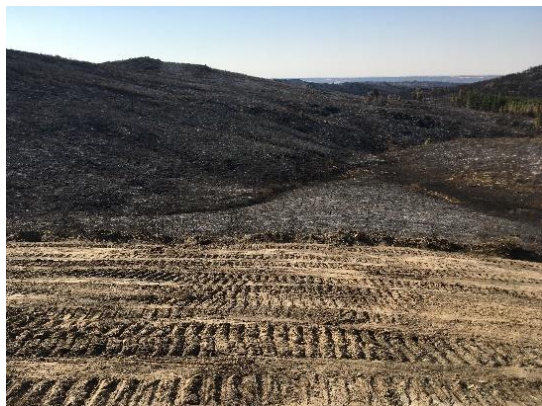
It was a mountainous zone, with a downhill slope above a forest road about 3 m wide and a slope on the other side of the road, bearing 255° W (photograph 3).

Photograph 3. Descending slope from the incident site

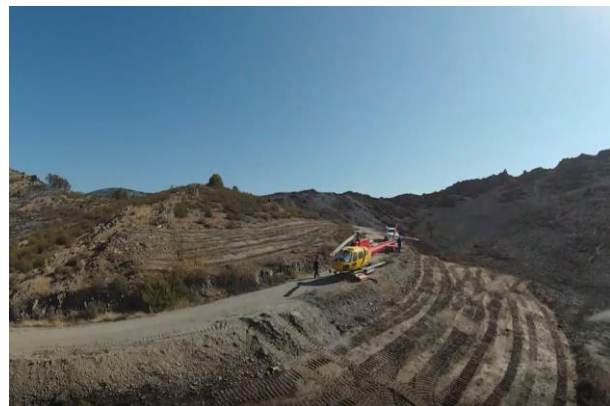
Photograph 4. Position of the aircraft above the descending slope

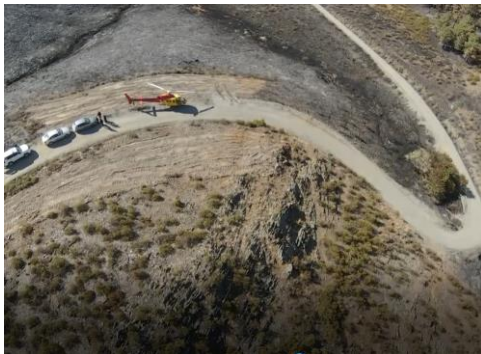
Photograph 5. Position of the aircraft on the forest road

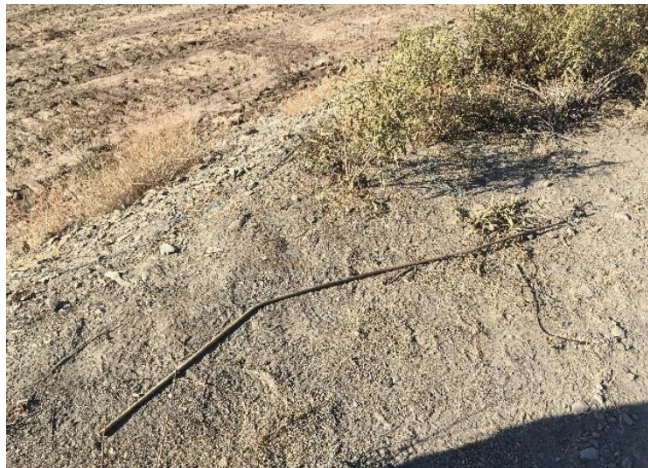
Photograph 6 shows the rod found 6 to 7 m in front of the aircraft with no traces of wire or the retaining insulator.

Photograph 6. Detached electrified fence rod

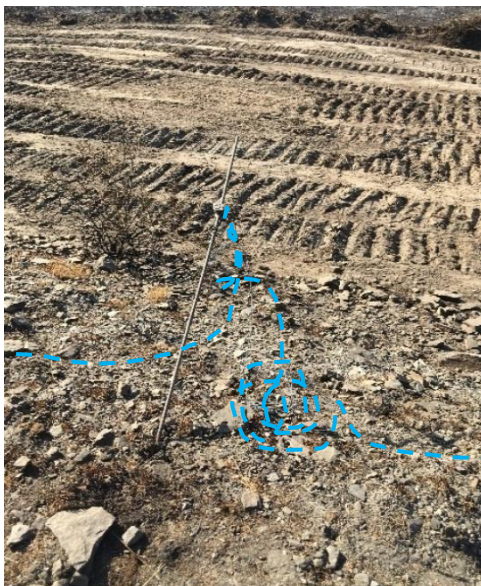
Photographs 7 and 8 show two rods with their conductor wire severed at one end still attached to the circular retaining insulator at the other. Given that it is hard to see in both photographs, the position of the wire has been highlighted in blue.

Photograph 7. Electrified fence rod bent after the accident

It was noted that the aerial wire of the electrified fence bordering the road on its downhill side, to the pilot's left, was severed. Two of the metal retaining rods were found tilted and bent towards the ground, with the wire severed and stretched at one end on both rods. Another of the rods was found about 6 or 7 m in front of the aircraft, kinked at a height of about 40 cm, corresponding to the point where it is inserted into the ground to secure it. This is consistent with the rod being dragged and pulled out of the ground abruptly, causing it to bend and projecting it forcefully forward of the aircraft.

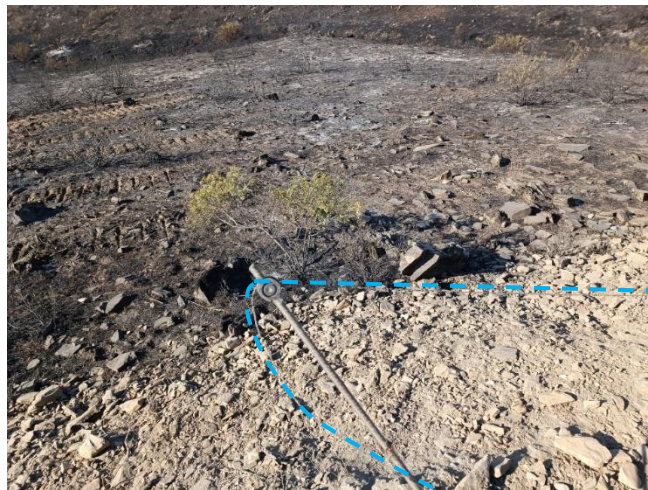
Photograph 8. Electrified fence rod bent after the accident, with the end of the electrified wire

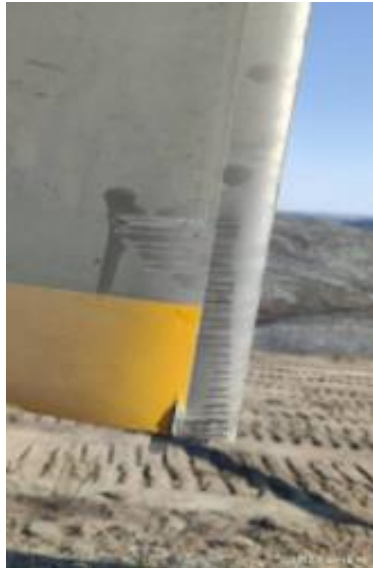
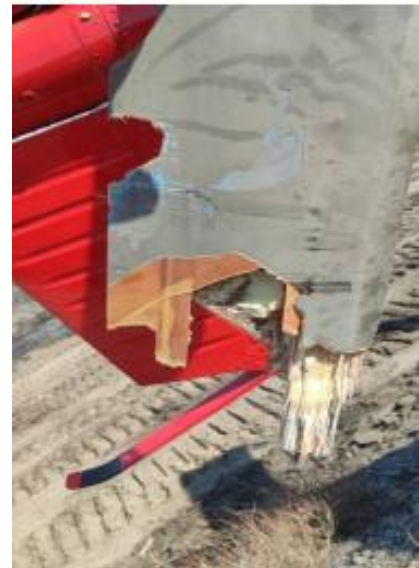
- Damaged tail rotor blades.
- Tail rotor drive system: damage to the fairing covering the gearbox, with loose tail cone attachment bolts.

Photograph 9: Damaged tail rotor blades

Given the marks and damage identified on the tail rotor blades and its drive and transmission system, it can be concluded that the tail rotor struck the aerial wire of the electrified fence, which then wrapped around the rotor, stretching the wire until it broke, leaving marks made by the steel braiding on the blade and causing the mechanical damage to the tail rotor yoke. This tension on the wire then moved three of the fence's supporting rods, bending the two at each end and dragging the central one until it was unearthed and projected vertically upwards, hitting and damaging the trailing edge of the horizontal tail stabiliser and then being propelled upwards again.

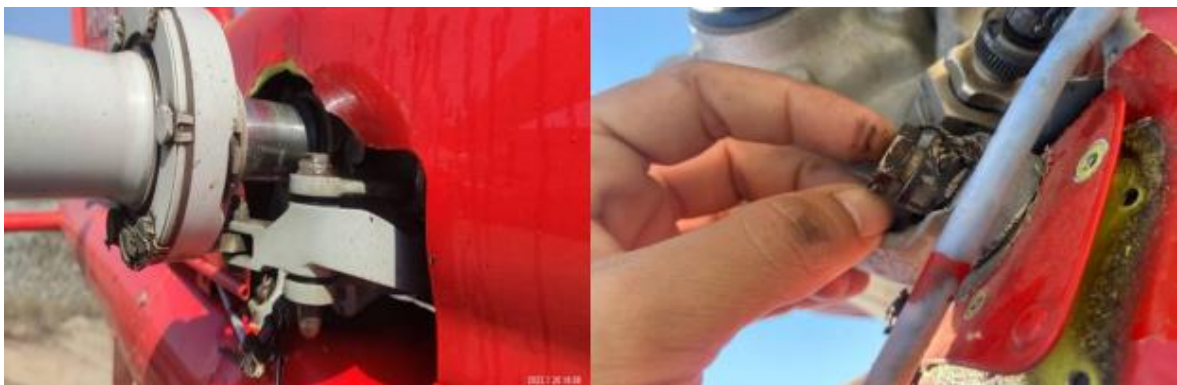
Photograph 10: Damage to the tail rotor drive system

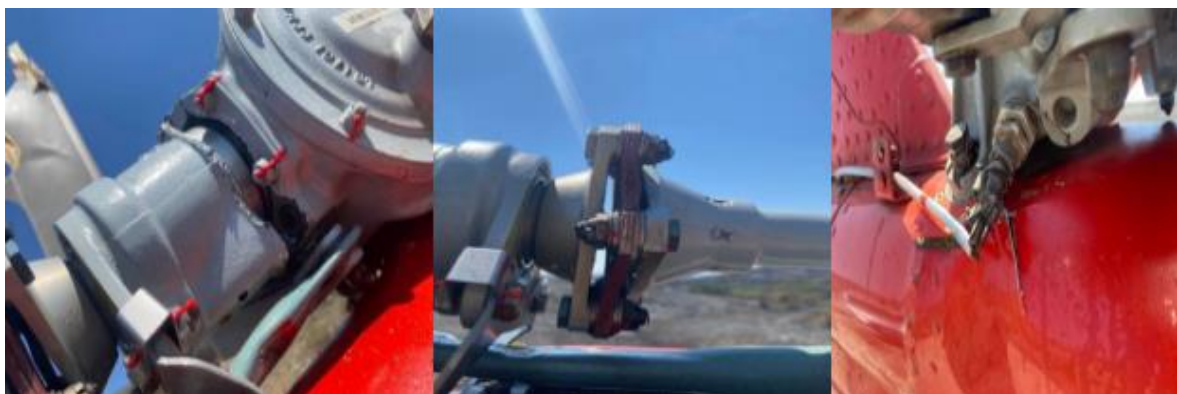
- Damaged quill shaft or input coupling, separating the gears from the gearbox, bending the flexible couplings linking the tail rotor section to the TGB (tail gearbox) and damaging the pitch change connection.

Photograph 11: Damage to tail rotor input quill and flexible coupling

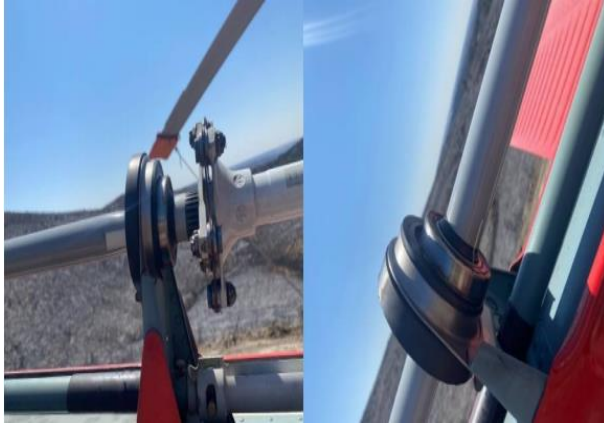
Tail rotor drive shaft: The bearings supporting the shaft are all out of their housings. The shaft is visibly displaced forwards due to the rupture of the TGB. The fairings covering the section have internal marks in the area of the flexible couplings.

Photograph 12: Gears on tail rotor drive shaft

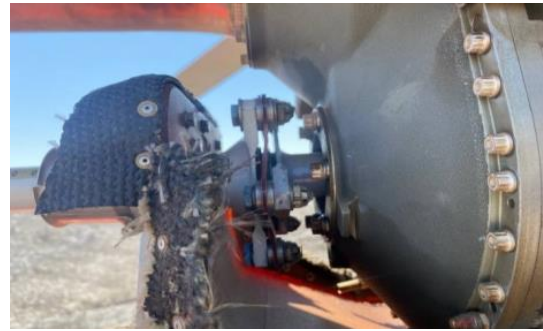
- The flexible couplings connecting the engine module 5 (reduction gearbox) to the bent tail shaft.

Photograph 13: Damaged flexible couplings

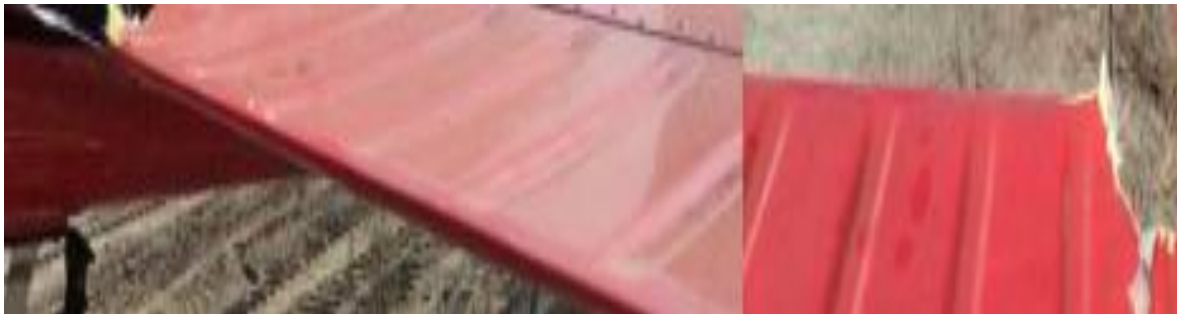
Breakage on trailing edge.

Photograph 14: Damage to horizontal stabiliser

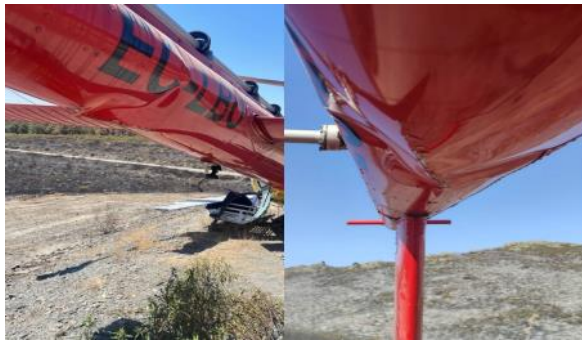
Major damage to both the primary structure and the skin from the horizontal stabiliser area rearwards. Severe dents and cracks. VHF antenna damaged.

Photograph 15: Damage to the tail cone

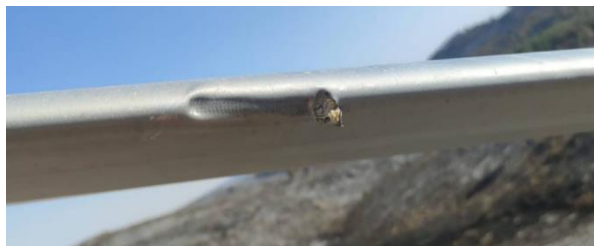
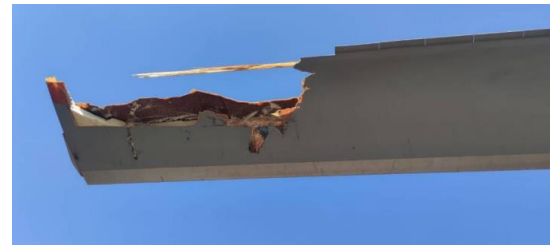
Damage to two of the three main rotor blades, the yellow blade and the blue blade. A dent on the leading edge of the blue blade, with damage to the main beam. Loss of material from the tip of the yellow blade.

Photograph 16: Damage to the main rotor blades

After that, the rod was thrown over the aircraft striking the main rotor as it passed, resulting in impacts and breakages to two of the three rotor blades. It hit the yellow blade on the underside of the tip, causing some material to break off, and then it hit the leading edge of the blue blade, damaging the main beam and propelling the rod to the ground. The shape and depth of the damage is consistent with being caused by an 8 mm diameter steel rod. Therefore, the marks and traces identified support this possible sequence of events.
