Technical report

A-038/2022

Accident on 25 July 2022 involving a Eurocopter AS-350-B3 aircraft operated by Pegasus Aviación, registration EC-NTE, in the municipality of Cerezo de Mohernando, Guadalajara (Spain)

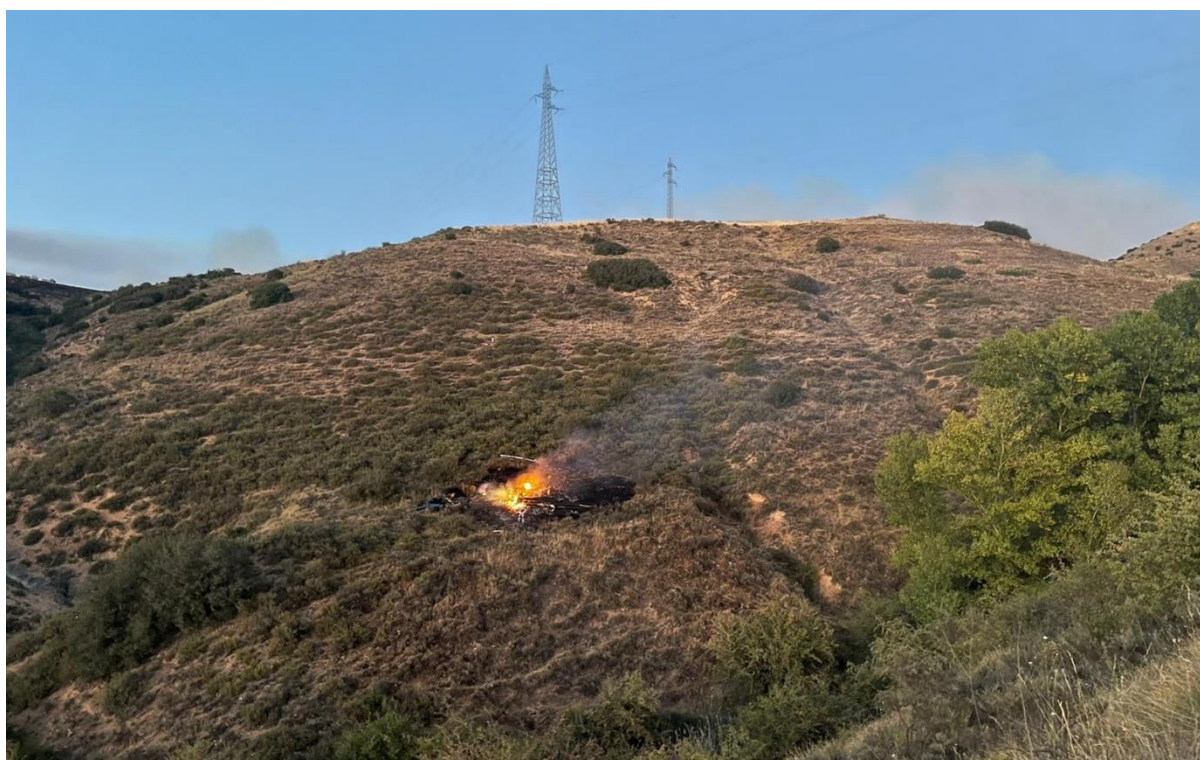
Photograph 1: Aircraft EC-NTE at the incident site

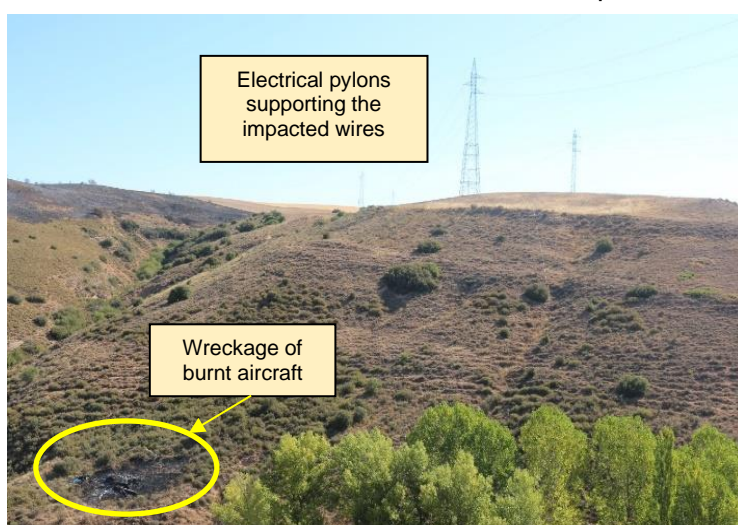
Photograph 3. Accident site

The accident site and extinction zone was an area of scrubland with pronounced slopes and steep descents into a ravine lined with large trees. The area was dotted with a large number of high, medium and low-voltage power

lines. More specifically, the aircraft made contact with the ground on one of the sides of the ravine with a gradient of approximately 20%, between two plateaus connected by high-voltage pylons.

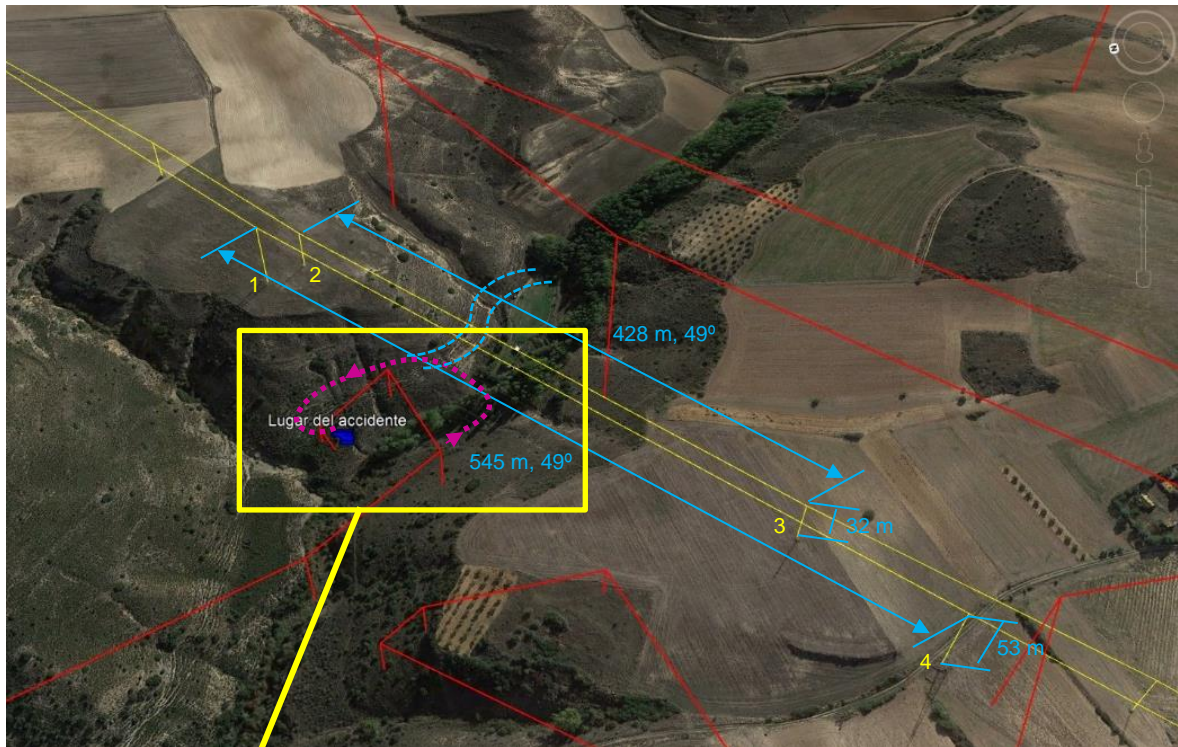
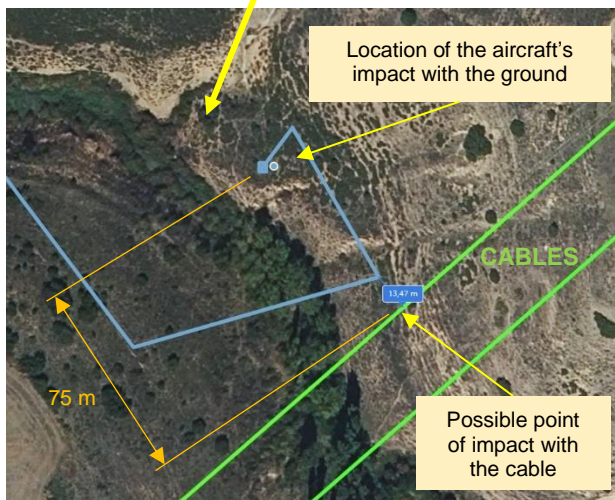
Figure 5. Trajectory of the accident aircraft and geometry of the impact.

Figure 5 shows the approximate path of the helicopter on the final leg of the flight before the accident, according to the records of the fleet tracking system. Also shown is the approximate geometry of distances and spacings of the high-voltage cables between the pylons, labelled 1, 2, 3 and 4 in the figure. The figure shows the heights of the pylons as approximately 32 and 53 m, and the lengths of cable between the

pylons, which are approximately 545 and 428 m, with an orientation of 49°. Based on this information, we calculated the distance between the high-voltage cables in the area where the main rotor blade may have hit and where the aircraft's wreckage was found to be around 75 m, as shown in the detail extracted from the figure. We were also able to calculate that the point of least distance between the aircraft and the cable between pylons 1 and 4 m (pylons 75 and 76 of the Iberdrola network) occurred during its left turn at 86 m of height (vertical coordinate) and was approximately 13.47 m (horizontal coordinate), according to the fleet tracking records.

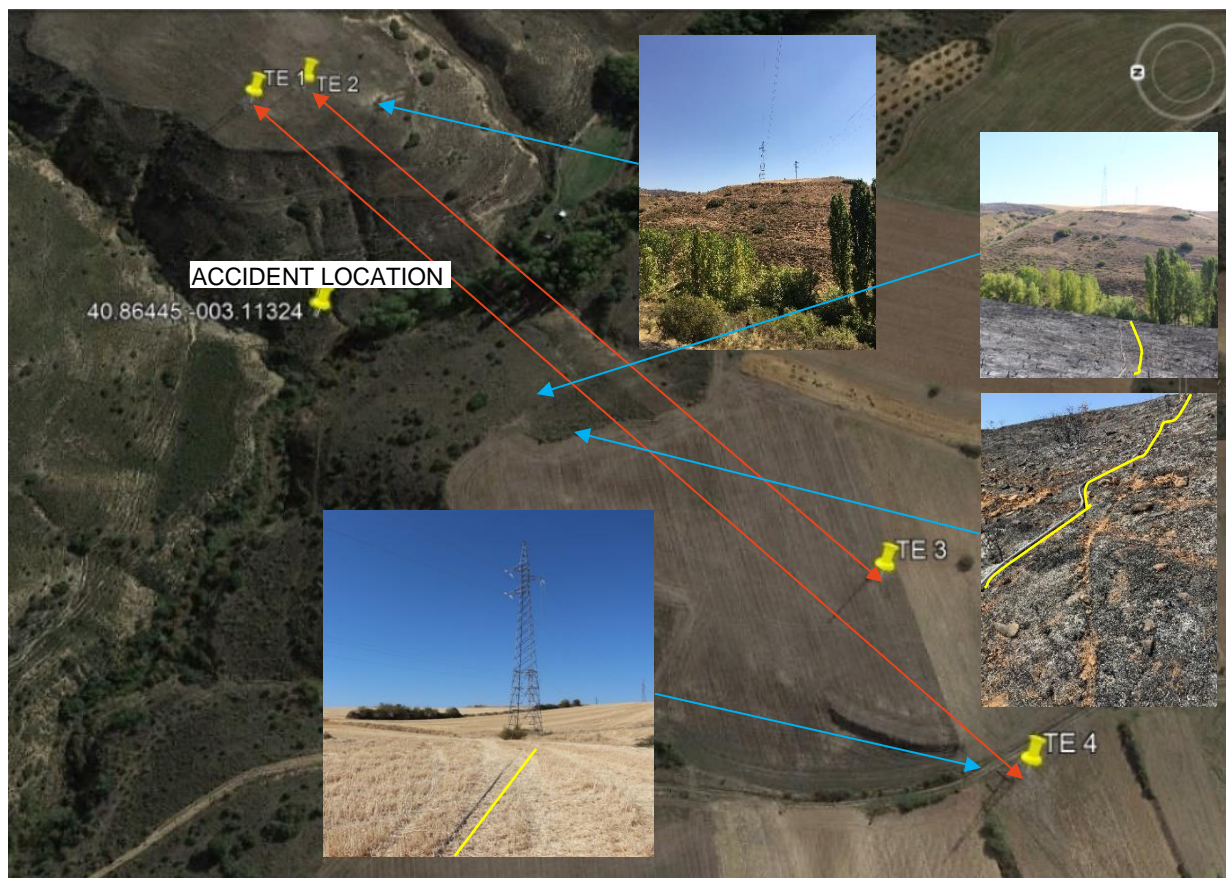
Figure 6 contains photos of the severed cable after impact with the helicopter and its position at the accident site, marked in yellow for better visualisation, with views from both sides of the ravine.

Figure 6. Severed cables at the accident site

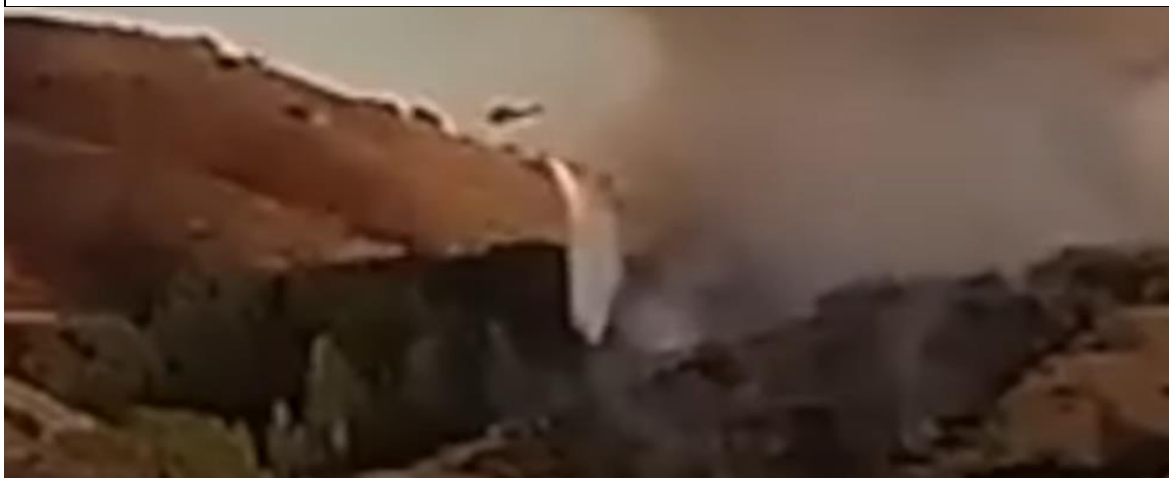
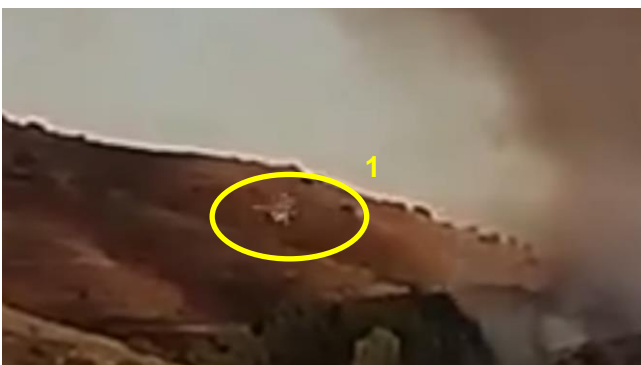
Photograph 4. Video images of the last water drop, the helicopter drifting (1) and descending to the ground (2).

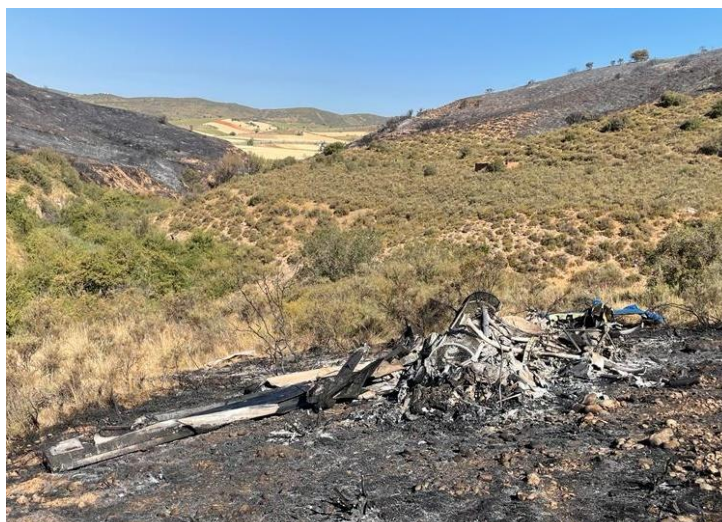
No traces of impacts were visible in the surrounding areas. Small traces of material from the blades, skid, etc., were identified within 2 to 3 m of the helicopter.

Identifiable among the wreckage were the empennage (vertical and horizontal stabilisers) and the end of the tail boom, which had not been burnt (marked with the number 1 in photograph 5); one of the skids (2), the three main rotor blades retracted to the same side and burnt (3) and the melted engine with the helibucket carrier on top which still retained its identifiable structure (4).

Photograph 6. Relief view of the accident site

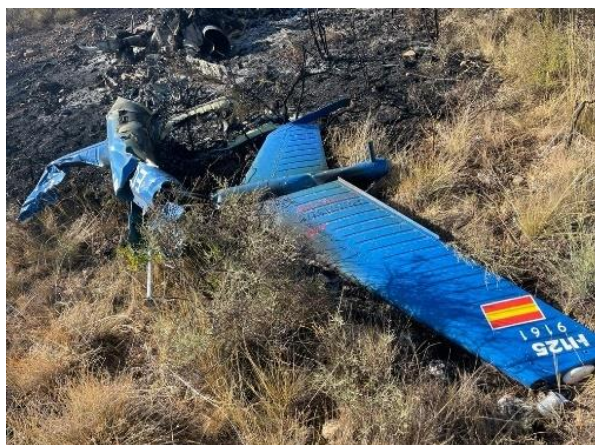
Photograph 7. Empennage and tail boom section

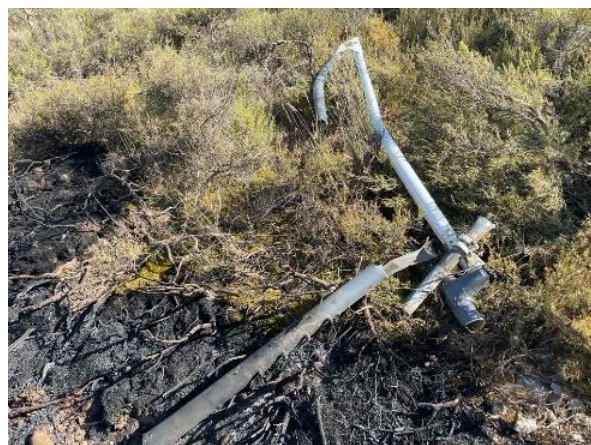
Photograph 8. Detached skid

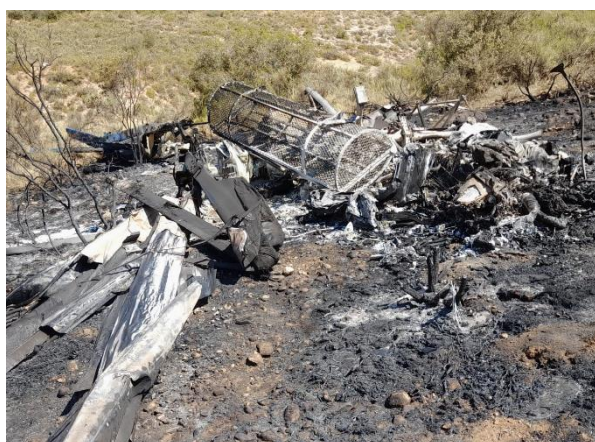
Photograph 9. Melted engine, helibucket carrier and main rotor blades

As for the other remnants of the aircraft, the engine and the structure had been melted by the high temperatures reached during combustion; some elements, such as the helibucket basket and the skid under the helicopter, although charred, were identifiable; the tail empennage had been severed, probably when the helicopter hit the ground and overturned, and was separated from the main wreckage, which initially prevented it from burning, unlike the tail boom; given the rupture of its supporting structure, the tail rotor possibly detached after the impact with the ground and also escaped the fire. One of its blades remained in good condition in its mounting, and the other was practically detached from the root of the hub but remained intact, so, presumably, it didn't come into contact with the severed electrical cable that caused the accident.

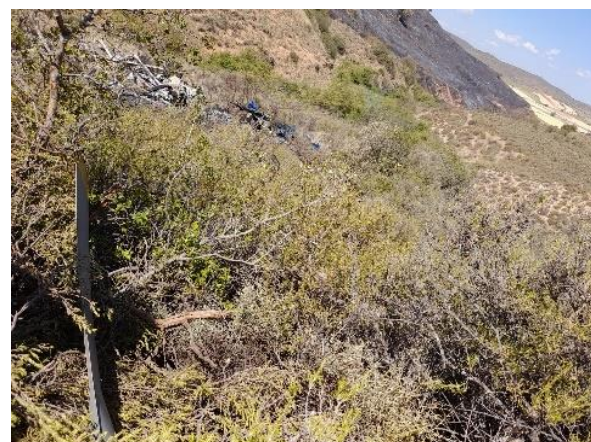
One of the two tail rotor blades had detached and was located about 3 m from the skid, separated from the aircraft, with no signs of charring.

Photograph 10. Detached tail rotor blade

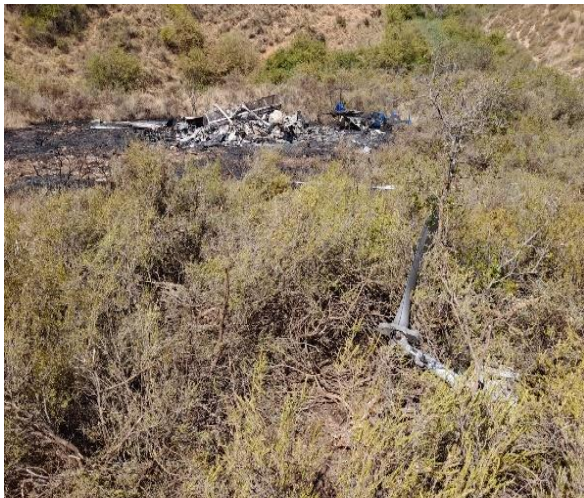
Photograph 11. Tail rotor at the accident site

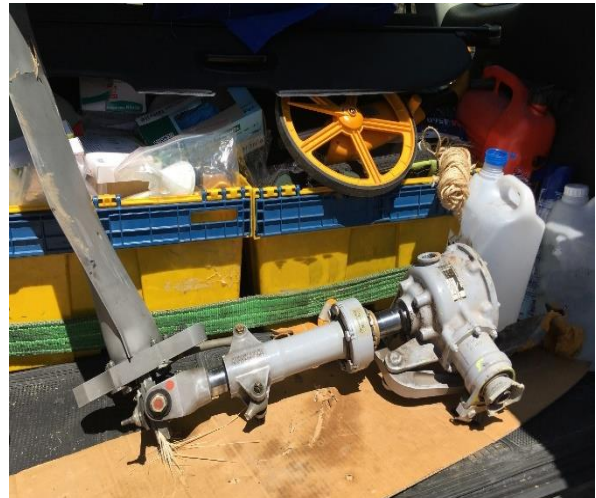
Photograph 12. Tail rotor

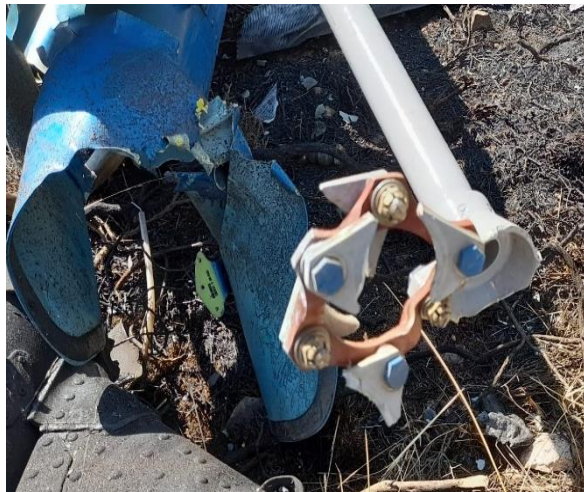
Photograph 13 left. Breakage of tail rotor attachment to tail boom.

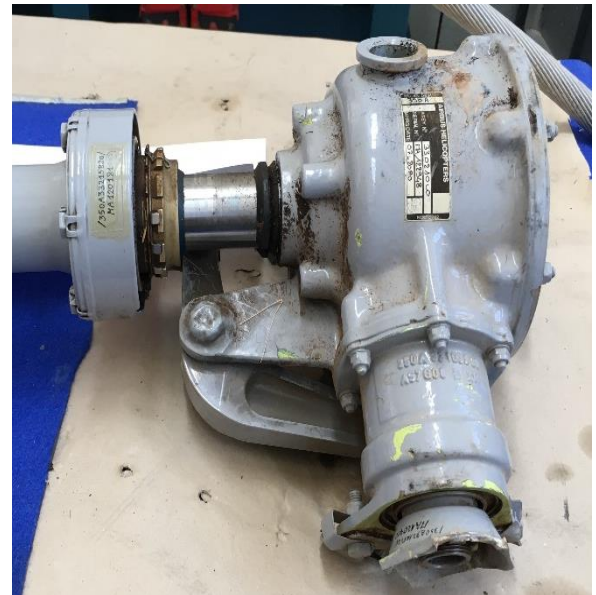
Photograph 14 right. Breakage of tail rotor

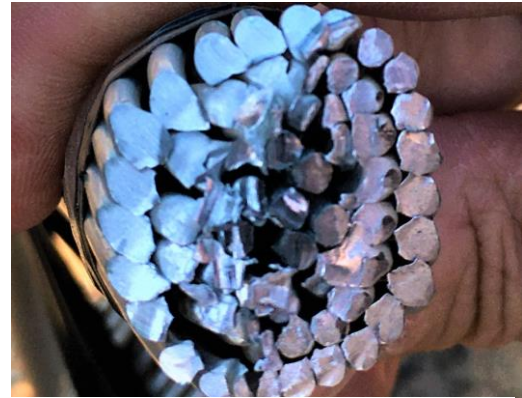
Photograph 15. Impacted section of the cable

The severed cables did not exhibit any melted areas (photograph 15), which would typically be found if a short circuit takes place during contact with the wiring. We, therefore, believe that the line was not live at the time of the impact with the aircraft. The cable displayed colour transfer from the helicopter, confirming its contact with the fuselage (photograph 17) in an approximate 1 m section close to one of the severed ends (photograph 18).

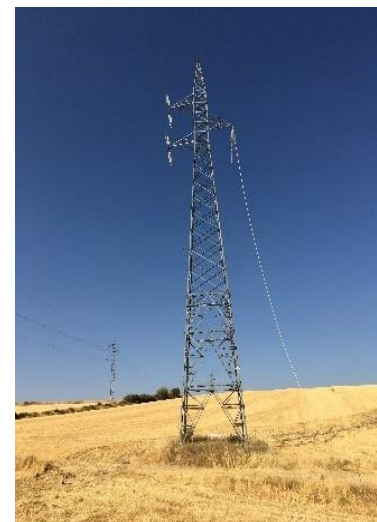
Photograph 16. Pylon and severed cable from the incident

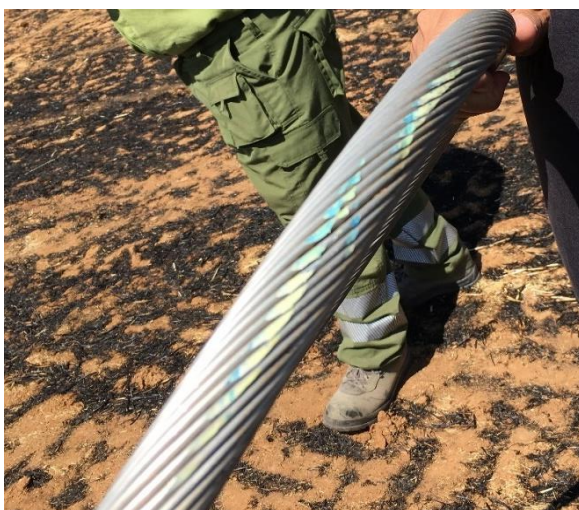
Photograph 17. Colour transferred to the cable by the impact

The severed power cable remained attached to the pylons and exhibited colour transfer from the helicopter in the form of blue and yellow scratches. There was no evidence of arcing, such as burnt ends, melted ends or material loss, which confirms that the power line was not live and had been switched off by the utility company following the declaration of a forest fire in the area.

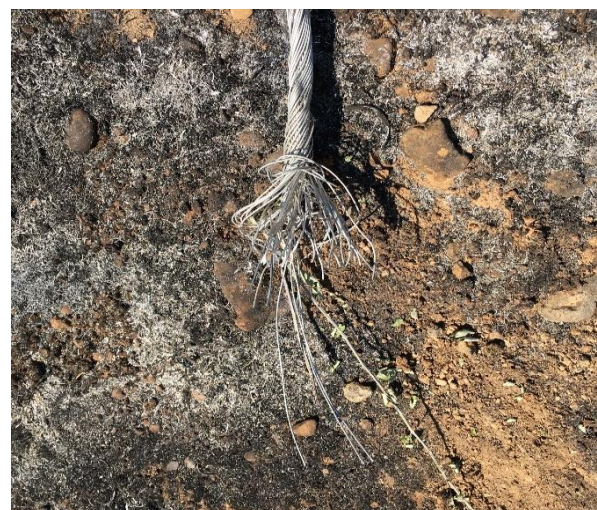
Photograph 18. End of the severed cable from the southern slope

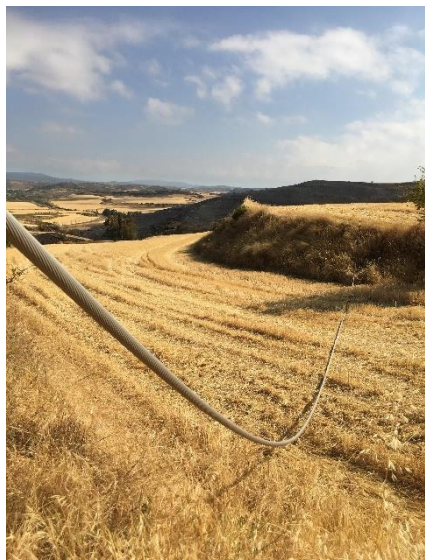
Photograph 19. Severed cable from the northern slope

Photograph 19 shows the end of the cable hanging from the pylon located on the north slope. It was on this slope that the helicopter hit the ground and caught fire.

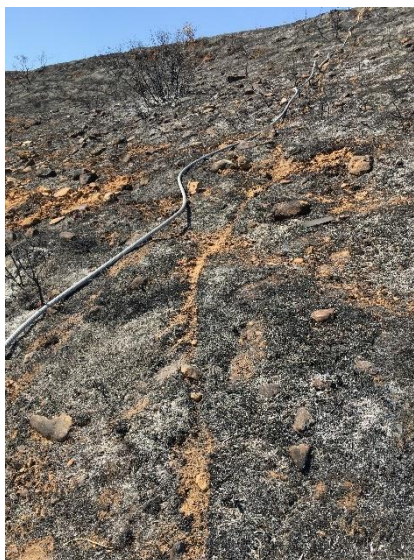
Photograph 20. Severed cable from the southern slope

Photograph 20 shows the other loose end of the severed cable from the pylon located on the southern slope, which was where the fire was spreading and was completely burnt.

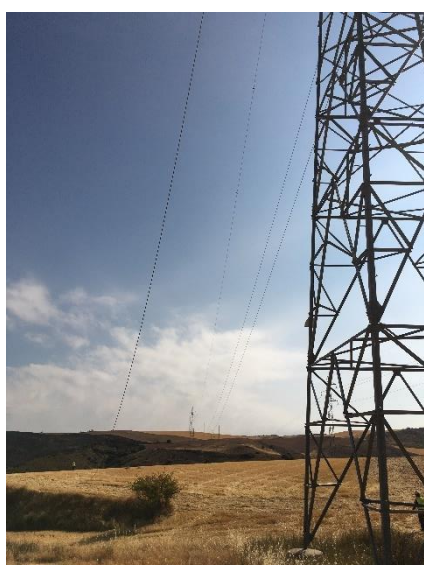
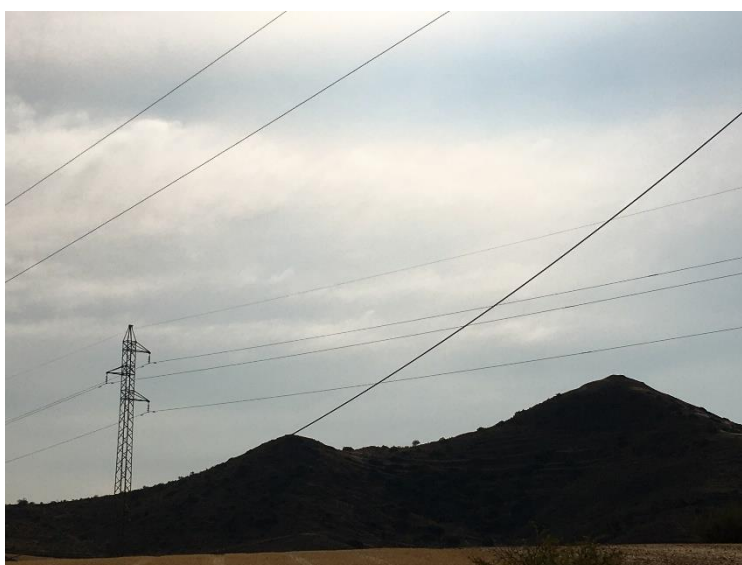
After the final water drop, on exiting the manoeuvre and making a left turn with the power line catenary on the right and the sun behind the pilot, he claims to have seen the reflection of a cable on his right side just before the impact with the main rotor. The concentration of power lines in the area and the position of the cables can be seen in Photograph 21.

Photograph 21. Pylon and overhead cables at the incident site, with the cable severed by the impact
