# Technical report A-039/2020

**Accident involving a Diamond DA-20-A1 aircraft, registration EC-IIS, operated by Fundación REGO, on 16 September 2020 at Reus Airport (Tarragona – Spain).**

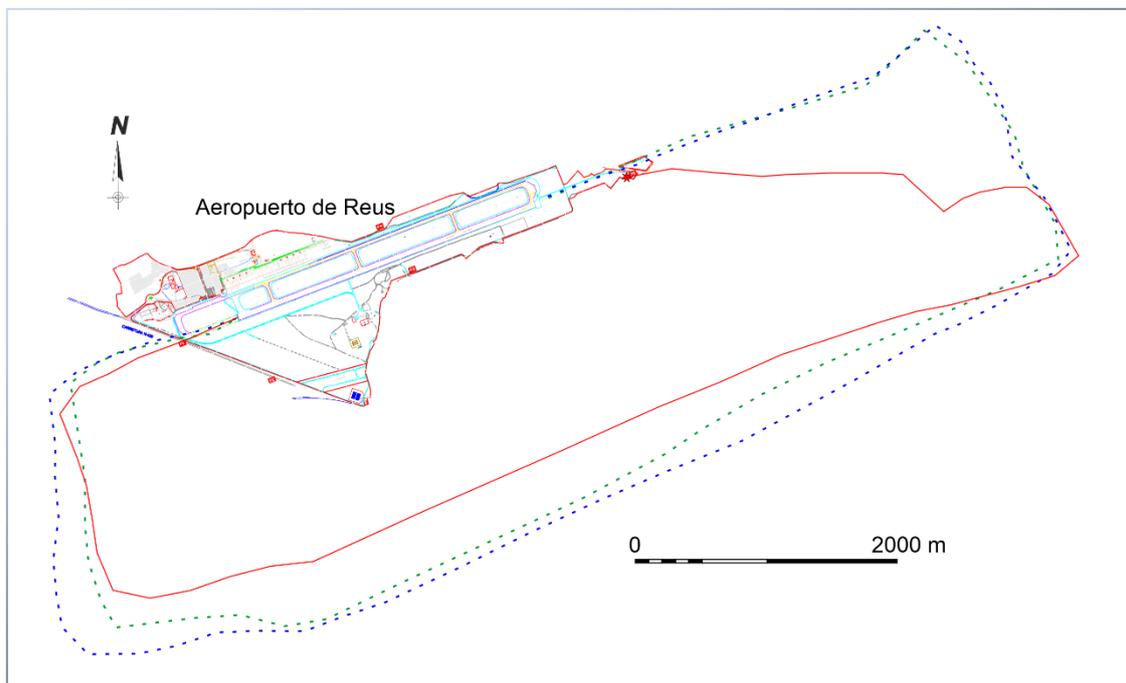
The information recorded by the air traffic control services made it possible to obtain the radar track of the aircraft's flight and reproduce its trajectory. The aircraft performed four circuits, the last three of which are shown in Figure 1; the accident occurred at the end of the last circuit, the trajectory of which is shown in red.

Figure 1.- The aircraft's trajectory.

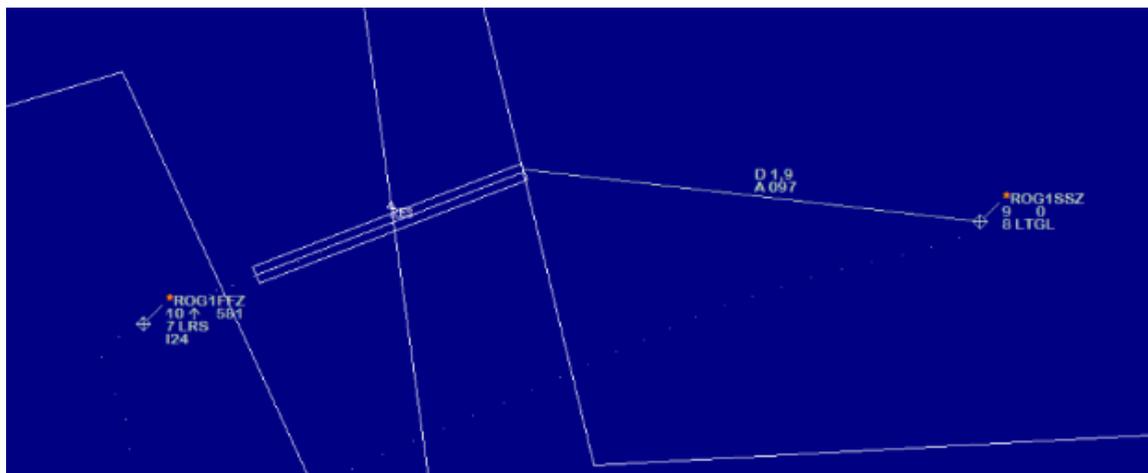
The aircraft continues on the downwind leg until it's 1.9 NM away from the runway head, at which point it maintains 80 kt and 900 ft and begins the turn for base.

Figure 2.- Aircraft on the downwind leg

The radar track images show that when the student initiated the turn from the downwind leg to the base leg, the aircraft was 1.9 NM from the runway. By this point, the engine failure had already occurred, as evidenced by the fact that the aircraft had descended to 900 feet while maintaining a speed of 80 kt.

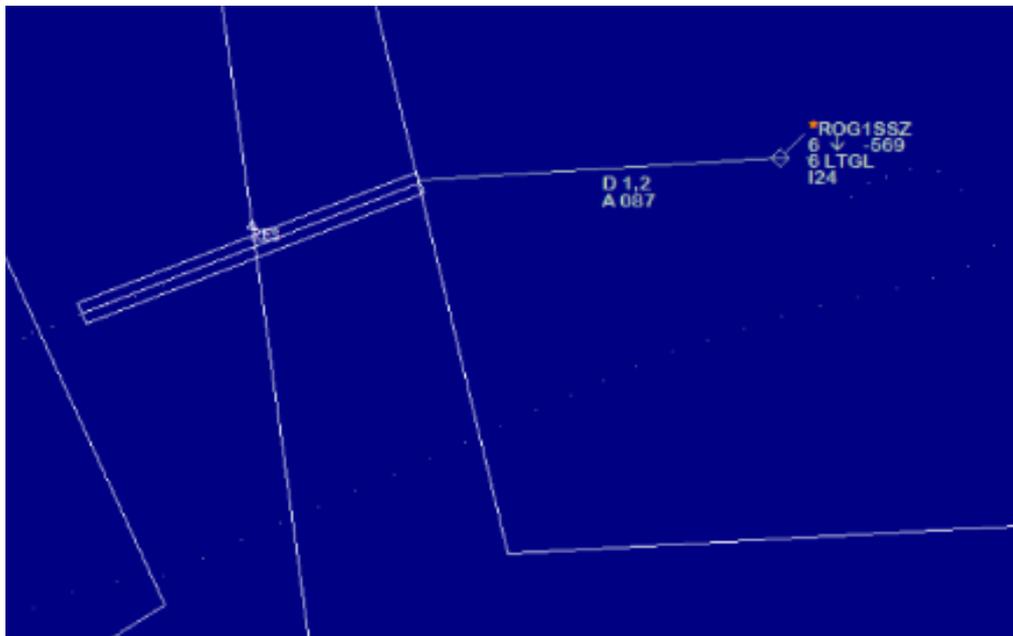
On the base leg, rather than maintaining a course perpendicular to the runway, the aircraft turns directly towards the runway, then turns perpendicular to the runway and finally turns onto final. On the base leg, the aircraft continues its descent at a rate of 569 ft/min, reaching 600 ft and a speed of 60 kt.

Figure 3.- Aircraft on the base leg.

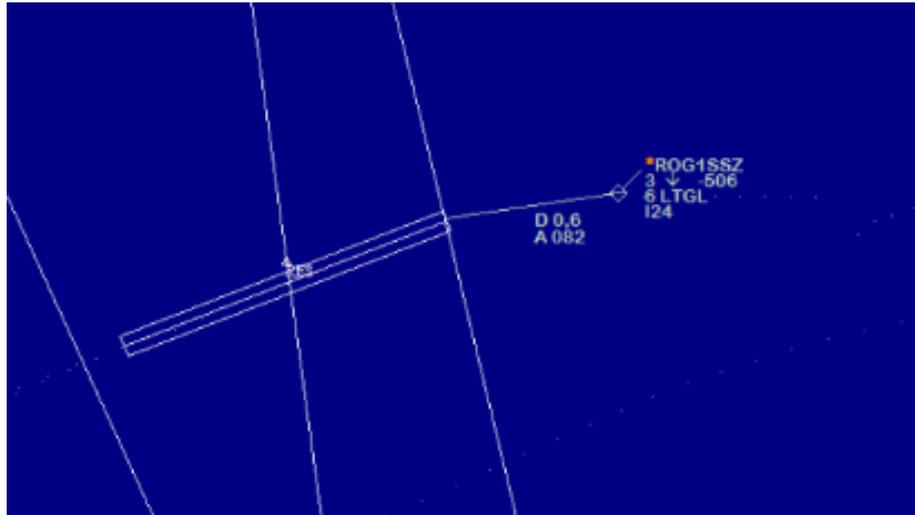
The last radar track image shows the aircraft descending at a rate of 506 ft/min at an altitude of 300 ft, a speed of 60 kt and a distance of 0.6 NM from runway head 25 at Reus Airport.

Figure 4.- Last image recorded by the radar track.

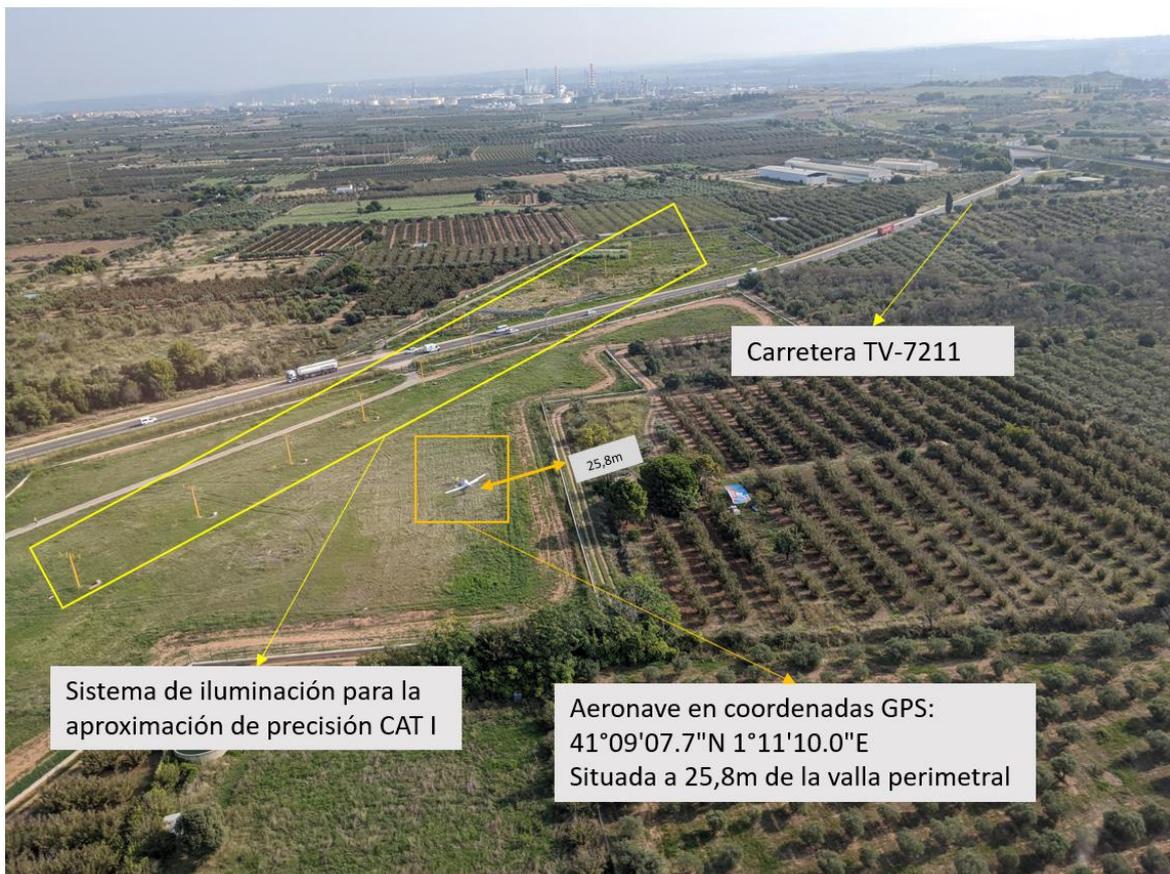
The aircraft came to rest within the airport perimeter, 25.8 m from the perimeter fence, specifically at 41°09'07.7 "N 001°11'10.0 "E.

Figure 5.-: Final position of the aircraft after the accident.

The aircraft initially hit the fence that surrounds Reus Airport. It then impacted the ground. After this second impact, the aircraft slid sideways to the left, causing the left main gear leg and the nose leg to collapse before coming to a definitive stop.

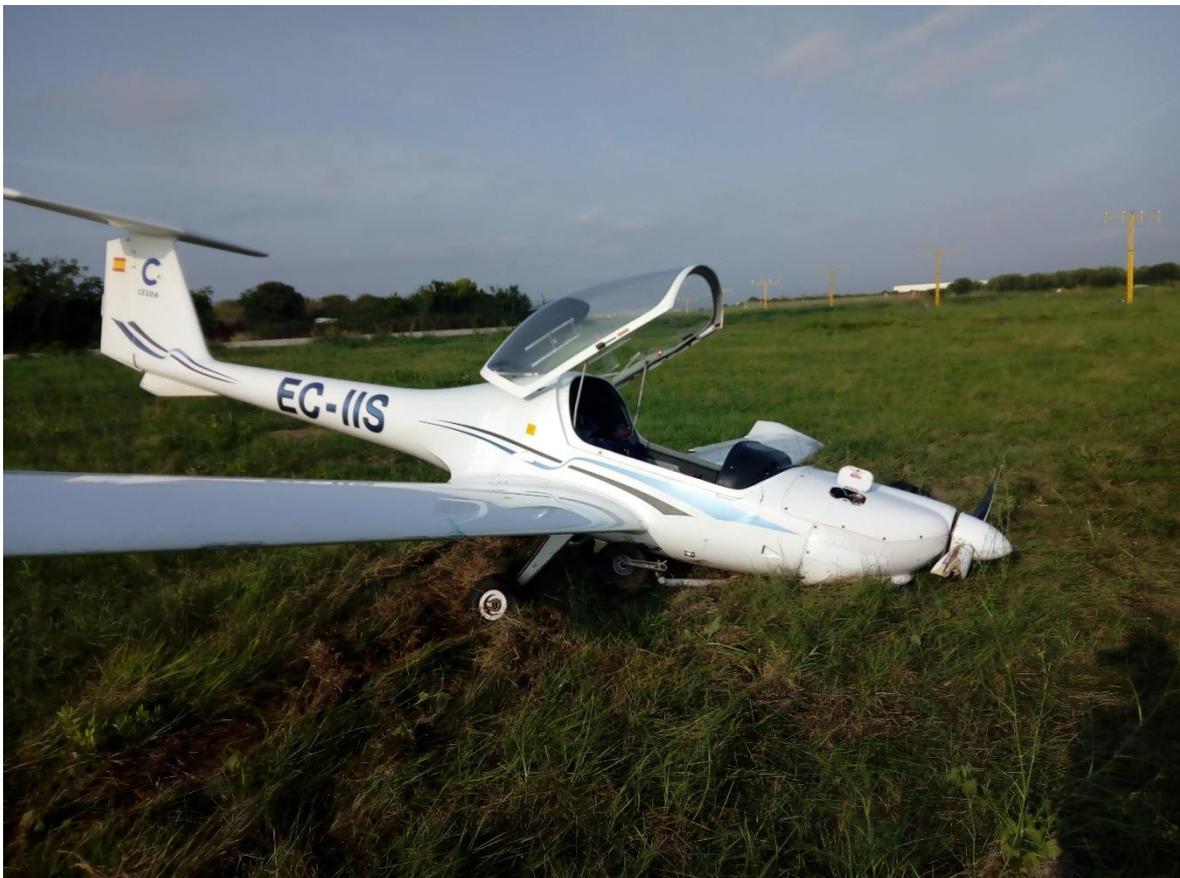
The cockpit retained its internal shape. The battery was switched off, the magneto key had been removed, the fuel shut-off valve was closed, and the flaps were in the take-off position.

Figure 6.- Aircraft after the impact.

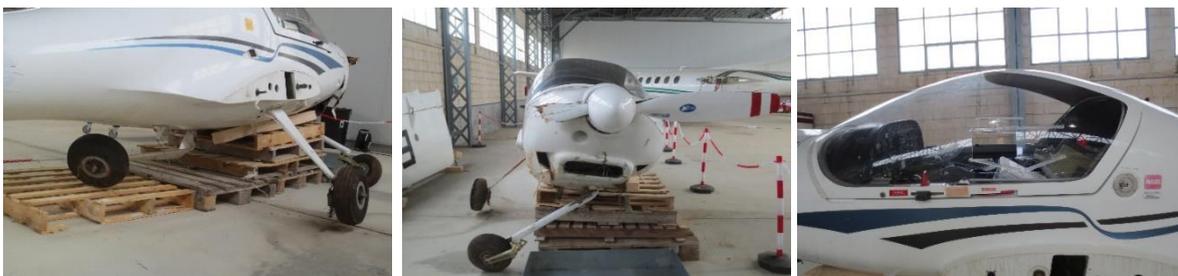
The landing gear exhibited deformations indicative of the aircraft's lateral displacement to the left: the left main gear leg and nose gear leg were displaced to the right, while the right main gear leg showed no apparent damage.

The lower engine cowling was scuffed and damaged due to slippage and impact with the ground.

The canopy had cracks on the lower left side, probably caused by the fuselage deformation in the area around the cockpit frame.

Figure 7.- Damage to landing gear, propeller, lower engine cowling, and cockpit.

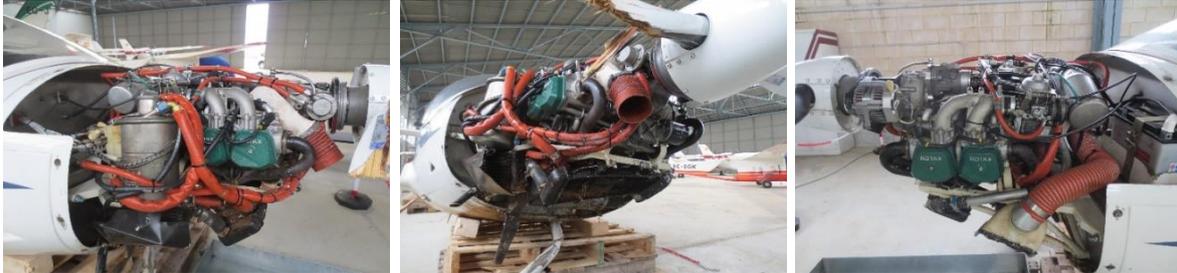
The cowlings were removed from the engine. Except for one impact to the lower part, which had affected the radiator positioned in that area, the engine appeared normal, and no oil was found on the exterior of the engine.

Figure 8.- Views of the engine installed in the aircraft.

The lubrication system components were in good condition, and no cracks or leaks were found anywhere in the system. The dipstick was used to check the oil level in the tank, noting that it didn't show any oil at all. The engine sump was drained, and about a litre of oil was obtained.

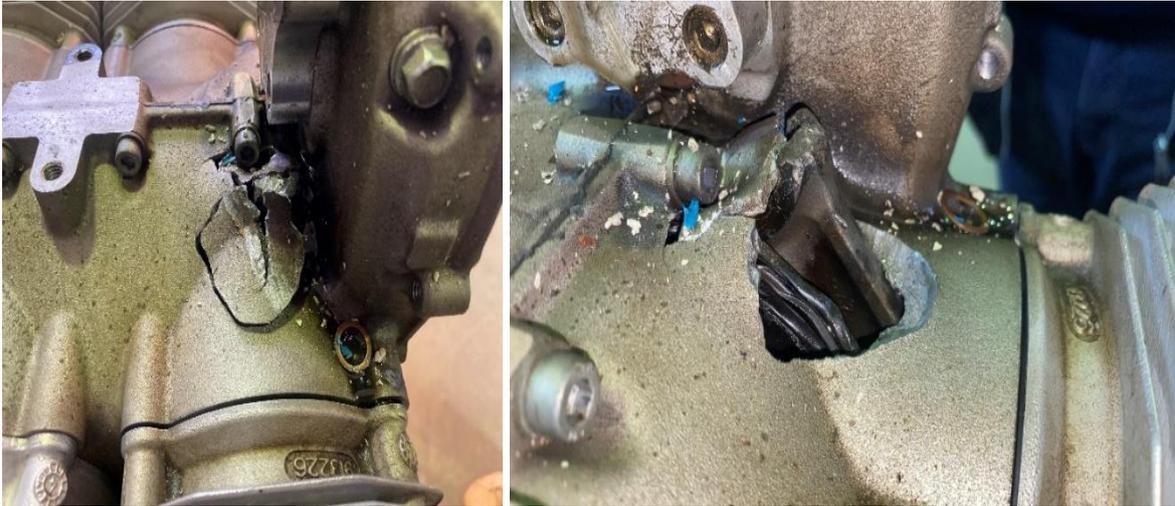
Once all the external components of the engine had been disassembled, a crack in the wall of the crankcase itself was found on the upper surface of the right half-crankcase, in the area corresponding to the movement area of cylinder no. 1; the connecting rod of piston no. 1 was visible through it, protruding from the wall.

Figure 10.- Crack in the upper surface of the right half-crankcase and the connecting rod of piston no. 1 protruding.

During the inspection of the engine, it was found that the engine was operating at a higher temperature than usual due to the limited amount of oil in the engine, which was estimated at one litre and clearly below the minimum required, preventing the engine from being properly cooled and lubricated.

- Perform oil changes in ROTAX engines every 25 hours of flight, instead of the 50 hours of operation recommended by the engine manufacturer.
- Reduce the time between general overhauls of ROTAX engines from 2,000 hours to 1,000 hours. This measure was implemented in September 2021 and was carried out in cooperation with the CAMO manager and with the approval of the Rego Foundation management.

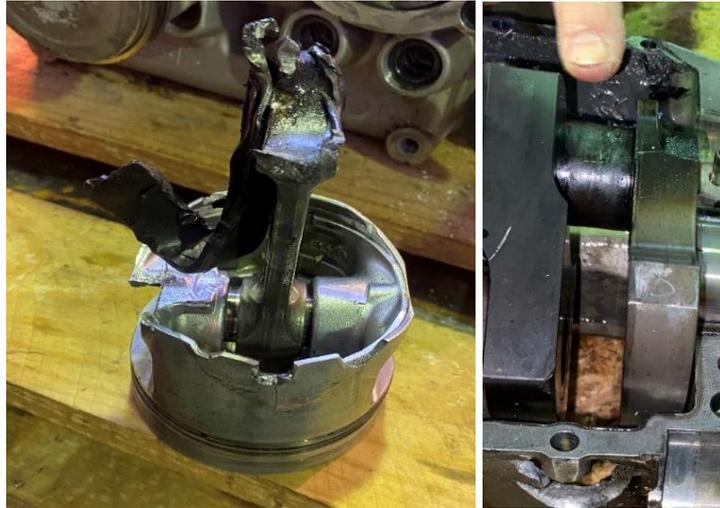
- Cylinder skirt damaged and with material loss.
- Piston degraded and with material loss from the skirt.
- Connecting rod in two parts, with signs of plastic deformation due to overheating. The larger part was attached to the piston, exhibiting evidence of severe stretching and deformation in the head area. The other part remained on the crankpin and also displayed signs of severe stretching and deformation.

Figure 11.- Connecting rod, piston and crankpin of cylinder no. 1

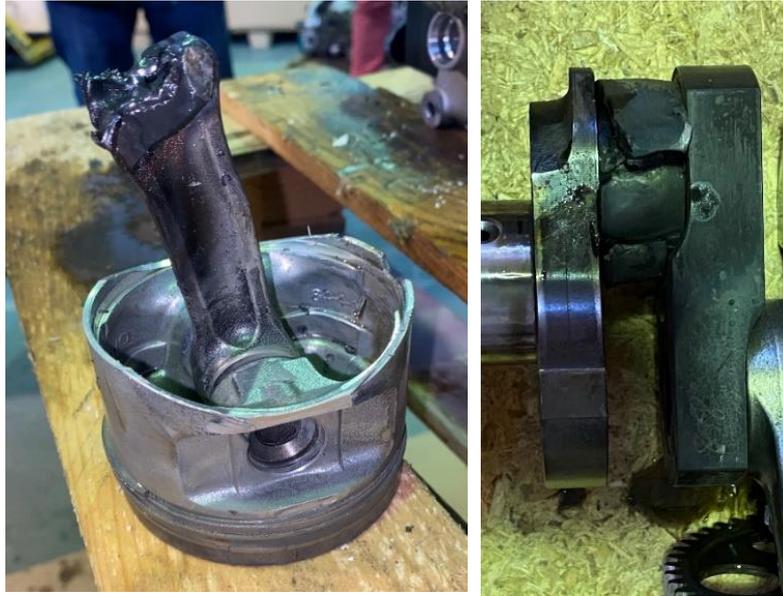
- Cylinder skirt damaged and with material loss.
- Piston degraded with material loss from the skirt and residue deposits in the head.
- Connecting rod in two parts, with signs of plastic deformation due to overheating. One part was attached to the piston and the other remained on the crankpin with signs of severe stretching and deformation.

Figure 12.- Connecting rod, piston and crankpin of cylinder no. 4

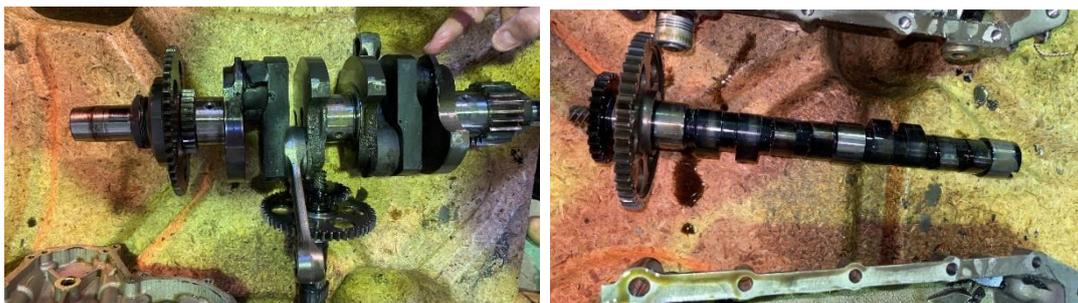
The camshaft was in its housing and intact. There was no malfunctioning damage to the camshaft and tappets, nor any damage caused by lubrication deficiencies. No oil flow holes were found to be clogged.

The crankshaft was supported in its bearings and remained intact, with all three bearings exhibiting heavy wear. No oil flow holes were found to be clogged.

Figure 13.- Crankshaft and camshaft.
