## Report A-046/2019

Accident involving a ROLLANDER  
SCHNEIDER aircraft, registration  
F-CESR, in the vicinity of Pico  
Bisaurín (Huesca) on  
21 August 2019

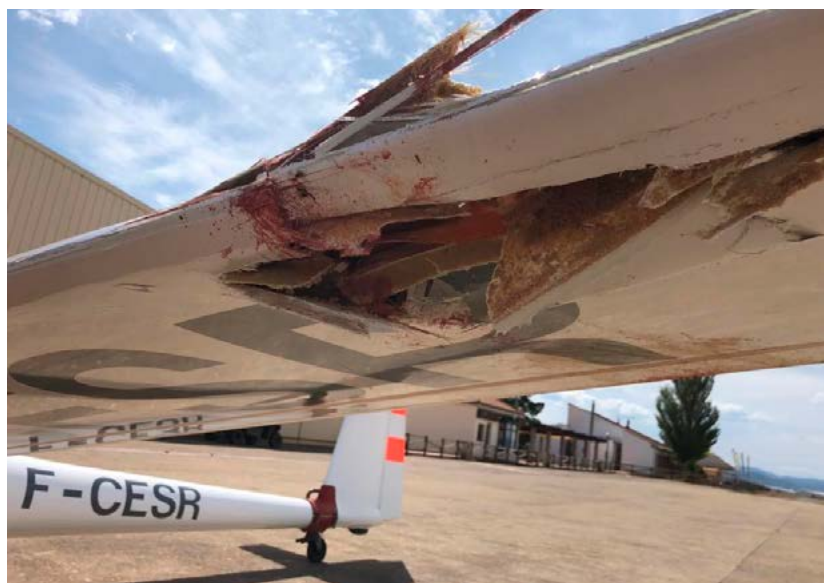
The glider had a hole at the midpoint of the left wing that measured about 40 cm long by 20 cm wide, crossing the wing perpendicularly.

Figure 1. Aircraft after landing

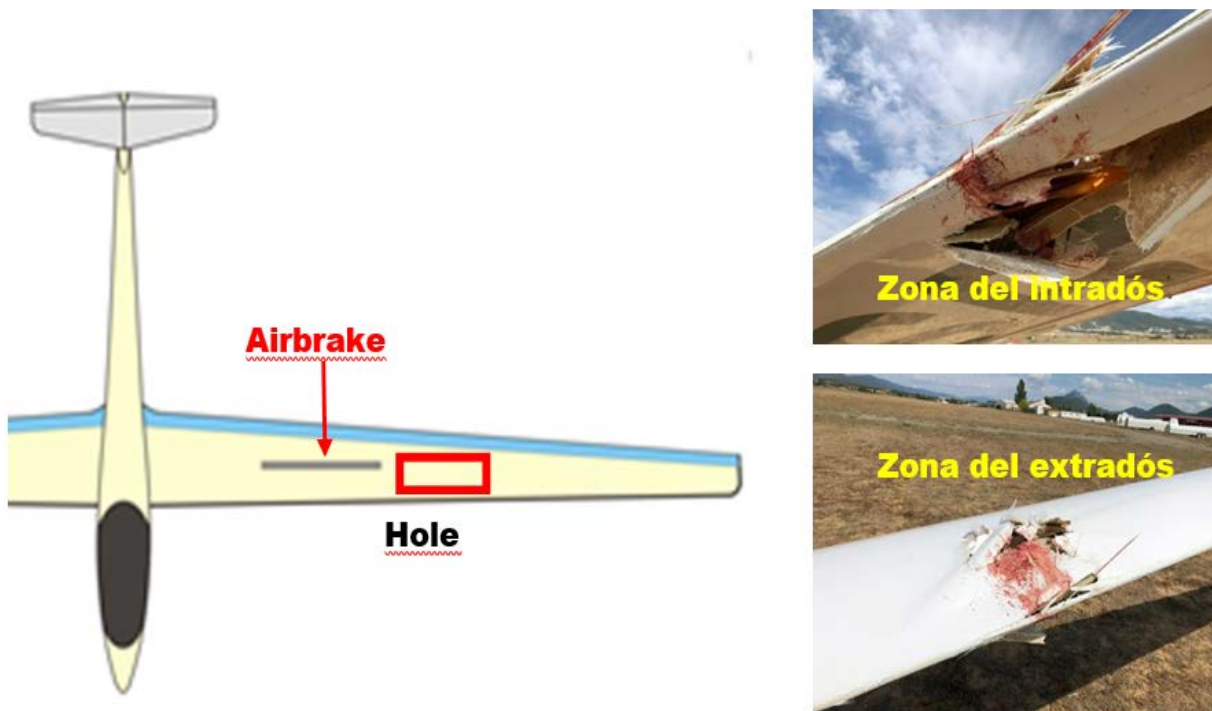
The bird impacted the left wing, creating a hole that went from the bottom to the top surface of the wing, starting immediately after the spar on the leading edge near the part of the airbrake closest to the fuselage. It was 40 cm long (parallel to the spar) and 20 cm wide (parallel to the chord).

Figure 6. Damage to the aircraft
