CIAIM-03/2020 REPORT

Collision of the passenger and wheeled vehicle ferry EXCELLENT against the South Dock (dock 24B) and the BABCOCK&WILCOX PANAMAX gantry crane number 904 on the 31st of October 2018

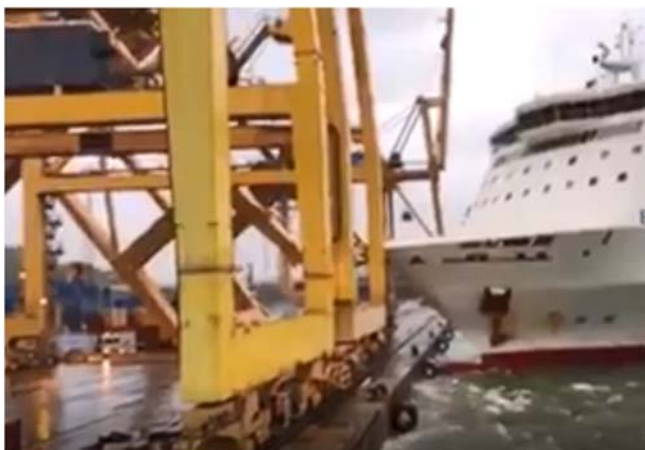
Figura 7. Moment of the collision

At 07:59:49 local time, the bow of the RO-PAX EXCELLENT collided with one of the legs of the BABCOCK & WILCOX PANAMAX gantry crane number 904, which toppled onto several containers stored nearby, causing a fire in the APM container terminal of the South Quay. Several containers were affected, some containing hazardous merchandise. The bulbous bow of the vessel collided with the South Quay (24 B) in the area of module 5. The approximate angle of the impact between the vessel and the quay was 45° with respect to the quay. At this time the vessel's engines were powering astern, its speed was 5 knots and its course was 260.8°. The wind speed indicated by the vessel's anemometer was 35 knots from 159.1°.

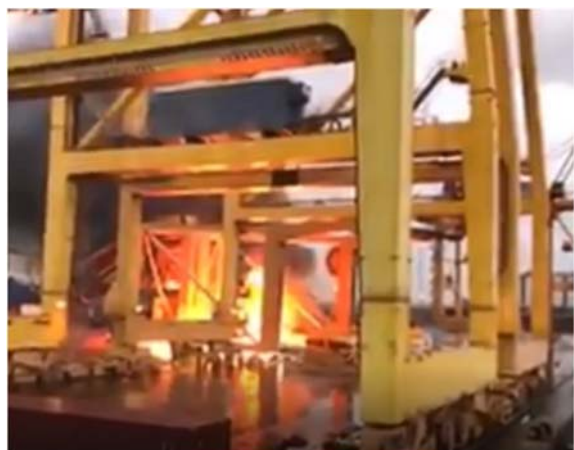
Figura 8. Collapse of the crane

On land, the crane fell, as already mentioned, and there was damage to various containers and their contents, which the CIAIM has not evaluated. Damage to the quay was also observed, in the area where the bulbous bow collided with it. No personal injuries were caused.

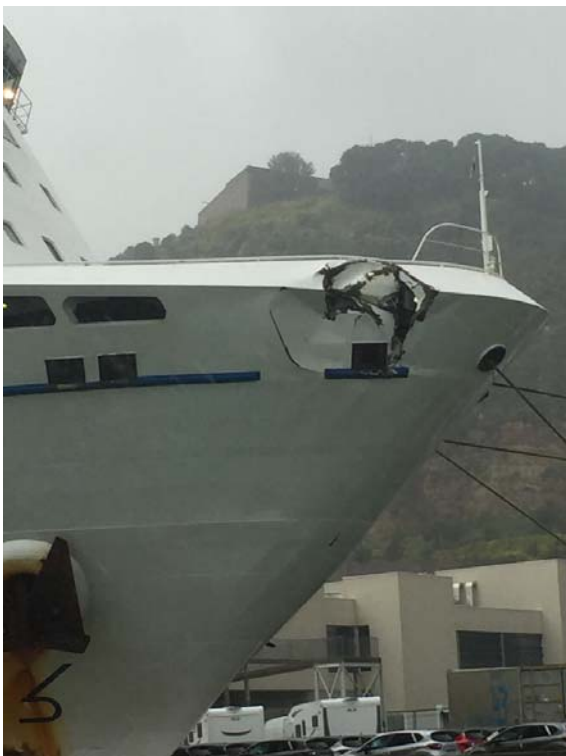
- In the bulbous bow: damage with a length of 3,000mm at approximately 2,000mm from the base line (deformations and splits). The most important damage was the V-shaped split located in the starboard side of the forepeak.
- Forecastle and weather deck: deformations and splits, including to reinforcements and hawsehole, with a length of 3500mm.

Figura 9. Damage to the starboard forecastle and the weather deck

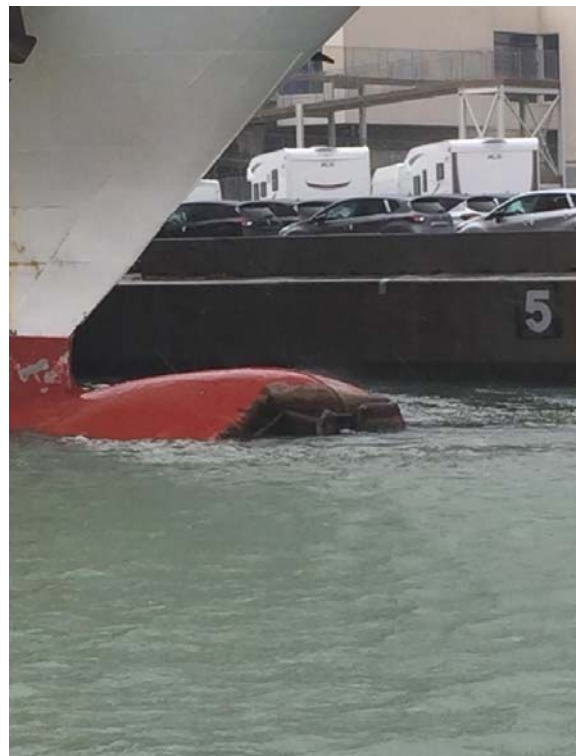
Figura 10. Damage to the bulbous bow

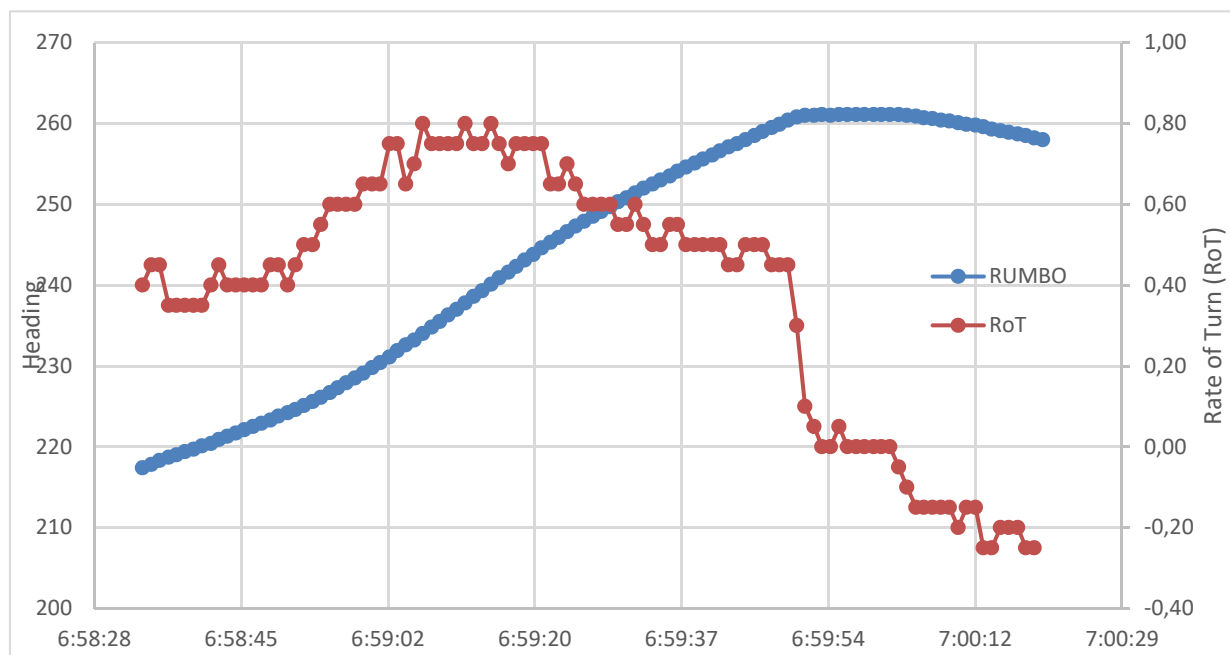
Figura 11. Vessel's heading and rate of turn - RoT (time in UTC)

Figura 11 shows the vessel's heading, obtained from data in its VDR, together with the Rate of Turn (RoT) during the moments before and after the accident. It can be seen that the vessel was veering starboard at a more or less constant rate. At a certain moment, at 07:59:49, the heading stopped increasing and the RoT decreased abruptly

to zero. This happened when the bow hit the quay, so the vessel could not continue to veer to starboard, and this establishes the exact time of the collision.

No effect of the manoeuvring propellers in the vessel's heading can be appreciated, since it maintained a positive RoT (see Figura 11) during the seconds prior to the collision.

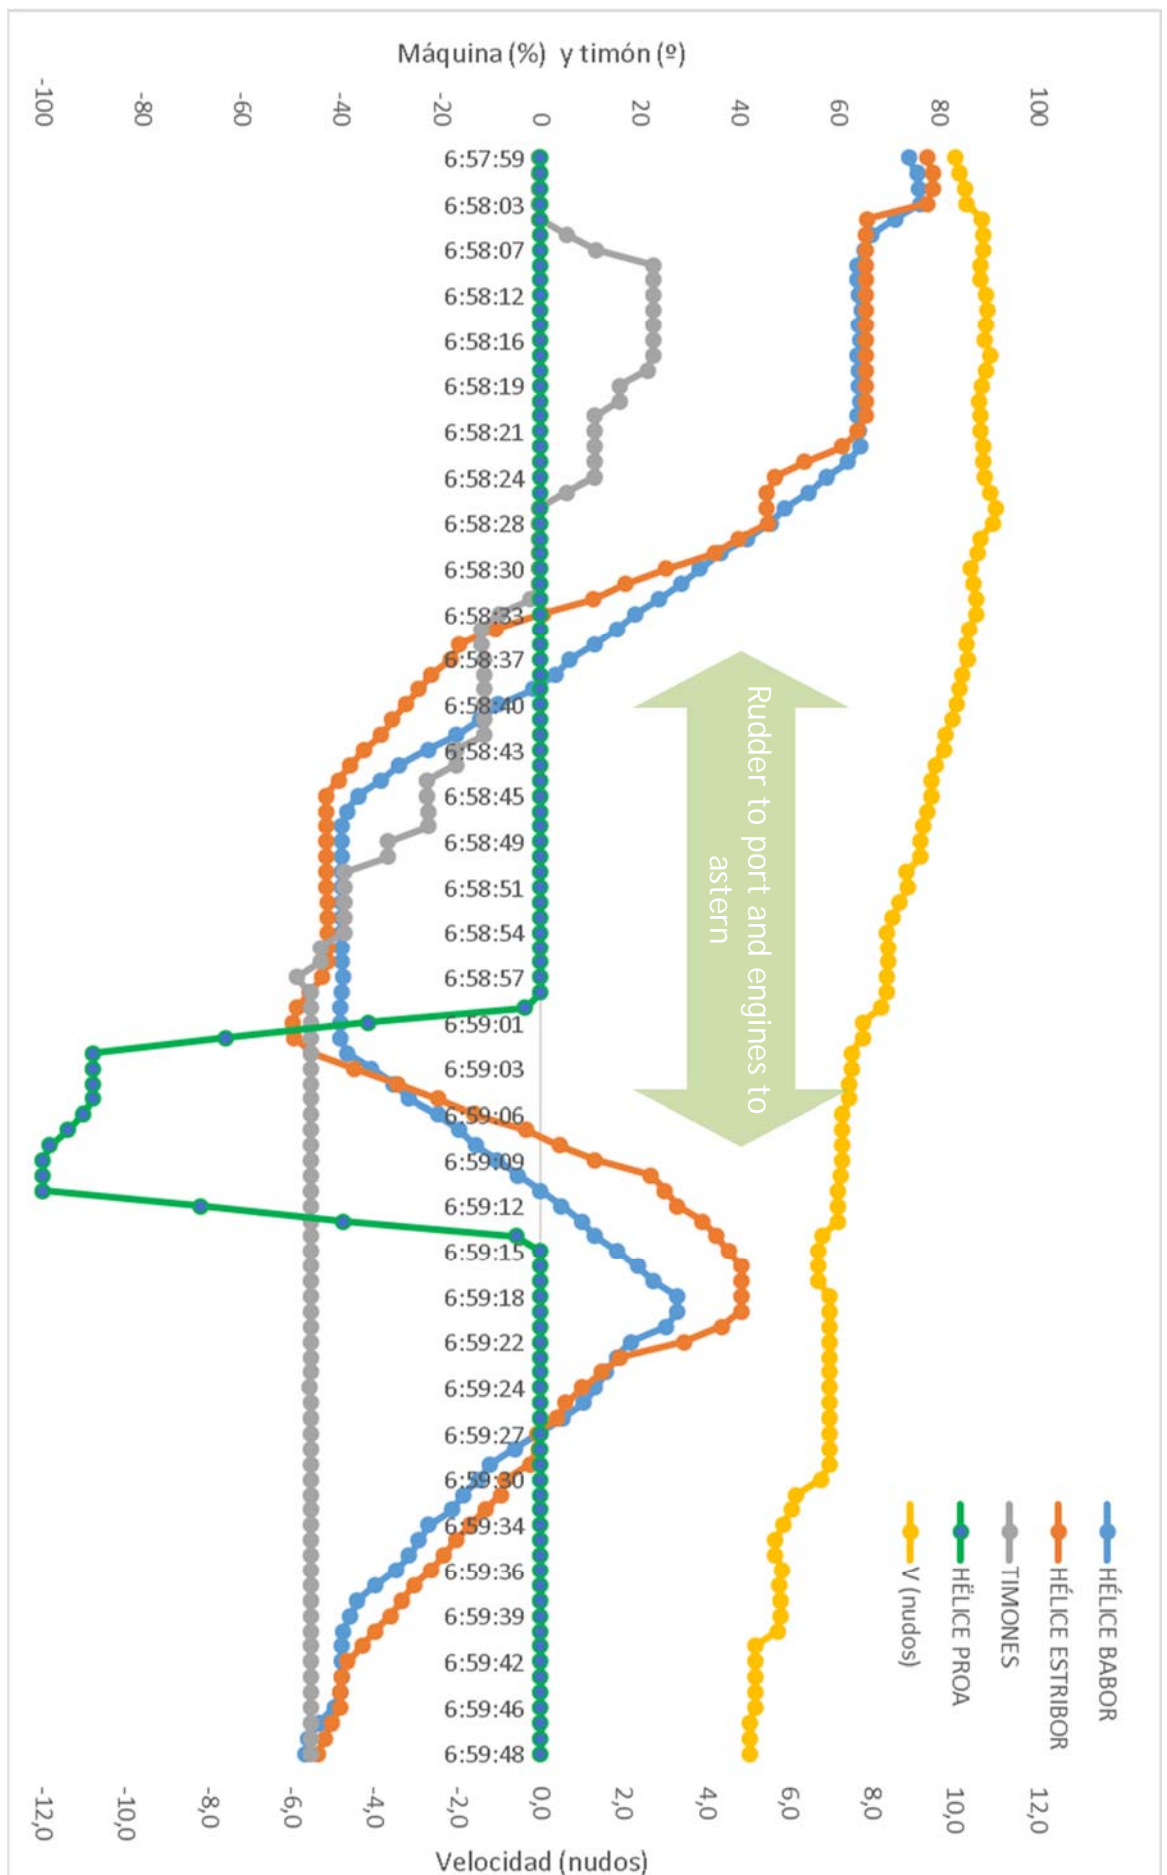
Figura 12. Engine speed and rudder positions (UTC time)

Tabla 1 shows an extract from the rudder, main propellers and transversal bow propeller data during the minutes preceding the collision, taken from the vessel's VDR. The data shown in red correspond to the port rudder and propeller, while those in green correspond to the starboard rudder and propeller. Figura 12 shows this data graphically.

During a period of half a minute (see Tabla 1 and Figura 12), the propellers were in reverse, so the rudders did not have the expected effect. In the VDR, the maritime pilot's surprise can be heard as he noticed that the engine telegraph was showing both propellers powering astern, ordering full ahead. Seeing that it was impossible to control the vessel, he then ordered both engines full astern. The captain ordered the anchor to be dropped, but there was no time for this, and seconds later the vessel collided with the quay and the crane.

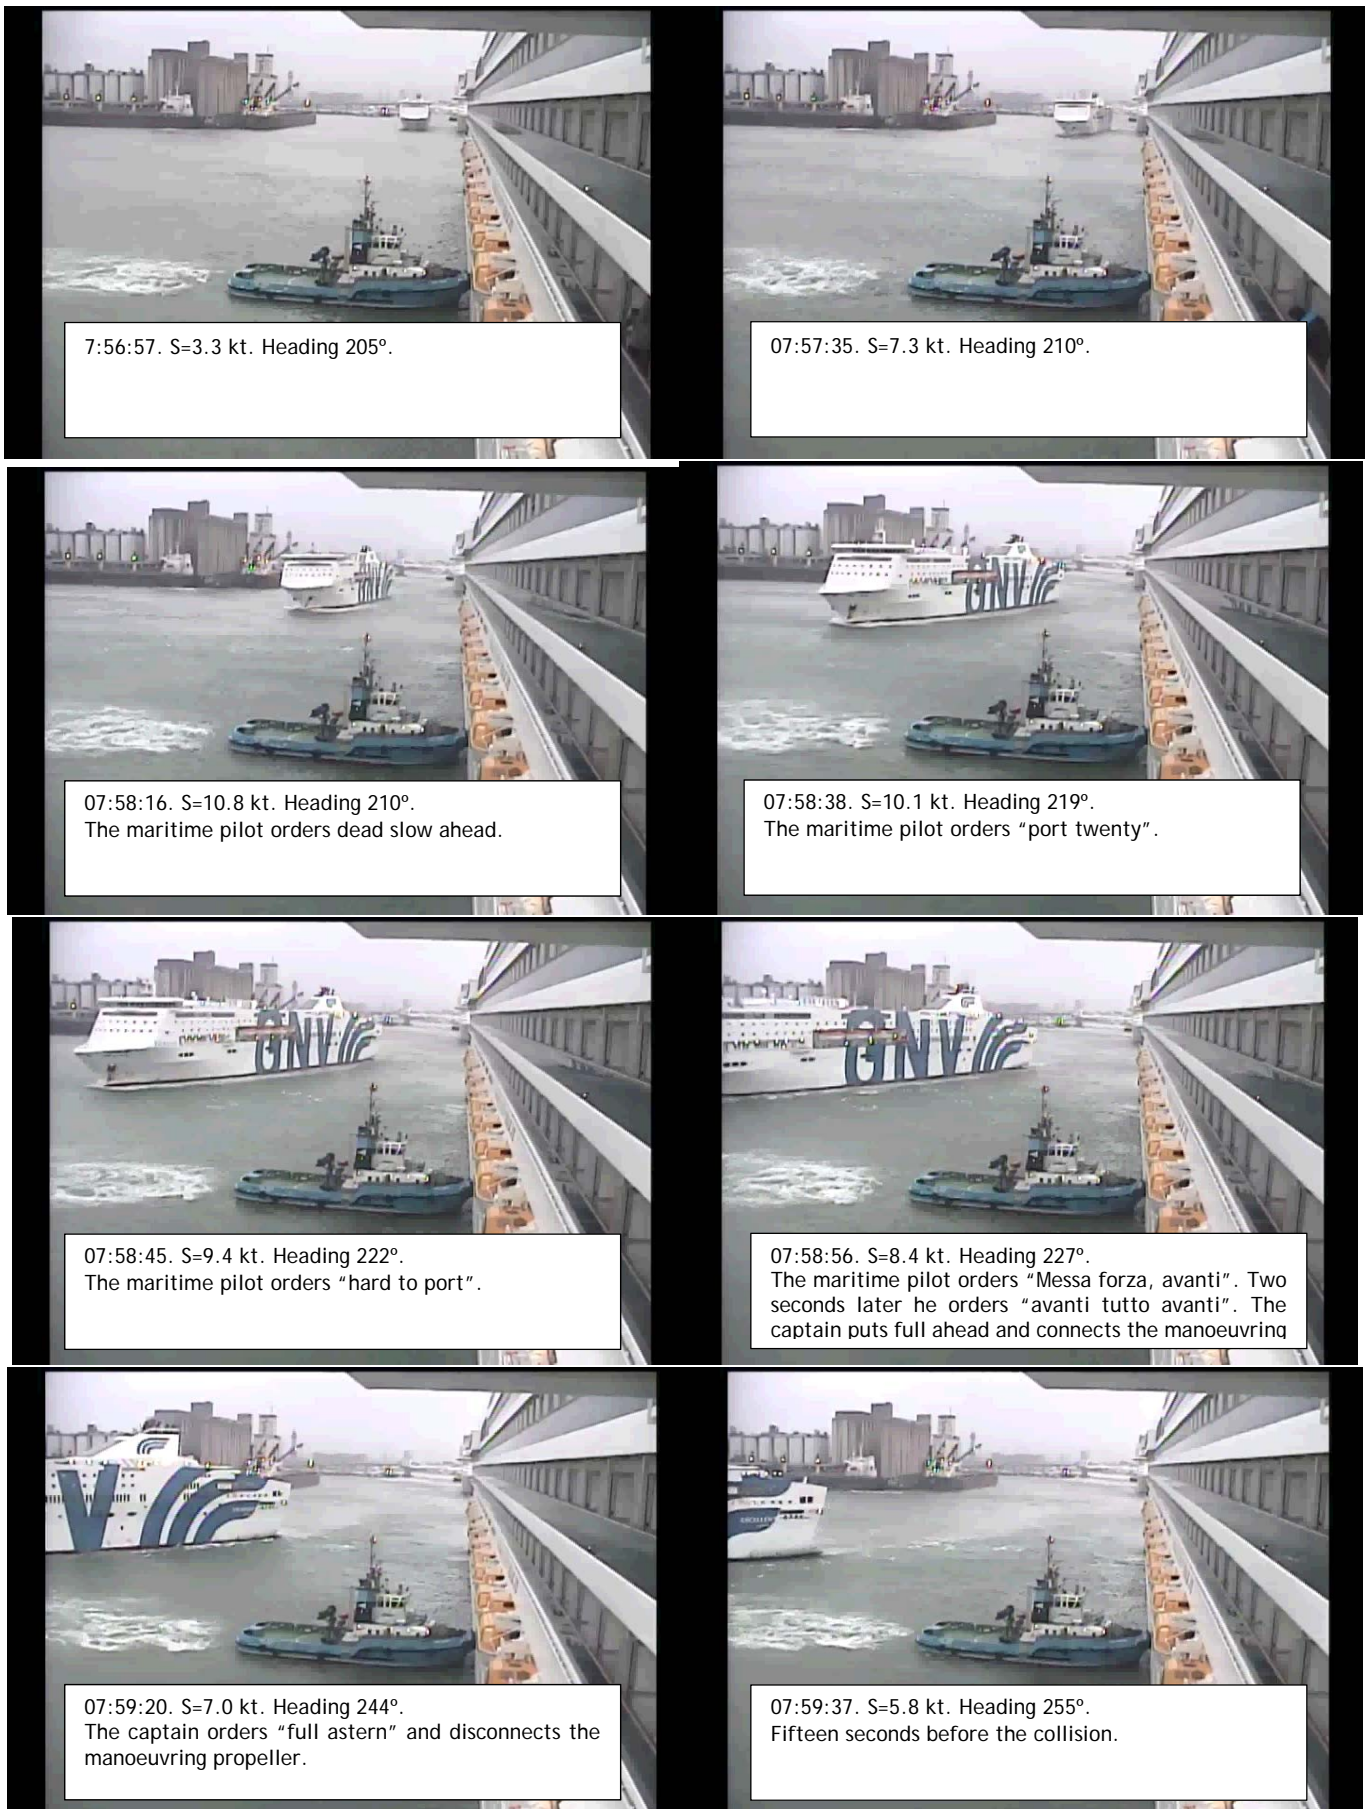
The following sequence of images shows the movements of the EXCELLENT, captured by a television camera located on the COSTA FAVOLOSA cruiser (Figura 13), and by the Port Authority AIS (Figura 14). At 07:58:38, the EXCELLENT had not yet come abreast of the tugboat CALA GULLO. In fact, it did not do so until a few seconds before the collision with the quay, so the propeller wash from the tug did not influence the EXCELLENT's veering to starboard.

Figura 13. Movements of the EXCELLENT and the tugboat CALA GULLO seen from the COSTA FAVOLOSA cruise ship

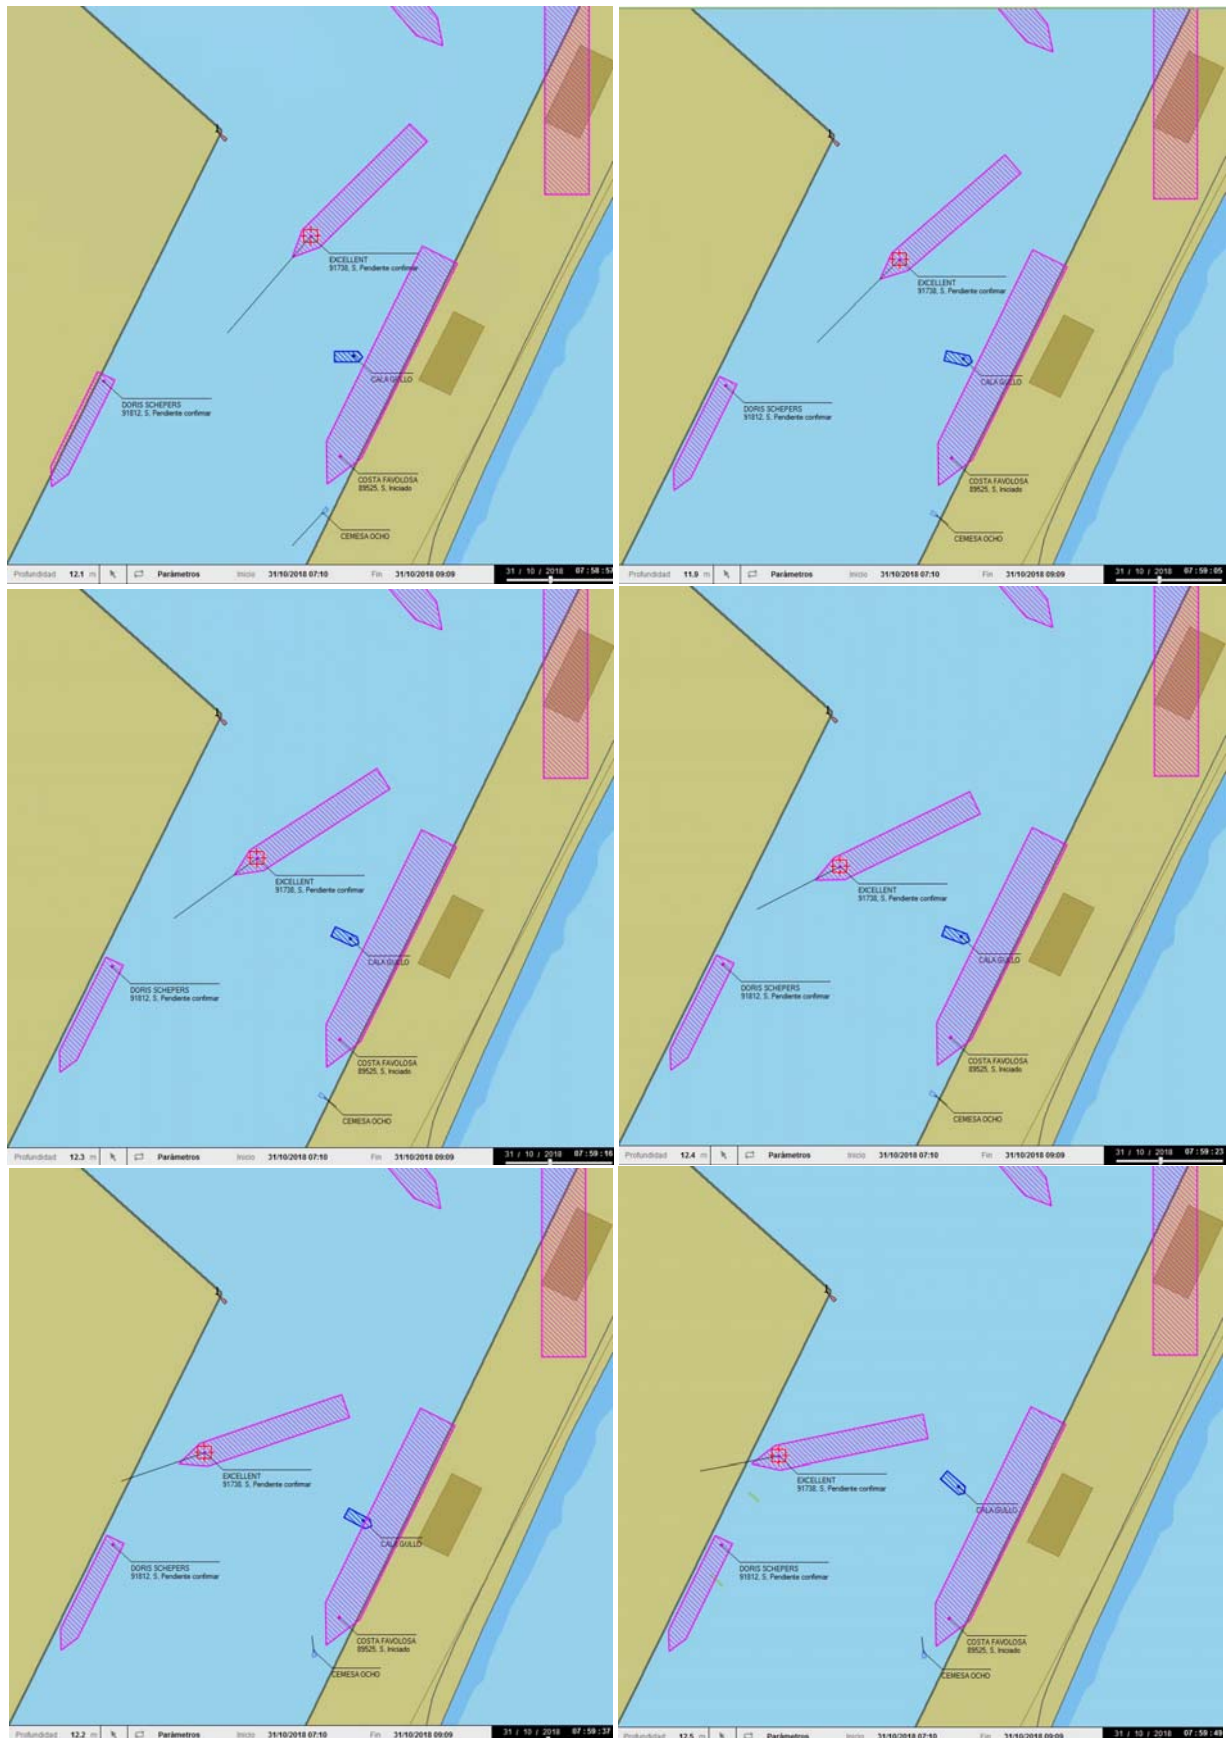
Figura 14. EXCELLENT, tugboat CALA GULLO and COSTA FAVOLOSA (source: Barcelona Port Authority)

The EXCELLENT came abreast of the CALA GULLO and its propeller wash approximately half a minute before the collision, so the collision was inevitable, and would have occurred even if the CALA GULLO had not been pushing the COSTA FAVOLOSA.
