## CIAIM-19/2021 REPORT

Operational accident on board the CIUDAD DE PALMA in Santa Cruz de Tenerife during loading operations on the 20th of June 2020, resulting in one fatality and two very serious casualties.

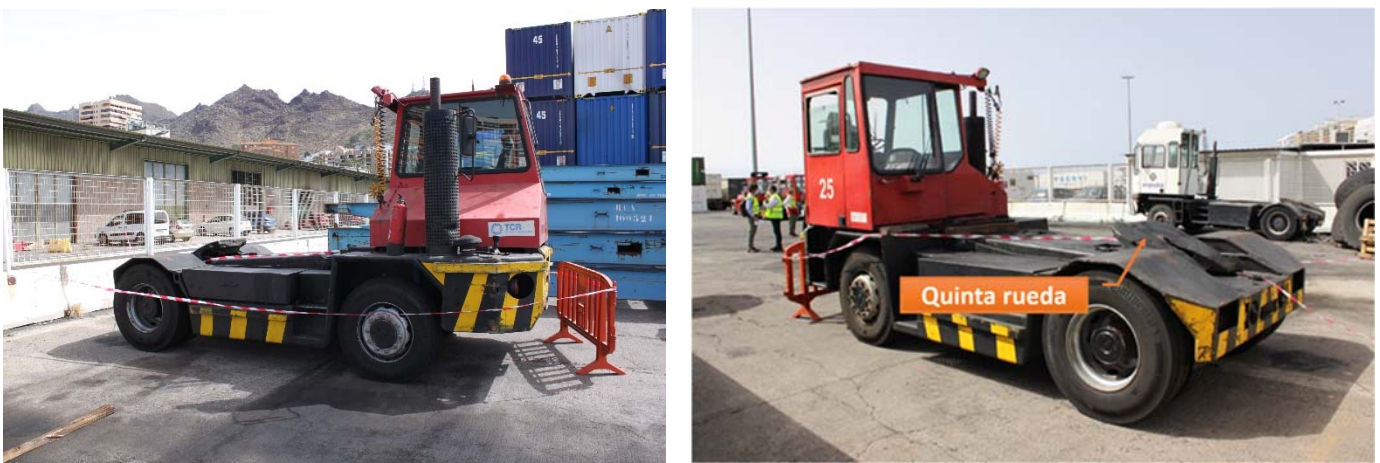
Figure 11. The tractor unit involved in the accident, shown from either side.

There are maintenance records for the unit. The last regulated maintenance carried out prior to the accident was on 11/02/2020, and consisted of a check following 250 hours of operation (the unit's hour meter marked 5,200 hours, according to this inspection). In this respect, it is relevant to note that the section corresponding to "Check the operation of the rotating seat and check that it anchors correctly in both positions" is marked as "seen", and in the "Comments" section the text "Check cab, outer bodywork has rust" was added.

An annual inspection was performed on 05/11/2019, according to the Certificate of Compliance issued by the company OCASUR 2010, S.L. in accordance with Article 4 of Royal Decree RD 1215/1997. No faults or comments were noted.

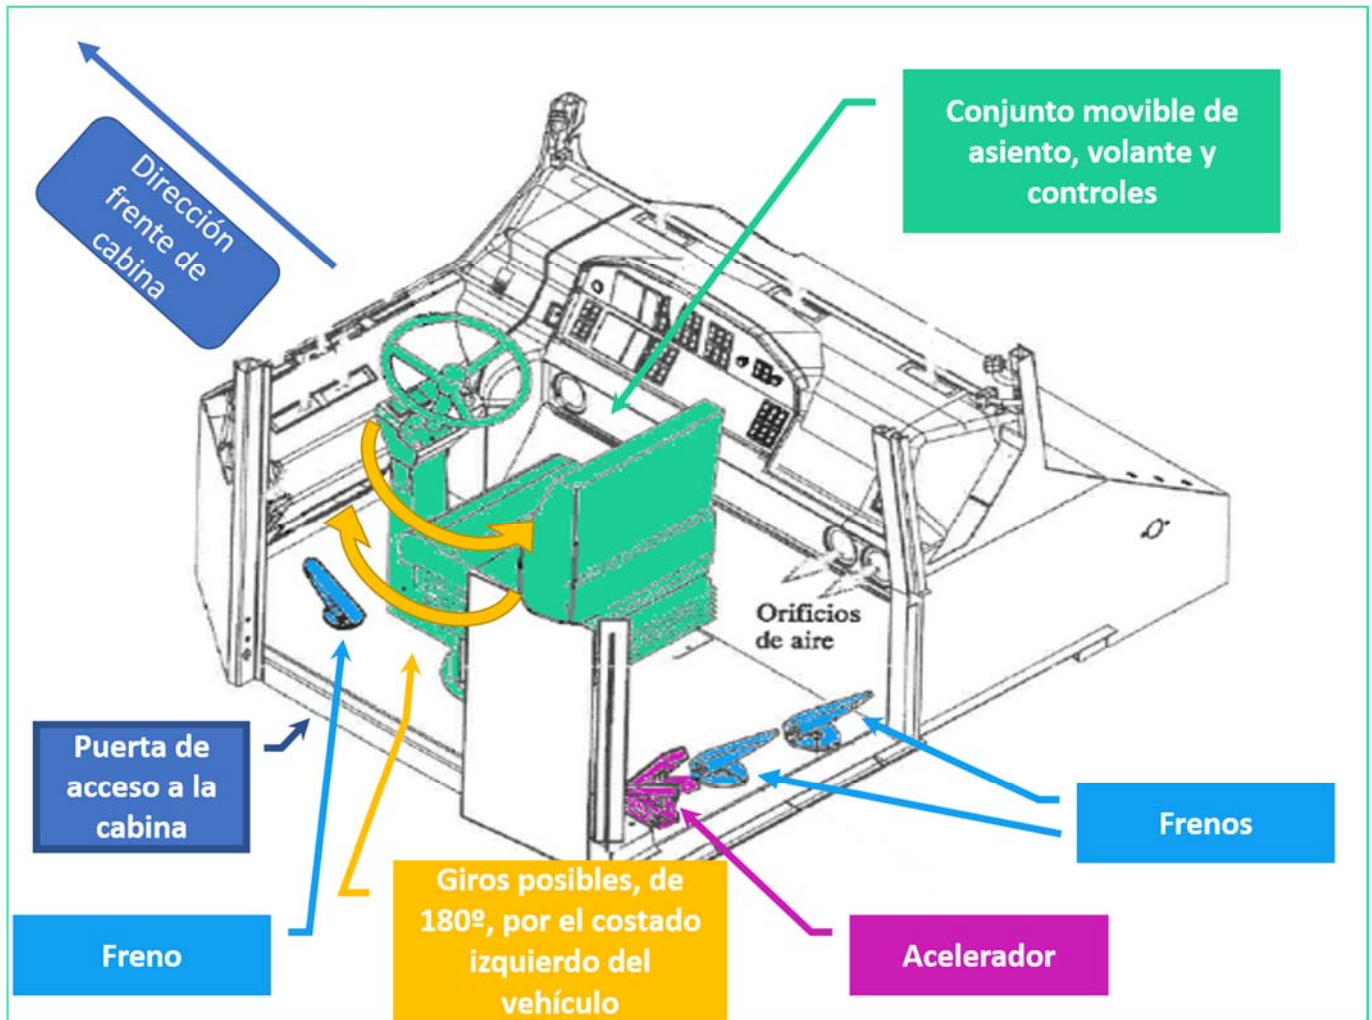
Figure 12. Cab of the tractor unit, with the movable driver’s workstation shown in green (source: Operating and maintenance manual for TRX / TTX-182/192 terminal tractors).

CIAIM checked whether the seat’s changeover device was working correctly, and found that the point of changeover was located at approximately 90° of the seat’s full range of movement (180°), and was therefore compliant.

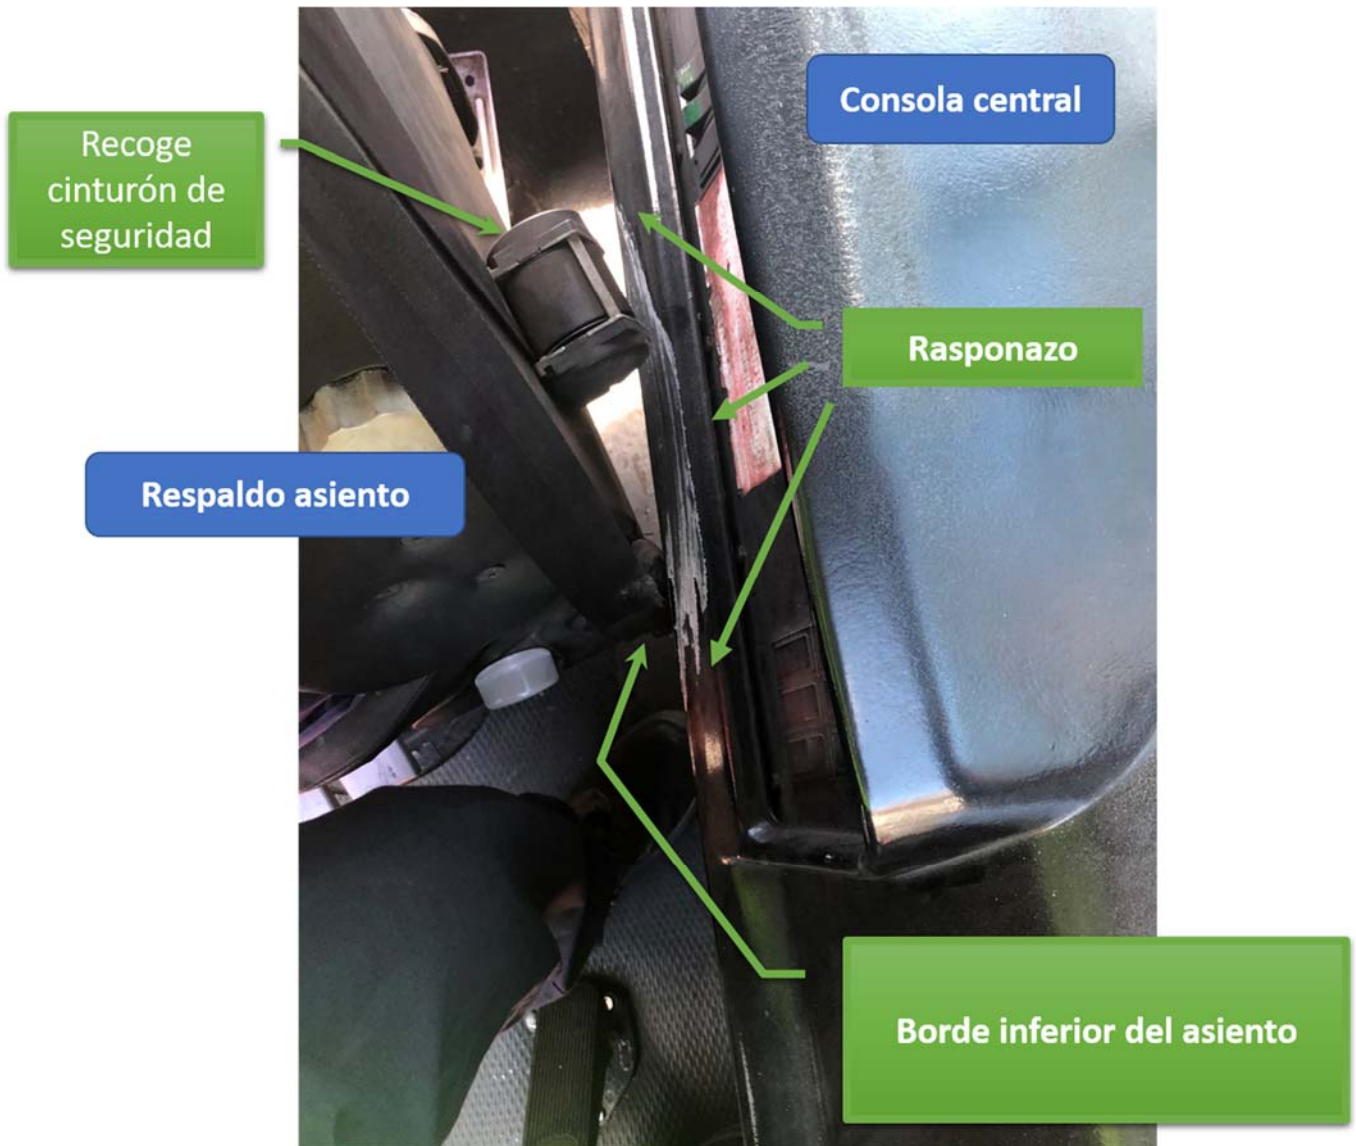
Figure 14. Area of friction between the driver's seat and the centre console

CIAIM checked the driver's seat extremely thoroughly. On the plastic cover of the tractor unit's control panel, on the right-hand side of the cab, there was a large area of abrasion, around 25-30 cm long by 7 cm wide, with a loss of material in the lower middle area. This abrasion is consistent with the deterioration observed in the rear/back section of the driver's seat, and in the seatbelt retractor that protrudes from the back of the seat. See Figures 14 and 15.

According to the statements of the dockers and the company, these abrasions were not produced immediately prior to the accident; rather, they were known about for some time beforehand. The areas most affected are the seatbelt retractor and the lower inner edge of the seat; both scrape forcibly against the cover of the centre console.

The investigation revealed that when adjusting the backrest to a certain depth, which is permitted by the adjustment system, the backrest strikes the cover of the panel and prevents the seat from rotating.

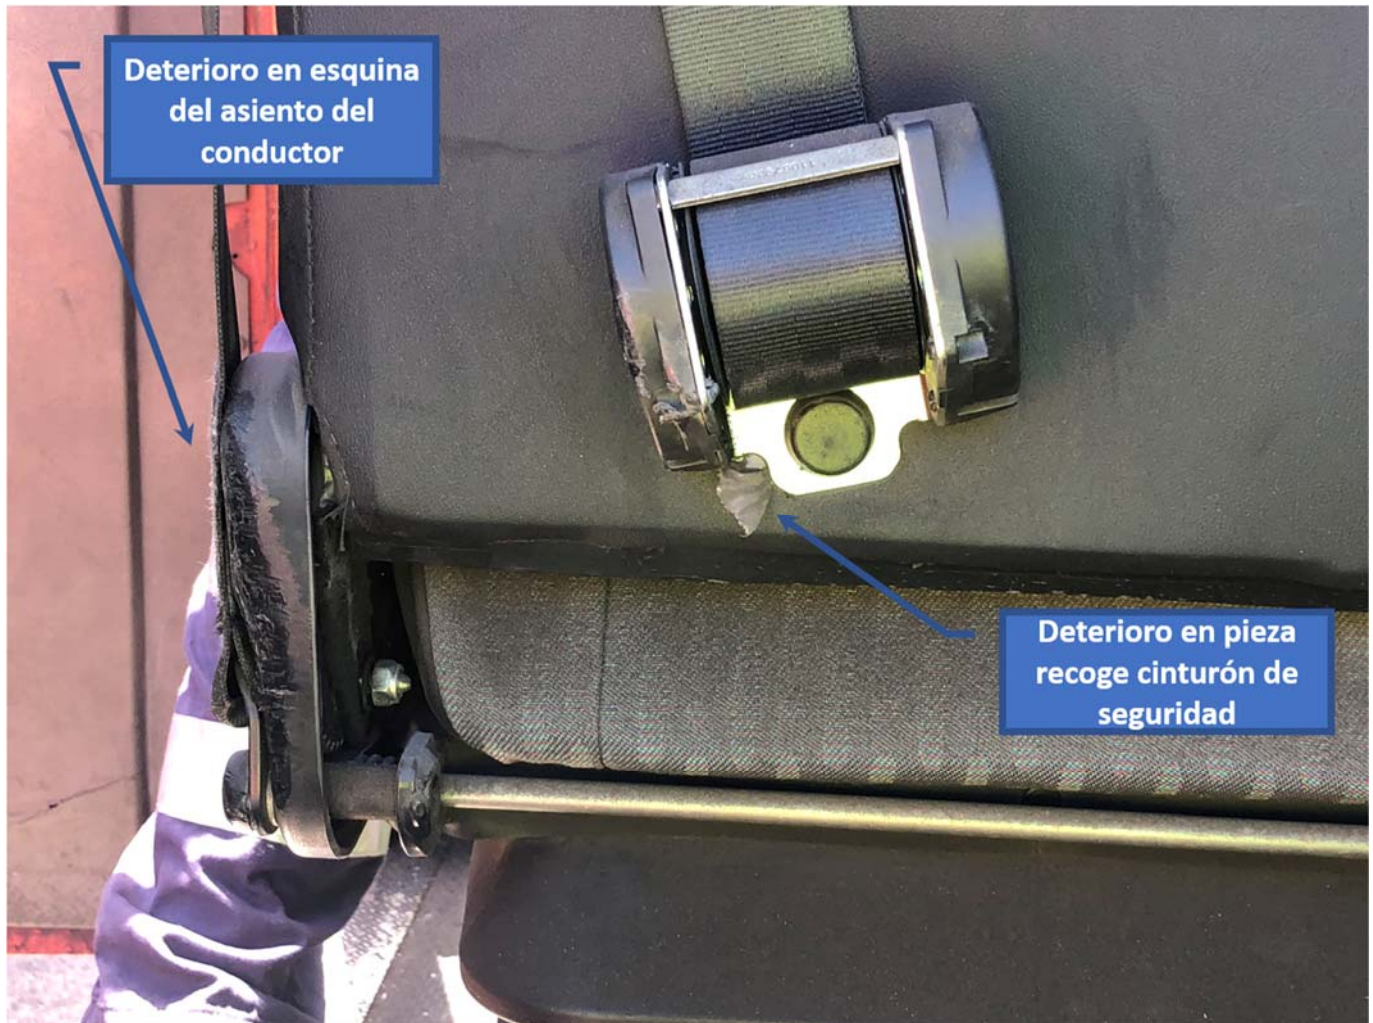
Figure 15. Deterioration of the driver's seat in the tractor unit

According to the various witness statements, the driver was heavysset. The investigation has not been able to explore the ergonomics of the workstation and determine, *in situ*, any restrictions to the movement of the workstation within the cab as a result of the size of the driver. However, the physical evidence found in the form of significant abrasions to the backrest of the driver's seat and the corresponding section of the console support the idea that there were restrictions to the seat's rotation.
