TECHNICAL REPORT

IN-001/2022

Incident on 08 January 2022 involving a privately-operated MOONEY M 20K 231 aircraft, registration D-EKUR, and a ROBINSON R 44 helicopter operated by AVIATION HELICOPTER CENTRE, registration EC-MTH, at Son Bonet Aerodrome (Mallorca, Spain)

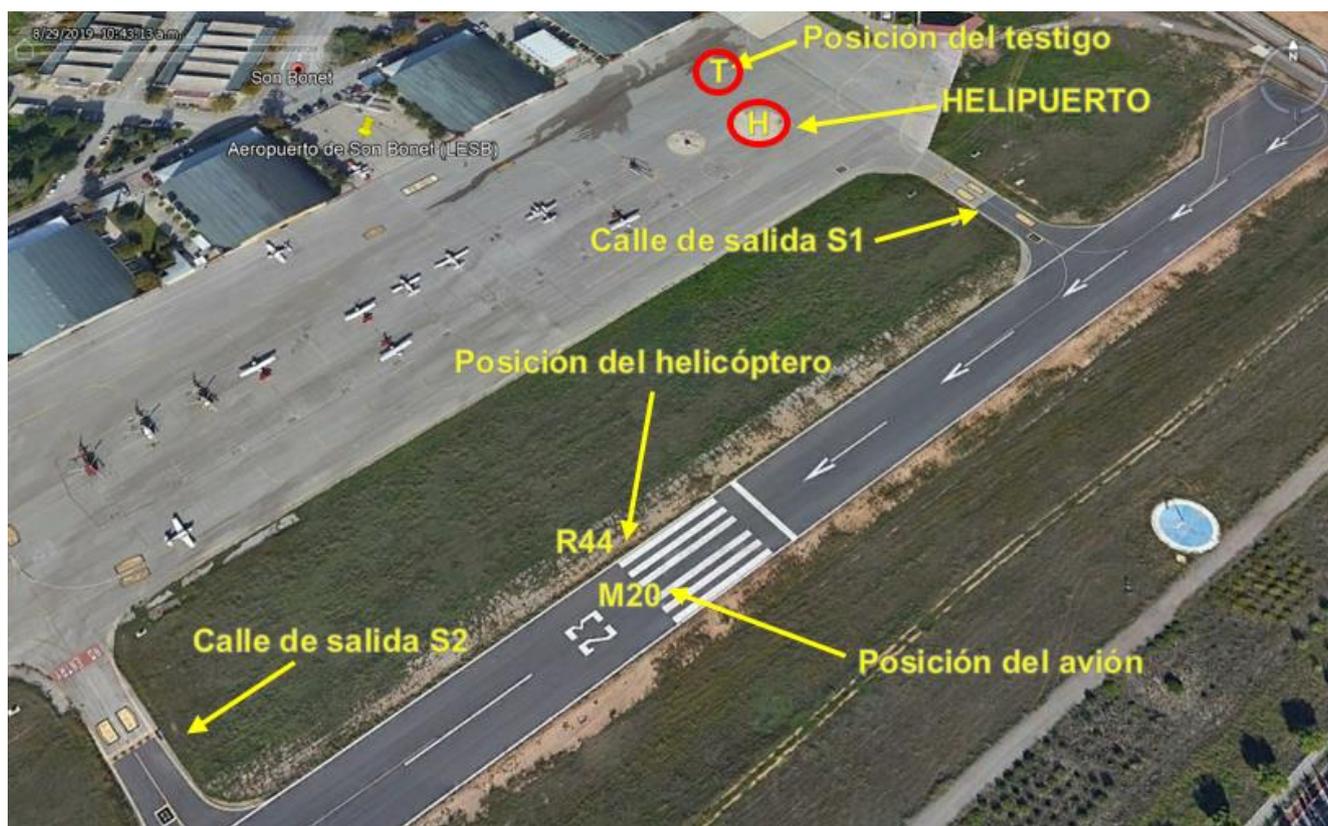
Figure 1. Overview of the situation

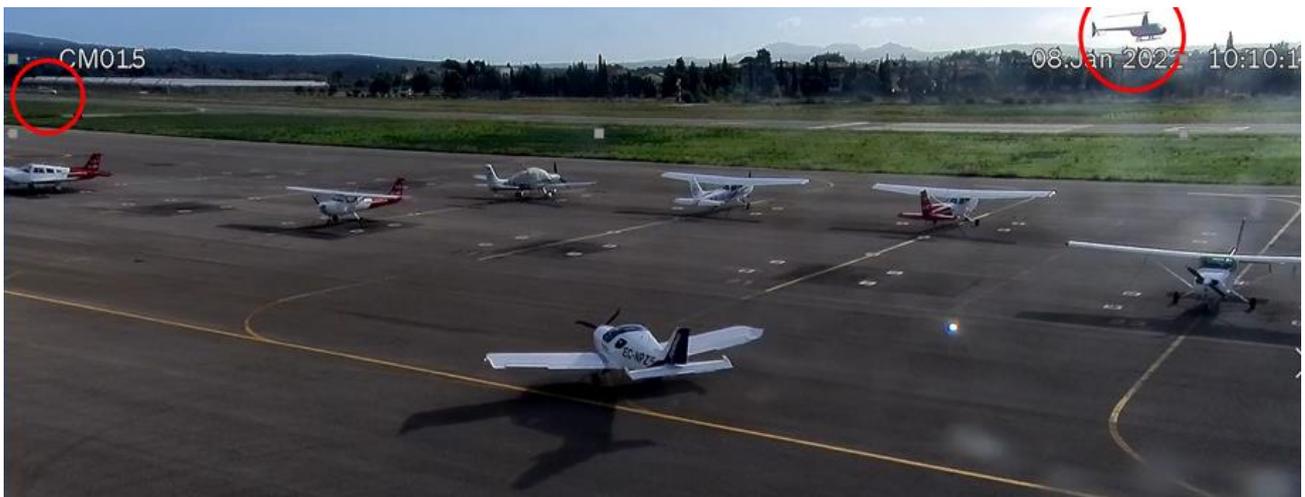
Figure 8. Moment the aircraft arrives on the runway, as seen from camera 15

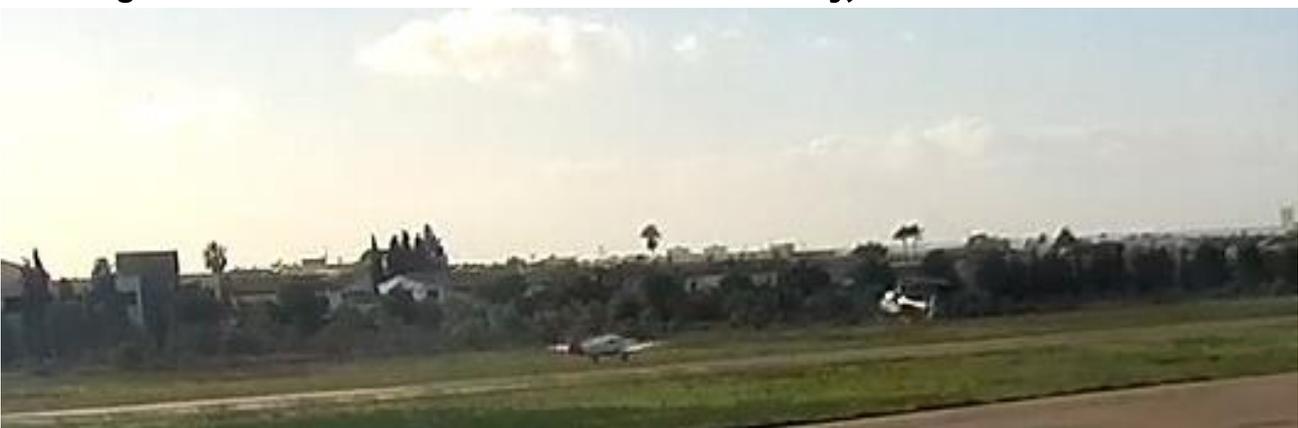
Figure 9. Instants before the aircraft passes the helicopter, as seen from camera 19
