# CIAIAC

## Report IN-007/2018

Incident involving a Boeing 737-740 aircraft operated by Jet Time A/S, registration OY-JTY, 35 NM north of Gran Canaria Airport (Las Palmas, Spain), on 25 February 2018

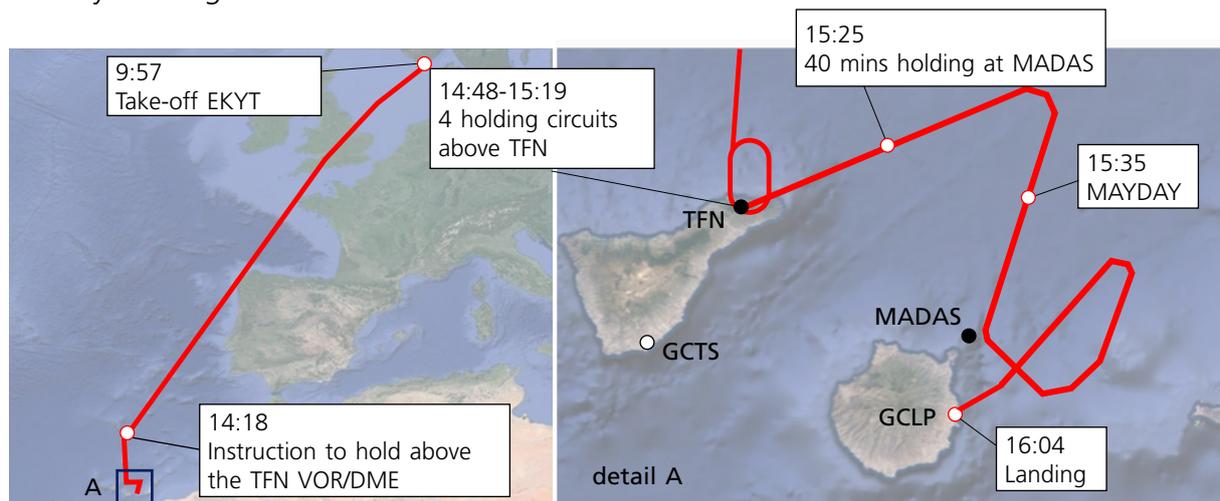
Figura 1. Trayectoria

At 09:57, the aircraft rotated for take-off. At 14:16, the aircraft was transferred to the Canary Islands ACC. Two minutes later, at 14:18, it was instructed to fly a holding pattern above the TFN VOR/DME (hereinafter TFN), where four other aircraft were already holding.
