Report IN-008/2020

Incident involving a Tecnam
P2006T aircraft, registration
LY-MEP, at the Castellón Airport
(Spain) on 10 February 2020

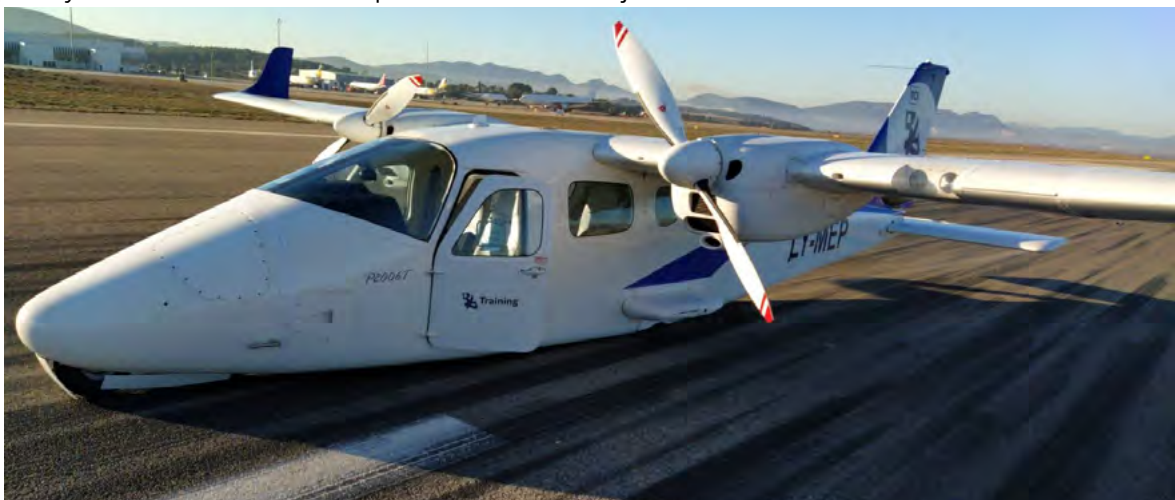
Photograph 1: Aircraft at the incident site

They checked the aircraft's status and saw that the MLG was completely retracted and the NLG was semi-retracted.

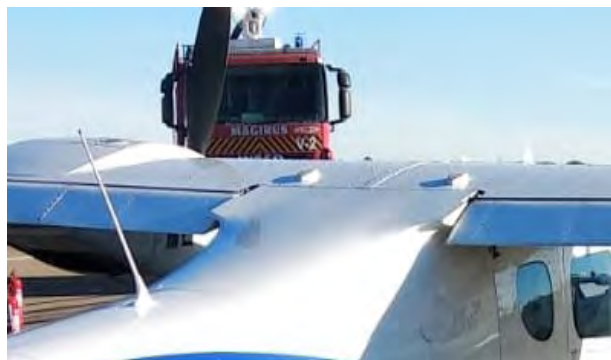
Photograph 3: Position of the flaps after the incident landing

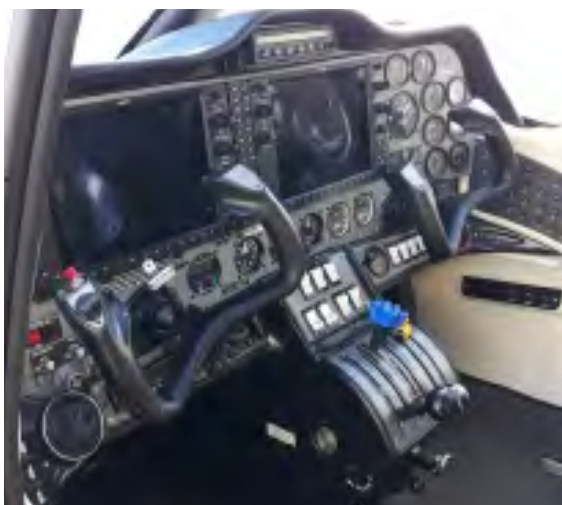
Photograph 4: Instrument panel after the incident

After the aircraft was evacuated, photograph 4, taken by the instructor, shows the following indications of interest to the investigation:

- Throttle levers full down, in the idle position.
- Propeller RPM levers full forward.
- Flaps up (0°).
- Position of landing gear lever: shown in greater detail in photograph 5, seems to indicate GEAR DOWN.

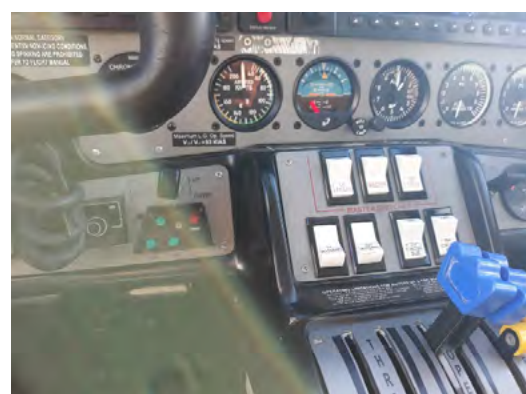
Photograph 5: Position of landing gear lever

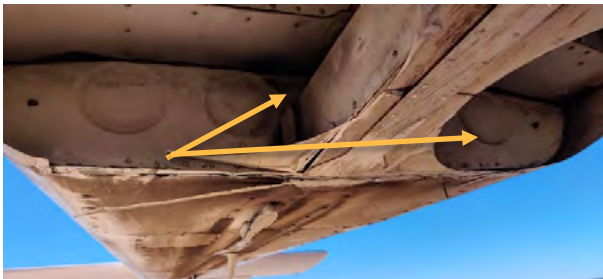
Photograph 6: MLG Wheel well

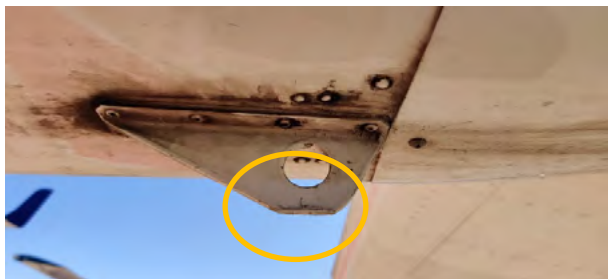
Photograph 7: Tie-down bracket on underside of tail

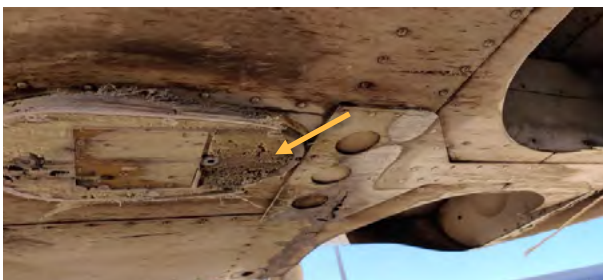
- The DME, ADF and transponder antennas, and the marker beacon receiver, located on the underside of the fuselage, detached during the aircraft's landing run and were deposited on the runway (photographs 9 and 10).
- Abrasions on the lower panels located between the LH and RH MLG wells.
- Horizontal abrasion on the tail tie-down bracket (photograph 7).
- Small fracture on the bottom of the right wing root (photograph 12).

Photograph 8: Detached marker beacon receiver

The wear on the underside of the fuselage, as well as the loss of the antennas located there (DME, ADF and transponder, as well as the marker beacon receiver), were due to landing on the runway with the underside of the fuselage with the gear not deployed.

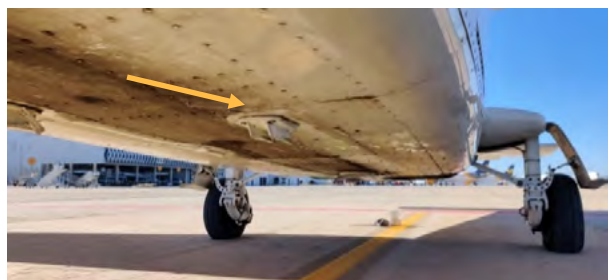
Photograph 9: Detached antennas

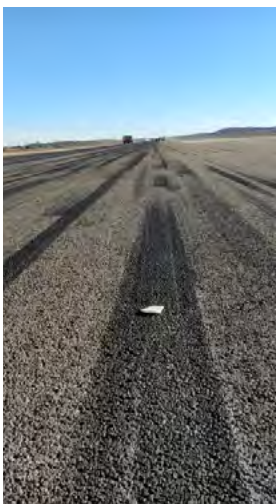
Photograph 10: Antenna fragments on runway

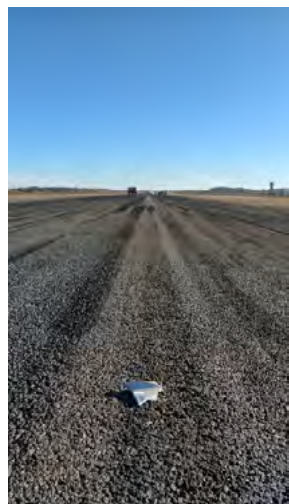
Photograph 11: Paint marks on runway

The white paint that was deposited on the runway during the landing was the result of the MLG wheel hubs being dragged on the asphalt. Since the MLG did not deploy, and since the wheels are, by design, not covered, both the wheels and the part of the hub that protrudes the most are exposed to the outside. The friction with the runway left them, on both the right and left sides, practically equally abraded, although the hub on the right wheel exhibited an area with no wear, which indicates that it was slightly more retracted into the wheel well and not in contact with the runway. The white paint marks on the runway were parallel and extended for the duration of the landing run.

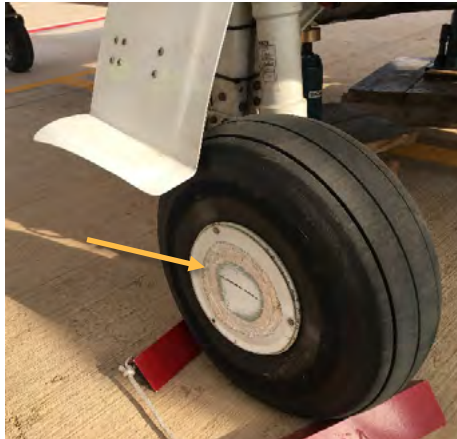
- Abrasion and transfer of paint to the asphalt runway from both MLG wheel hubs. The right-wheel hub showed uneven wear, while the wear on the left-wheel hub was even (photographs 13 and 14).
- Small dents on the MLG wheel well doors (photographs 15, 16 and 18).
- Deformation of the left NLG wheel well door (photograph 17).

Photograph 13: Left wheel and hub

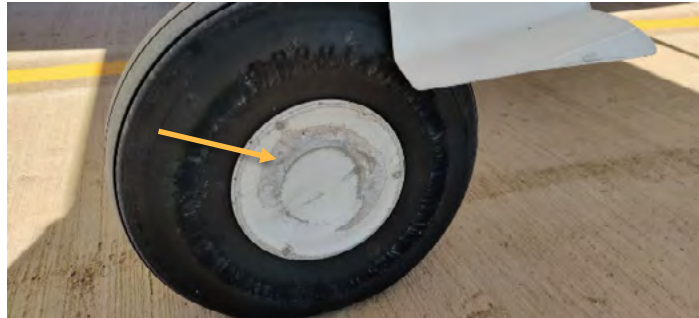
Photograph 14: Right wheel and hub

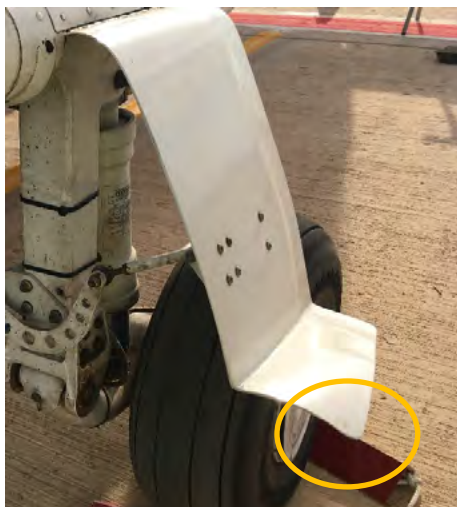
Photograph 15: Bent left MLG wheel well door

The minor damage to the doors of the MLG wheel wells, due to their shape and to being bent in the direction of motion, indicates that it was caused by minor contact between the ends of the doors and the runway.

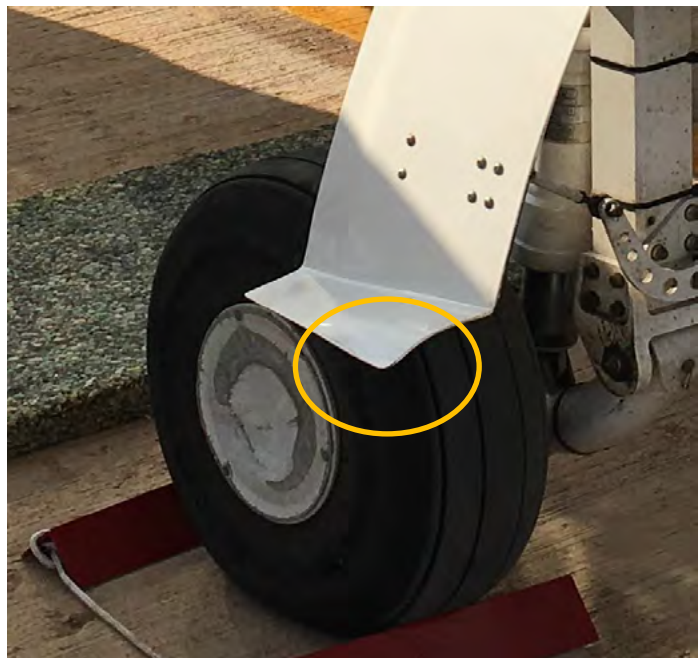
Photograph 16: Bent right MLG wheel well door

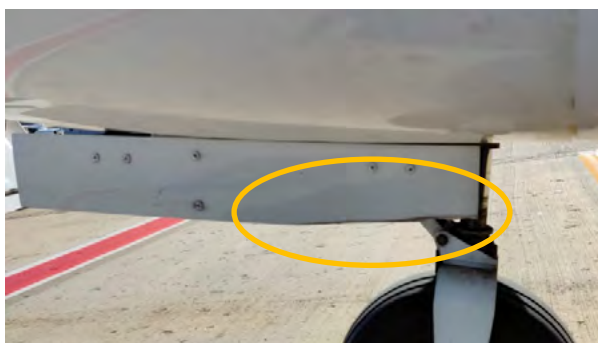
Photograph 17: Bent NLG door

The minor damage to the NLG doors indicates slight contact between them and the runway, which confirms the nose-high attitude of the airplane for much of the landing run due to the NLG being semi-deployed.

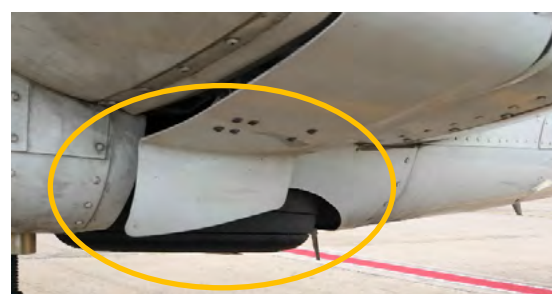
Photograph 18: Closed position of bent left MLG door

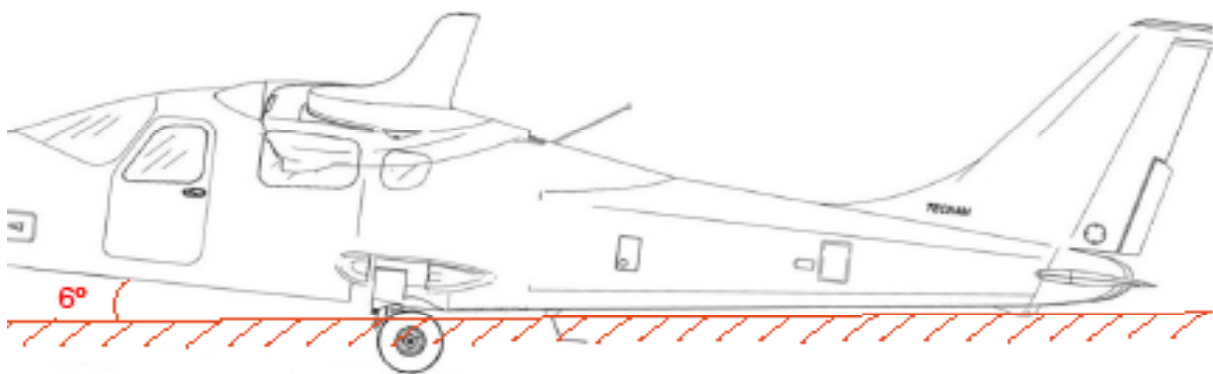
Figure 3. Position of the aircraft upon contacting the runway

Assuming the gear was operational at the time of the incident and that no random failures occurred involving the microswitches or the warning system, the most likely conclusion of the above analysis is that when the tie-down bracket made contact with the runway, the crew realized that the gear was not down and, thinking there was enough time to lower it, hastily moved the gear to the DOWN position, by which time it was impossible to execute a normal landing.

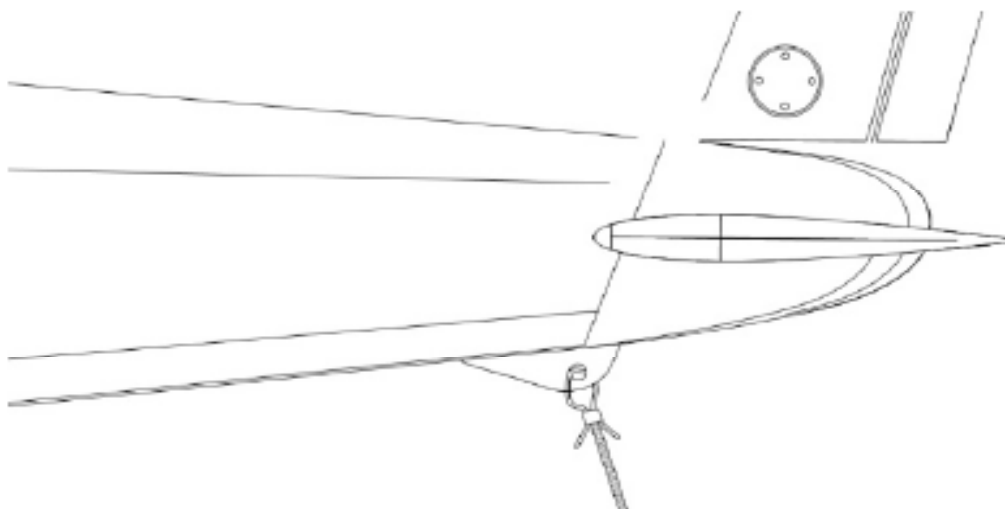
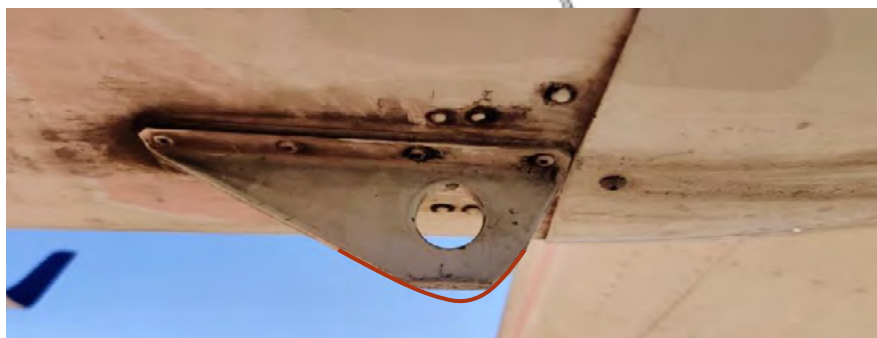
Photograph 19. Tie-down ring on the underside of the tail cone

The abrasion experienced during the landing by the tie-down bracket, located on the underside of the aircraft's tail cone, due to friction with the runway, shows a lack of material in this component, as evidenced by photograph 19. The original outline of this bracket is indicated by the red line traced out over this component in its final state.
