Technical report

IN-010/2022

Incident on 06 March 2022 involving a BOEING B737-8AS aircraft operated by Ryanair, registration EI-EVR, 19 NM to the northwest of Málaga-Costa del Sol Airport (Málaga)

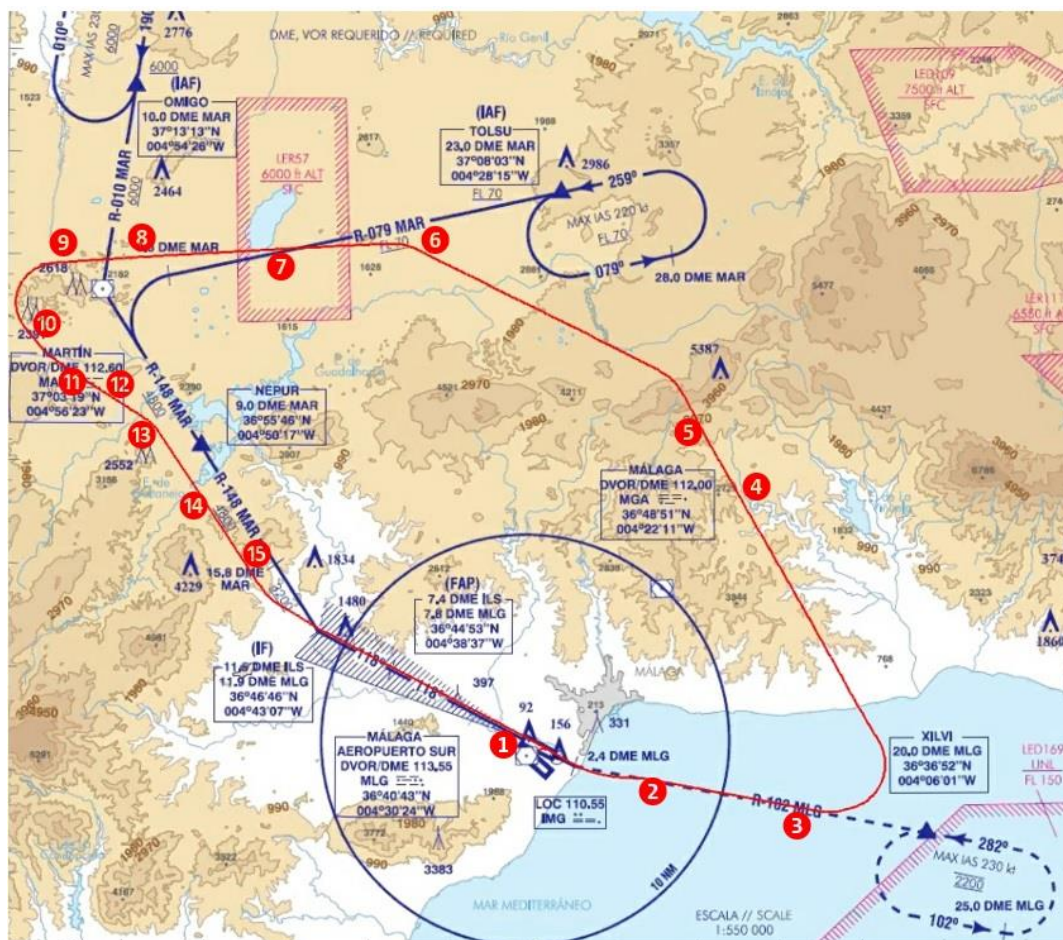
Fig. 1 Extract from the ILS Z RWY 12 approach chart showing the path followed by the aircraft, with the points of interest marked in red circles

At 08:57:05 h (see ⑪ in figure 1), proceeding to the NEPUR waypoint, the EI-EVR aircraft descended below the cleared altitude (which was 6000 ft).

At 08:58:35 h (see ⑬ in figure 1), when the EI-EVR aircraft was descending through 4554 ft, it turned to its right before reaching the NEPUR waypoint and flew parallel to radial 148 MAR, positioned 1.5 NM to the west of it.

At 08:59:58 h (see ⑭ in figure 1), the TERRAIN, TERRAIN, PULL UP warnings were activated, the autopilot disengaged, and the aircraft began to climb. The lowest barometric altitude recorded was 3235 ft. The minimum radio altimeter altitude recorded was 1065 ft at 09:00:12 h whilst already climbing through 3343 ft at 18.5 NM from LEMG. The captain took over the controls and PF role until landing.

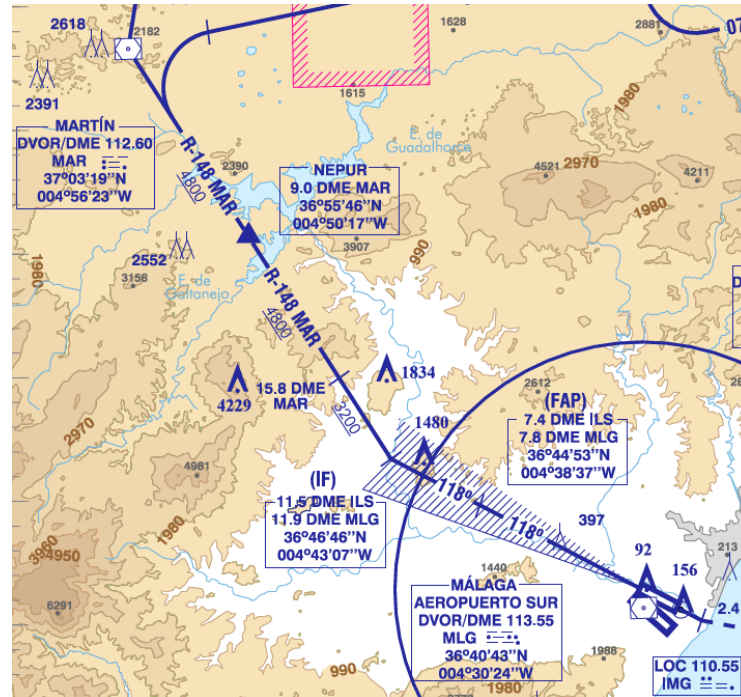
Fig. 4 Extract from the ILS Z RWY 12 approach chart

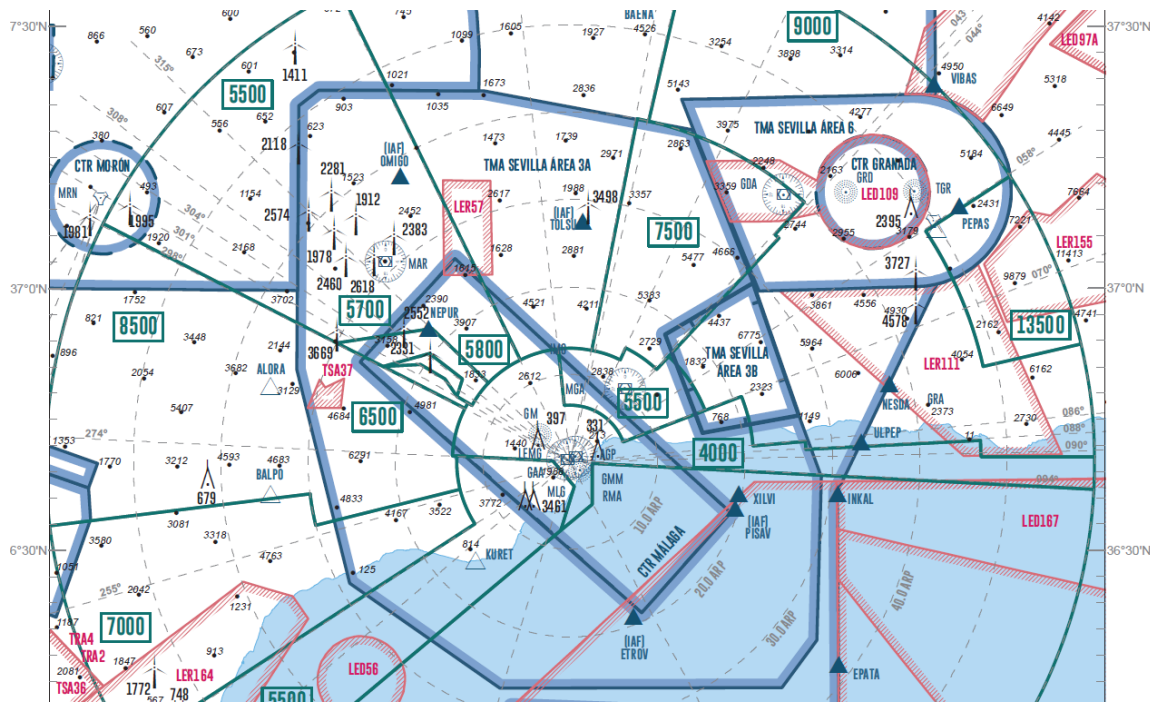
Fig.6: Relevant extract from the ATC-ICAO Minimum Surveillance Altitude Chart for Málaga-Costa del Sol Airport
