## **Report** **IN-014/2019**

Incident involving a Boeing  
737-800 aircraft, registration  
G-TAWA, at Lanzarote Airport on  
25 March 2019

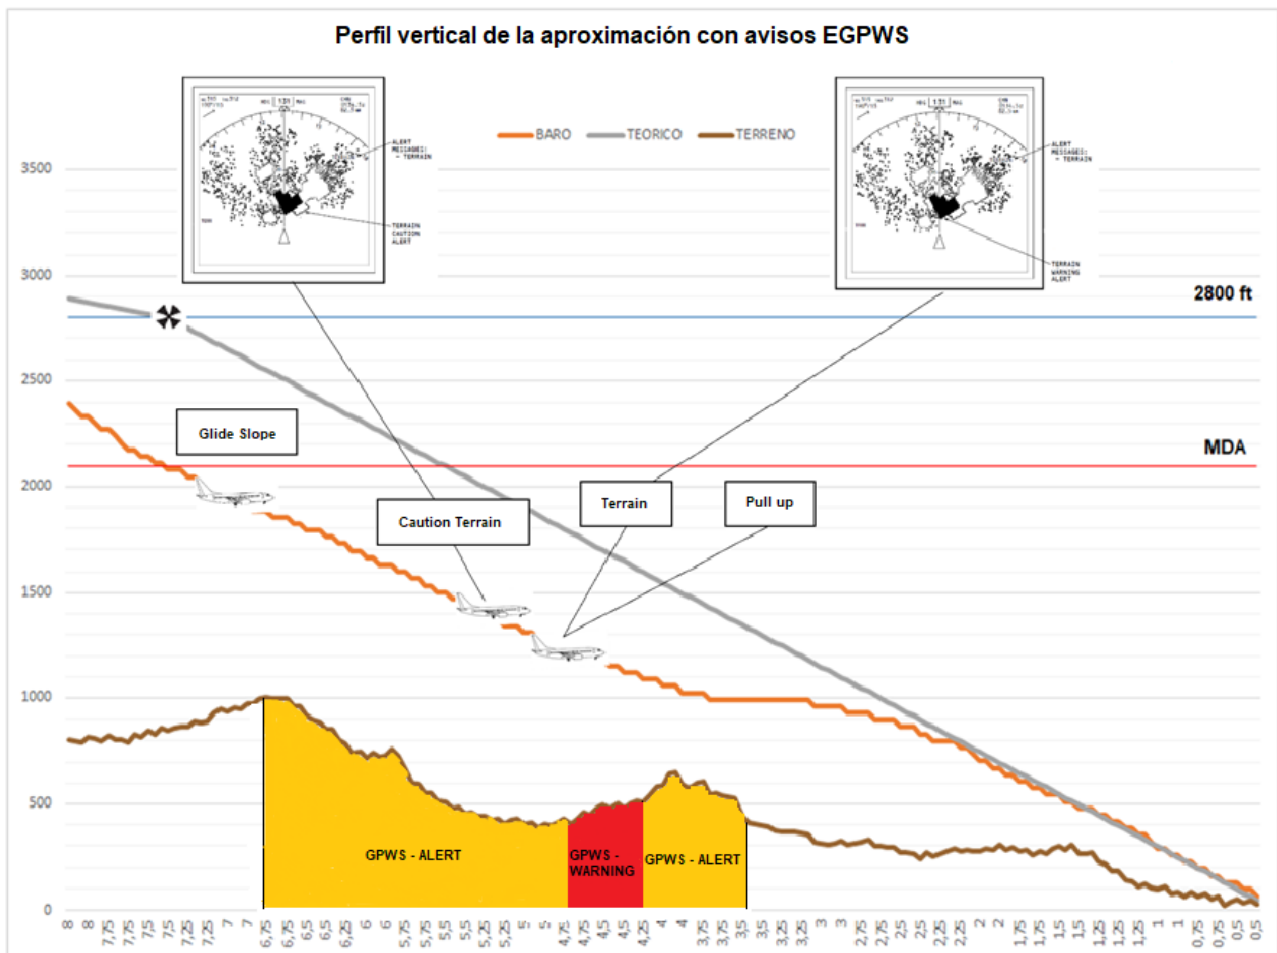
Illustration 7: Vertical profile of the approach with the EGPWS warnings

- The aircraft's highest vertical descent speed values were reached between miles 9.0 to 7.5 DME LTE. In that section, values of between 1200 and 1300 ft/min were maintained.

- At mile 3.75 DME LTE and an altitude of 1024 feet, the autopilot and autothrottle were disconnected and the aircraft levelled-off for fifteen seconds. The descent was then resumed.

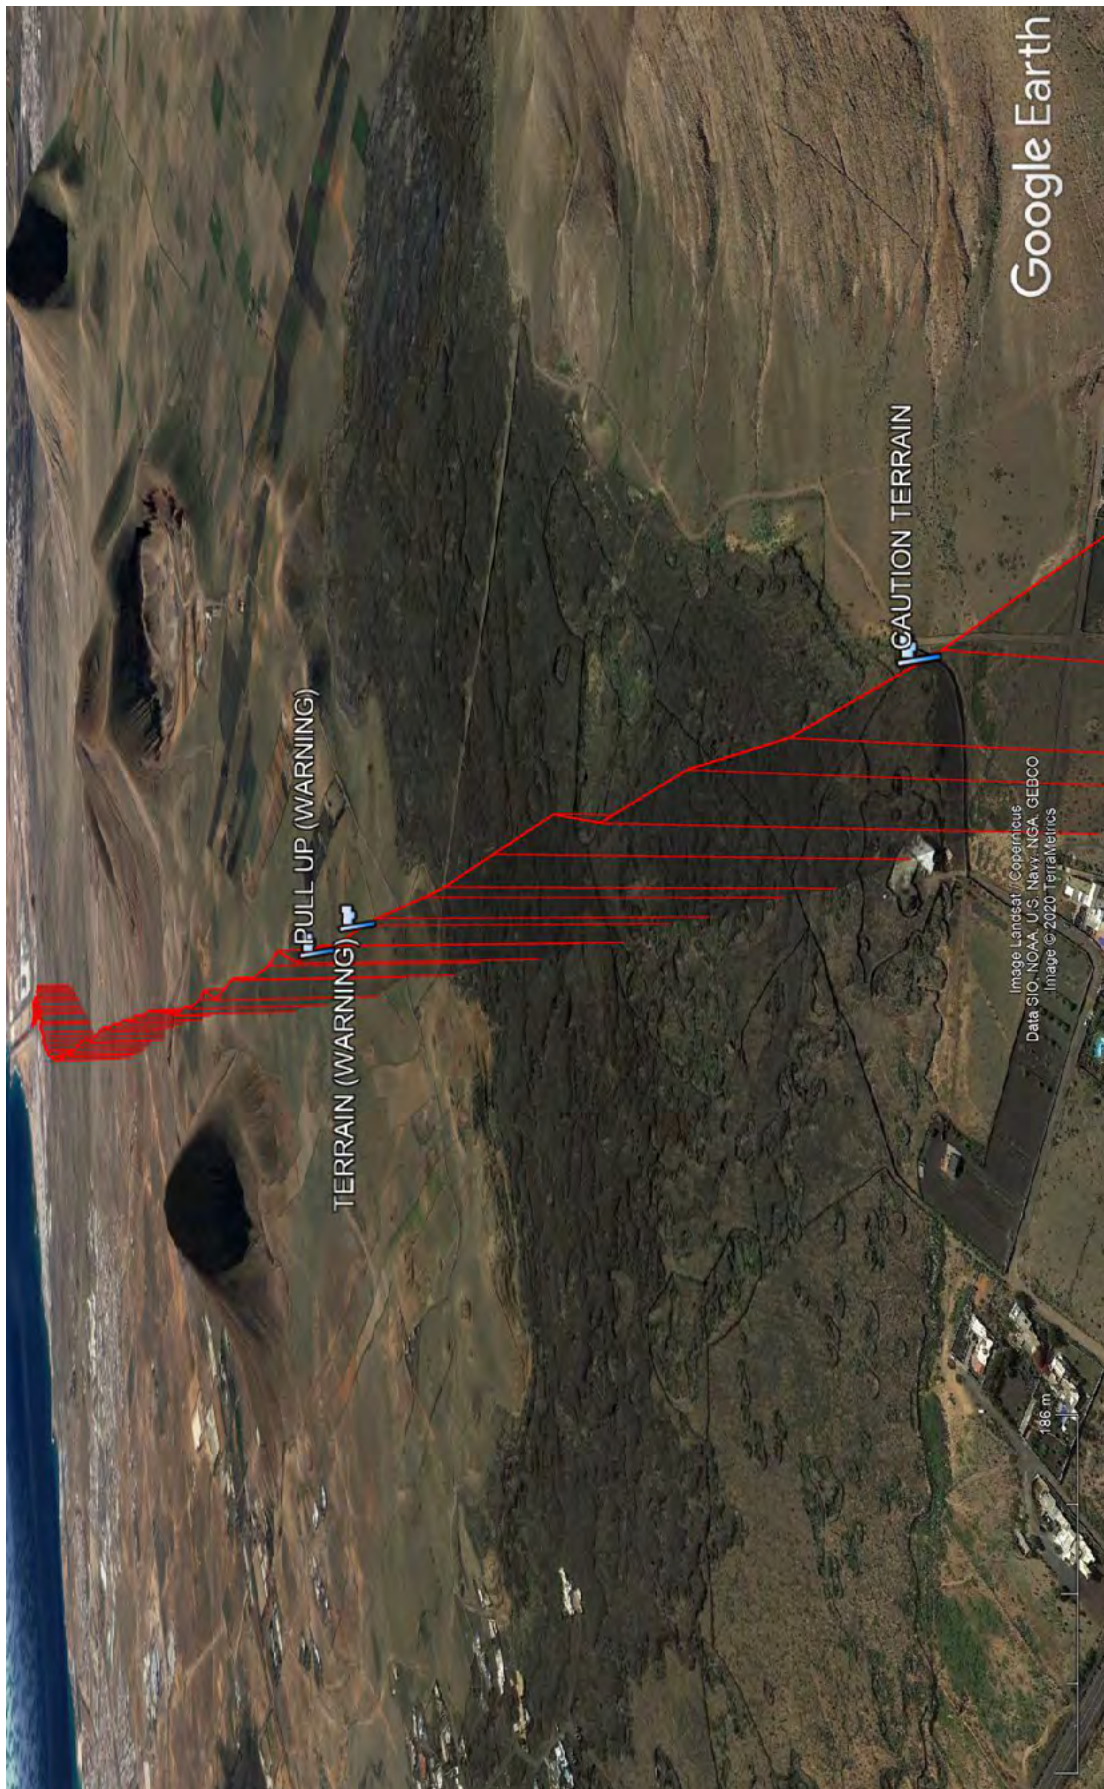
ANNEXE III: TRAJECTORY OF THE AIRCRAFT WITH THE EGPWS WARNINGS

At 13:47:27 h, when the aircraft was at 5.25 NM from the DME LTE, the enhanced ground proximity warning system (EGPWS) sounded the "CAUTION TERRAIN" alert. When the aircraft was 4.75 NM from the DME LTE, the "TERRAIN, TERRAIN, PULL UP" warning was also activated.

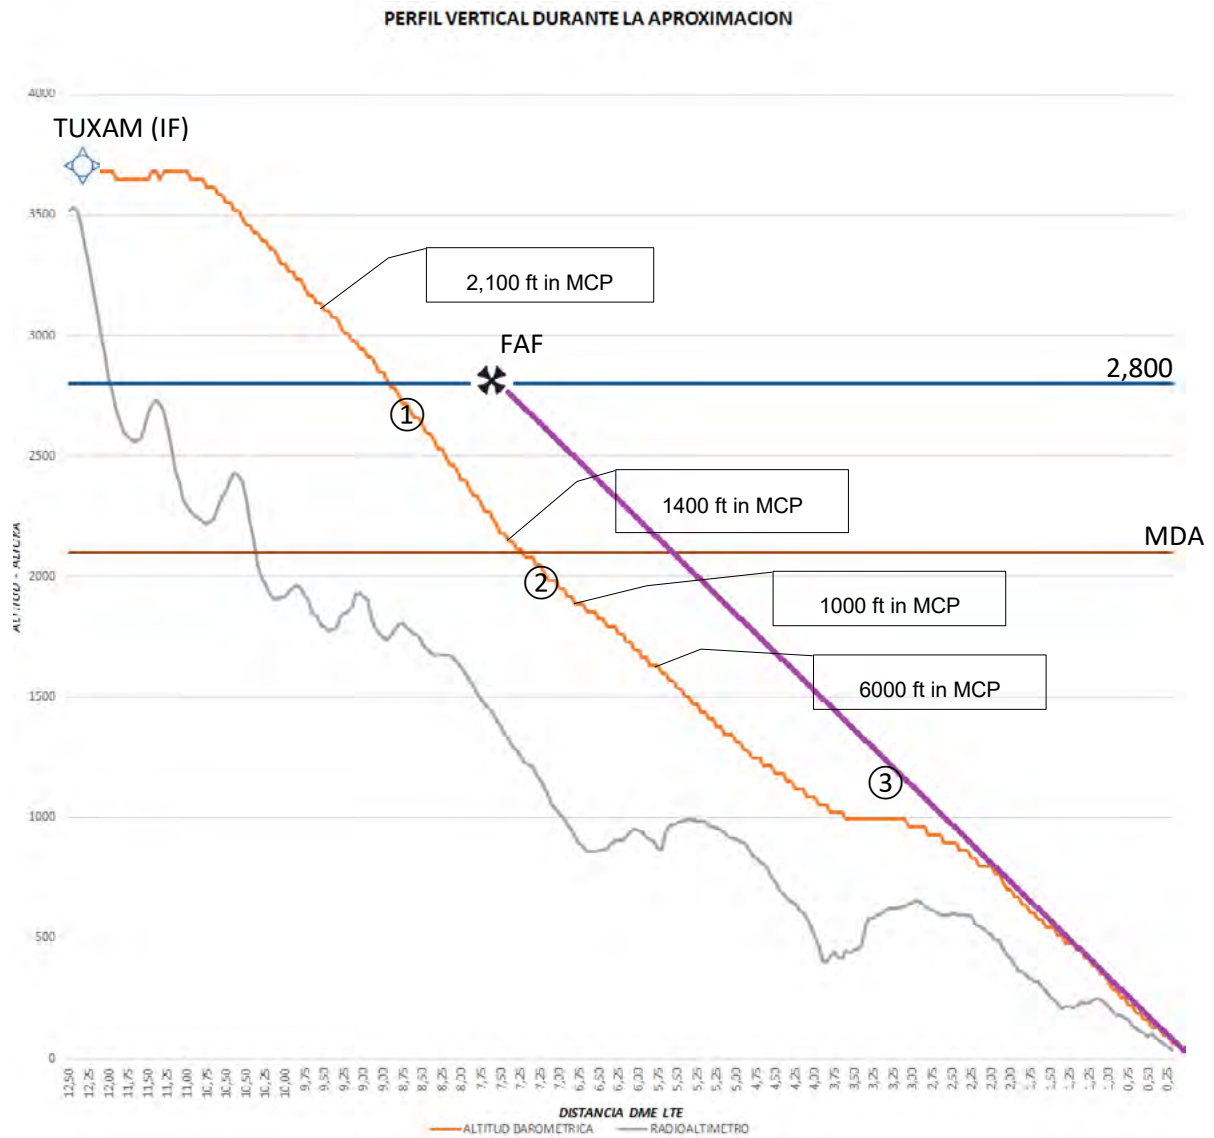
## ANNEXE IV: ALTITUDES GRAPH

The illustration shows how the aircraft descended below 2800 feet at mile 8.75 DME LTE (1.35 NM before the FAF), reaching the circling MDA of 2020 feet around mile 7.4 DME LTE (approximately 1.8 NM before mile 5.6 DME LTE). It then stays below the descent profile until, after levelling and halting the descent, it then joins it.

- ① The aircraft descends below 2,800 ft at mile 8.75 DME LTE.
- ② The aircraft reaches the circling MDA around mile 7.4 DME LTE.
- ③ The aircraft halts its descent, levels up and corrects to the 3.7-degree profile.
