# Technical report IN-014/2022

Incident involving a Cessna 560 XL aircraft,  
registration D-CNOC, on 24 March 2022 at  
Seville Airport (Seville, Spain)

## IN-014/2022

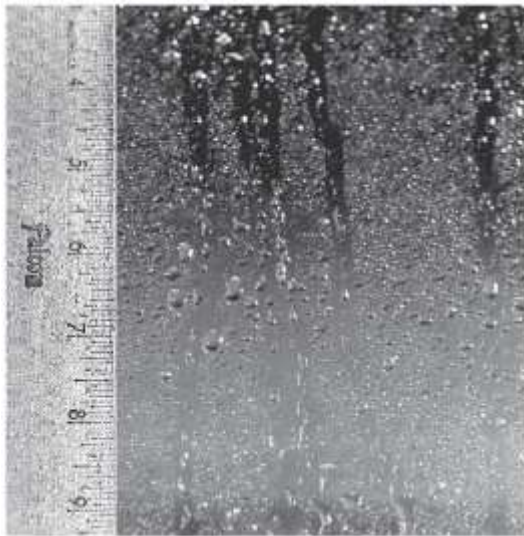
Image 5: Coating in "condition"

A coating classified as in "condition" (see illustration 5) should be subjected to an additional test that measures the contact angle of water droplets to determine the remaining permissible operating hours before renewal.

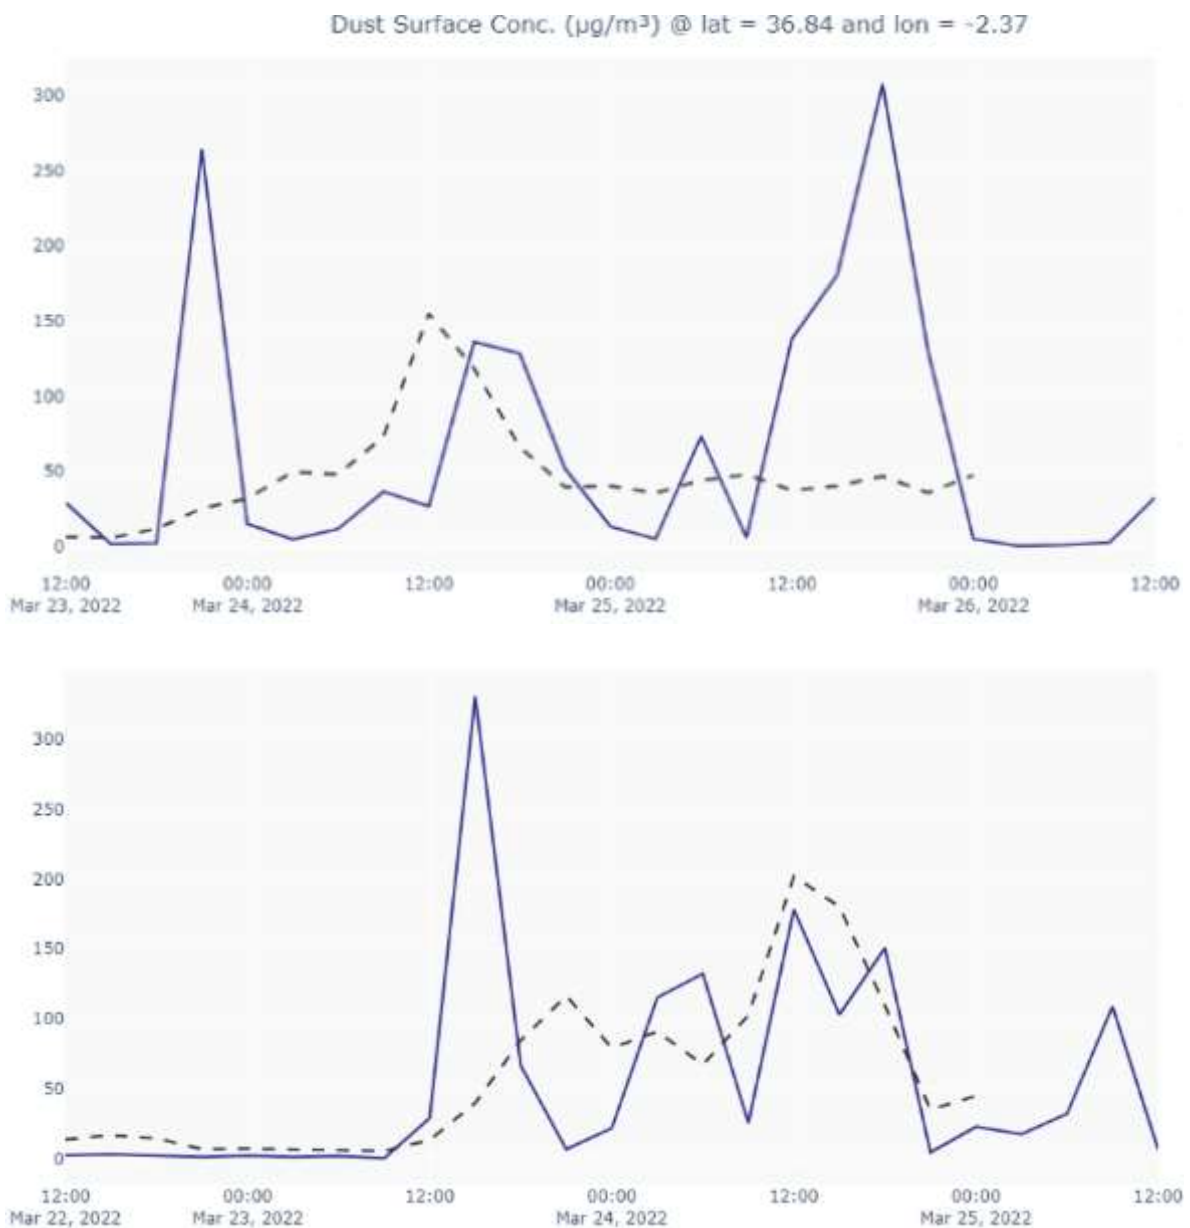
Between 12:00 h on 23 March and 0:00 h on 24 March, the Monarch model predicts a peak in the concentration of dust particles, reaching  $250 \mu\text{g}/\text{m}^3$ . Subsequently, between 0:00 h and 12:00 h on 24 March, the concentration does not exceed  $50 \mu\text{g}/\text{m}^3$ .

The Multi-model places the peak concentration of dust particles at 12:00 h on 24 March, with a value of  $150 \mu\text{g}/\text{m}^3$ .

Given that the aircraft landed at Almería Airport on 23 March at 13:55 UTC and remained there until the following day, 24 March, when it took off at 10:33 UTC, according to the Multi-model, it would not have been affected by high concentrations of dust particles, but according to the Monarch model, it would have been.
